**City of Evanston  
Civic Center 2000+**

**2100 Ridge Avenue  
Evanston, Illinois**

**RECOMMENDATIONS FOR  
INTERIM MITIGATIONS**

MARCH 24, 1999

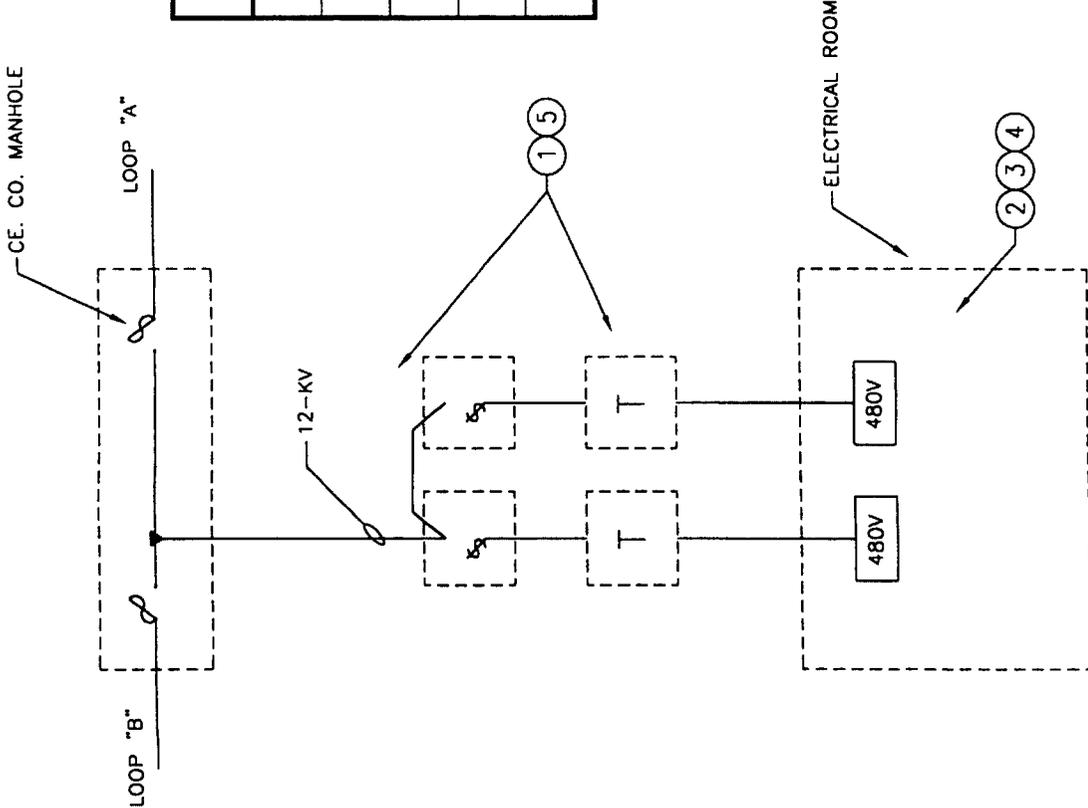
Dwg No : **SK-1**

It is unusual that a building of this size has two independent services of the same voltage. Fire departments usually desire a single source of disconnect to ensure that power is off before applying water and introducing personnel to a fire situation. The existing condition is in violation of the National Electric Code. The facility should obtain a letter of variance for its files.

A grounding system at the main switchboard or at the main water service was not observed. This does not mean the distribution system is not grounded but it may be grounded in an unconventional manner deviating from the code approved method. This should be corrected.

A large percentage of the mechanical electrical equipment is in poor condition. Open wiring in junction boxes, wire ways, and taps were observed in a number of locations, especially in the attic. In addition, minimum clearances around the electrical equipment are not maintained.

This is a safety hazard according to the National Electric Code. All code required minimum clearance dimensions should be maintained. If these conditions are to remain, a letter of variance should be obtained from the Electrical Department.

TAG NOTES	
①	LINE & RENTAL FEES
②	GROUNDING CONFLICTS. (CODE ISSUE)
③	EMERGENCY DISTRIBUTION CONFLICTS (CODE ISSUE)
④	CLEARANCE CONFLICTS. (CODE ISSUE)
⑤	SEE SK-2 FOR PROPOSED SERVICE ENTRY.

We believe a weak infrastructure is the wrong approach and recommend that the main electrical distribution system should be reconstructed. This would result in a simpler and more cost effective installation and correct the code issues for the short and long term. (See SK-2).
