Robert Crown Center and Ice Rink Complex

Evaluation of Existing Facility and Infrastructure Report

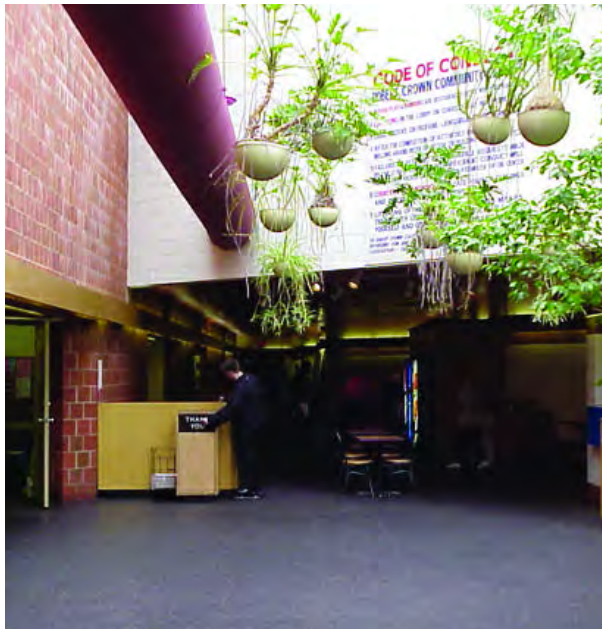
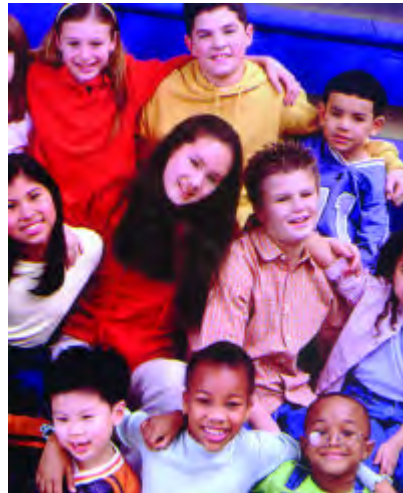
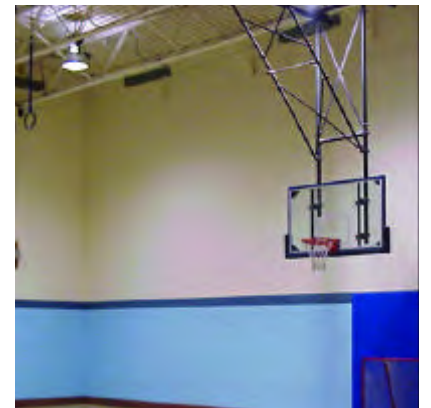
Submitted by:
A. Epstein and Sons International, Inc.

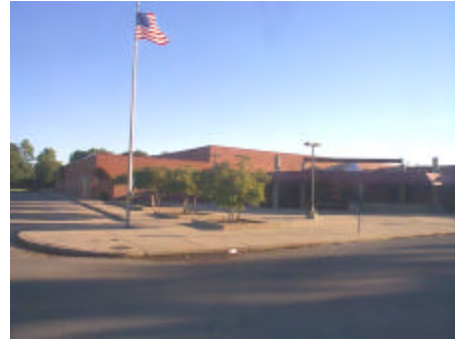
Photo O1: Main Entrance façade of the Robert Crown Center

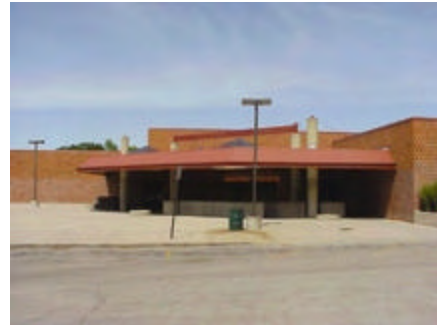
Photo A-1: Overall Front Entry

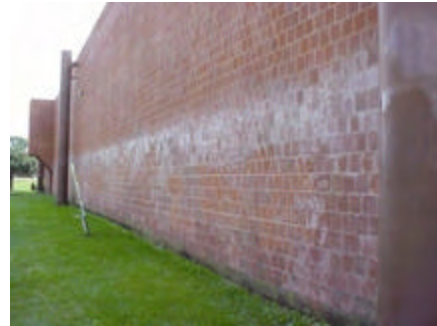
Photo A-2: North Side Masonry Wall – Showing Graffiti Block

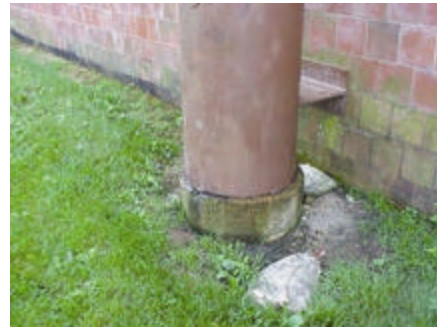
Photo A-3: North Side Drainage Condition

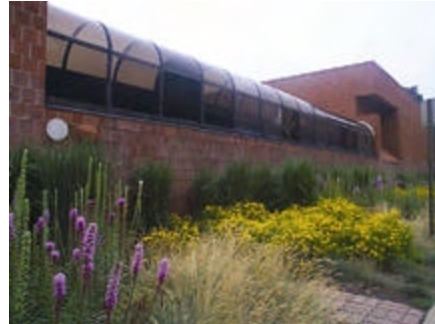
Photo A-4: South Wall Skylight

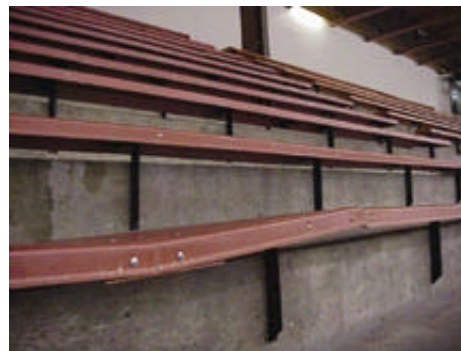
Photo A-10: Broken Bleacher Seats

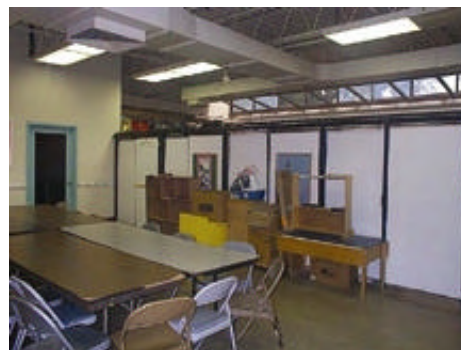
Photo A-11: Craft Room

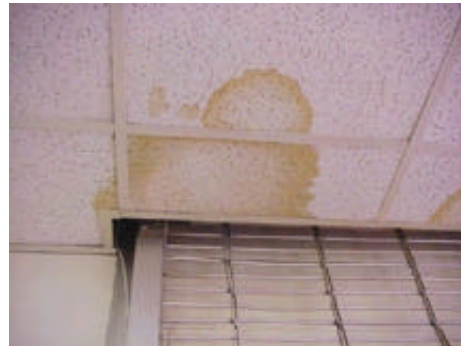
Photo A-13: Water Stained Ceiling Tiles at Office Area

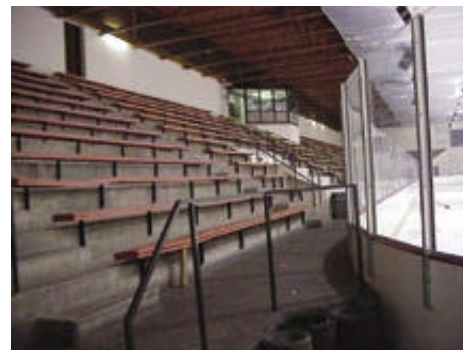
Photo A-14: Ice Rink/Bleachers Showing Sound Booth

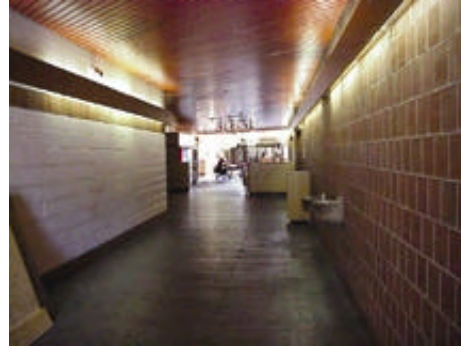
Photo A-15: Main Concourse

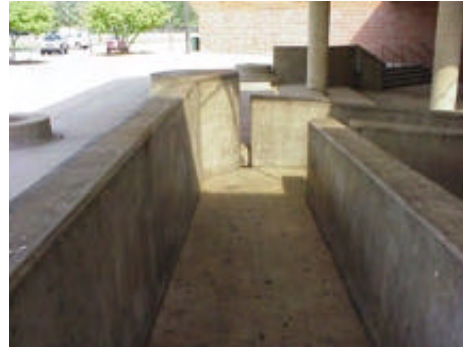
Photo A-18: Main Entry Ramp

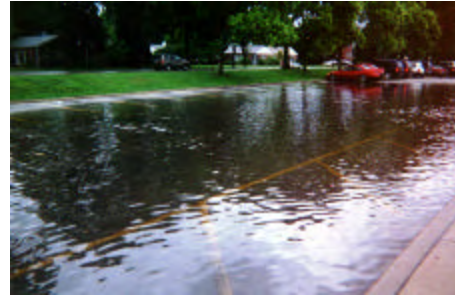
Photo C-1: Parking lot flooding looking Southwest.

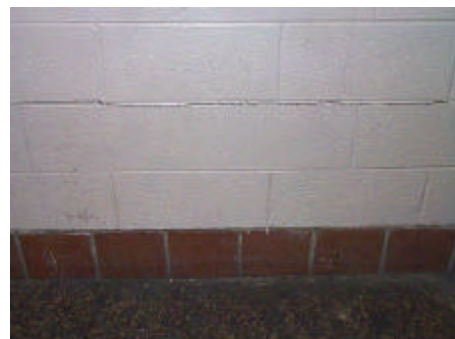
Photo S3: Main Ice Rink – Eastern Wall – Crack in masonry wall.

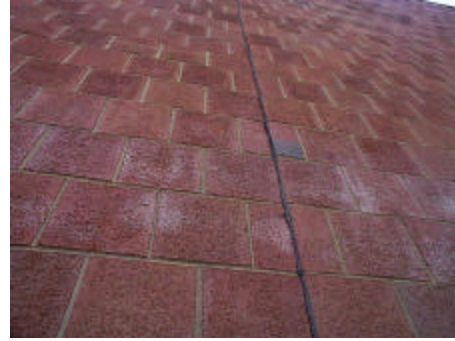
Photo S-4: Main Ice Rink – Eastern Wall – Bowed masonry wall.

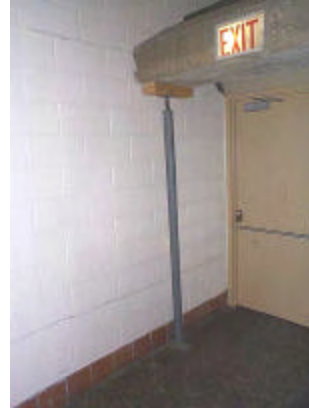
Photo S7: Main Ice Rink – Eastern End of Concrete Grandstand – Shoring adjacent to pinched doorframe.

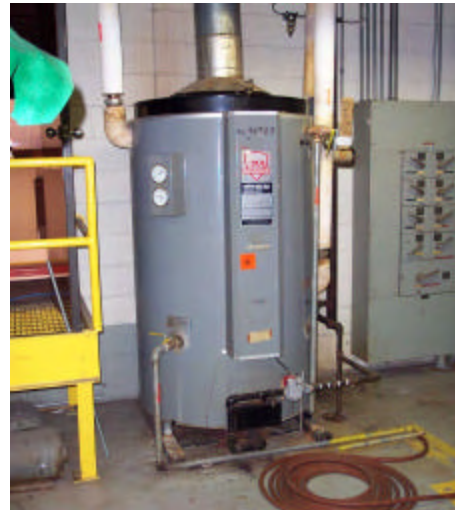
Photo E-1: Distribution Panel in Rooftop Mechanical Room

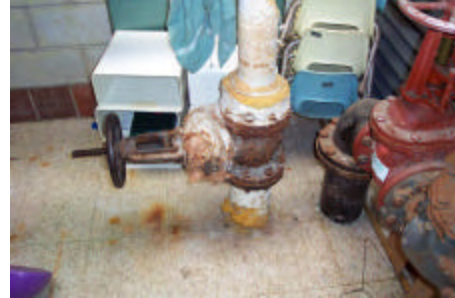
Photo P-1: Incoming water service.

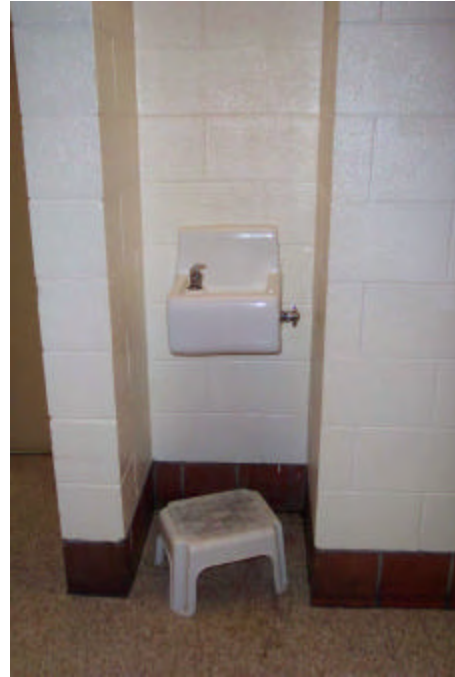
Photo P-4: Drinking fountain.

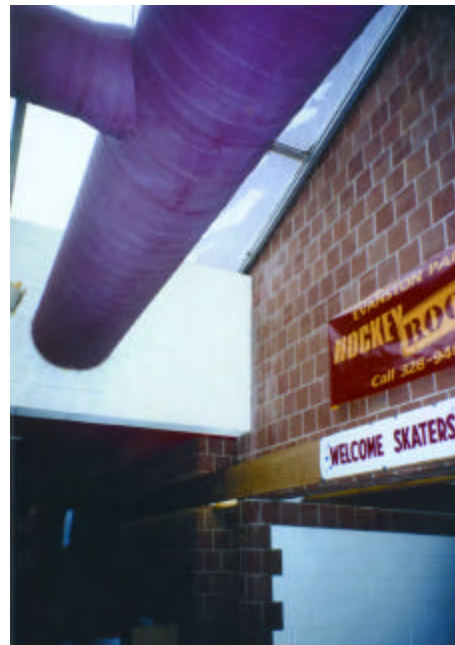
Photo R-2: View of leakage area at the northwest corner of the main skylight.

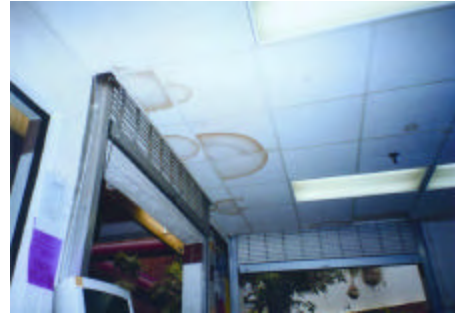
Photo R-3: View of stained ceiling boards in room A132.

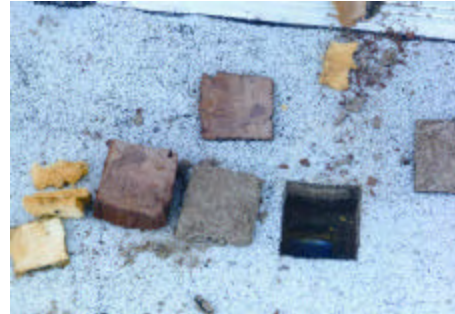
Photo R-4: Components left to right: Rigid fiberglass, phenolic, perlite, built-up membrane (above the perlite), sample opening, modified bitumen membrane.

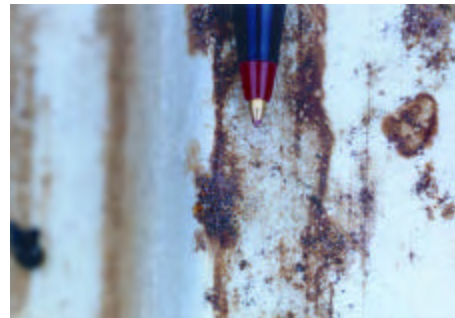
Photo R-7: Close up of test-cut #2, showing superficially corroded steel deck (the tip of the ink pen shows the scale of the photo).

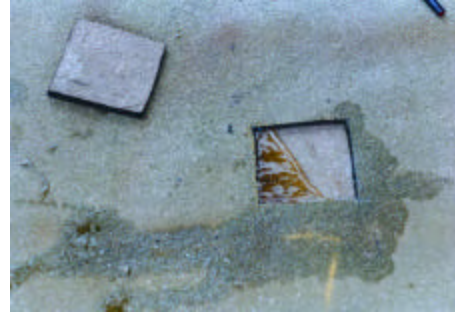
Photo R8: View of test cut #7, after removal of the modified bitumen membrane. Note the water at the left portion of the sample.

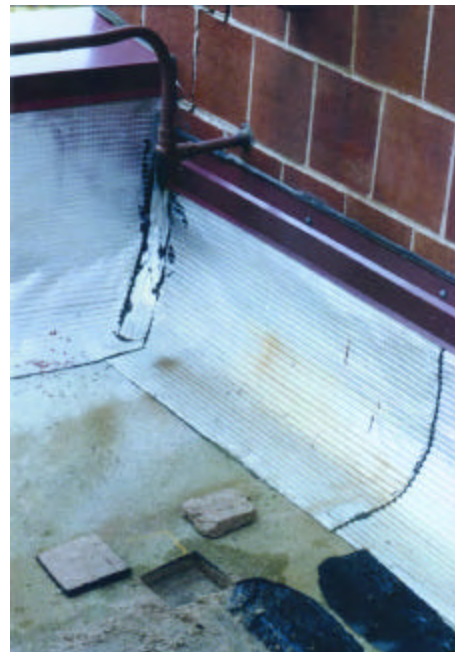
Photo R9: View of test cut #7 after removal of the membrane and perlite. Water may have migrated from the wall cracks (upper center).

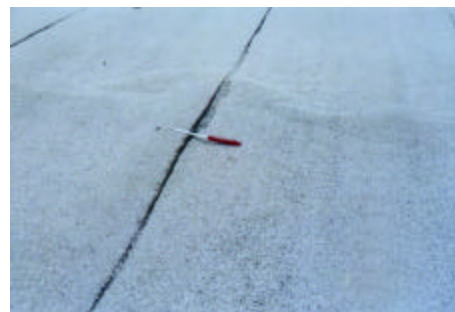
Photo R-10: View of a blister on Roof E.

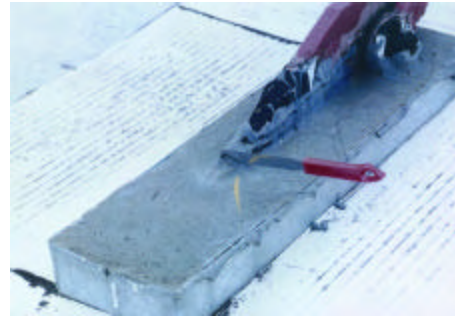
Photo R11: The putty knife is in an opening in the pitch pocket sealer. Photo R-1 shows where the pitch pockets occur.

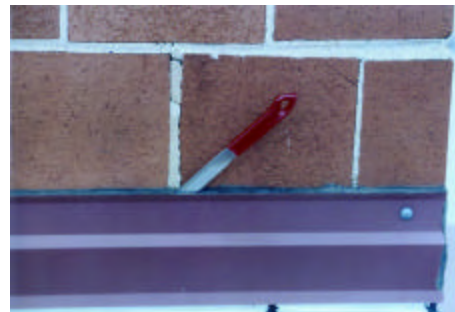
Photo R-12: The putty knife is in an opening where the sealant is no longer bonded. Note the cracked mortar joint.

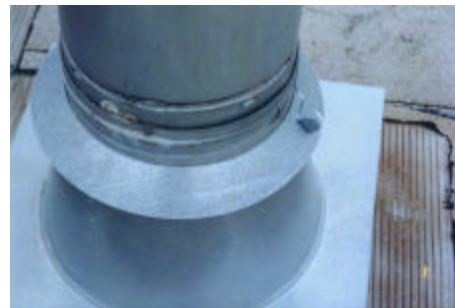
Photo R13: The storm collar was not sealed to the flue.

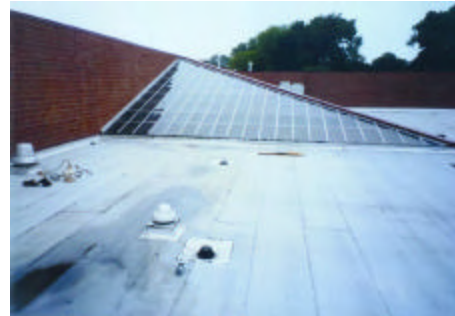
Photo R14: General view of the main skylight. The coping on the diagonal wall was loose.

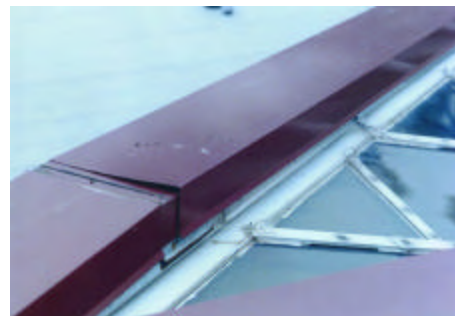
Photo R-15: Close-up of loose coping on the sloped diagonal wall of the skylight.

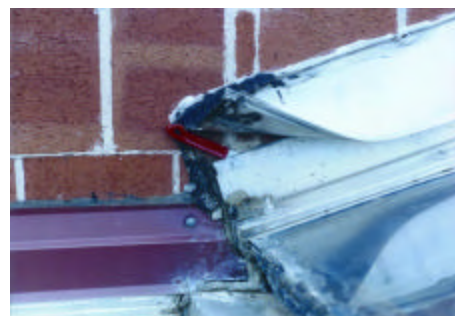
Photo R-16: View of the counterflashing at the main skylight. A putty knife is in the unsealed opening between the wall and the flashing leg.

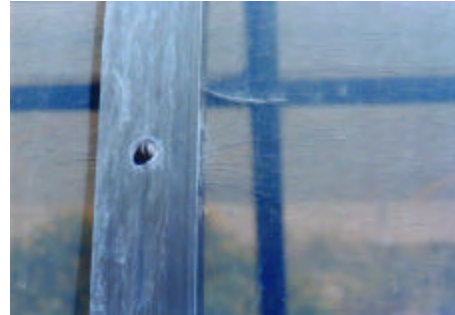
Photo R17: Close-up of crazed-crack glazing at the barrel vault skylight.

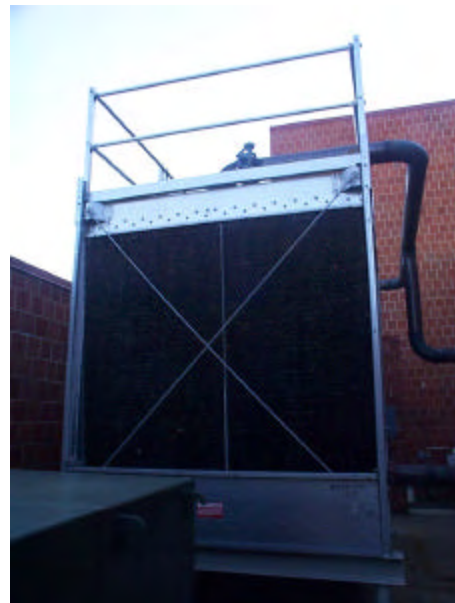
Photo RF-2: Cooling Tower.

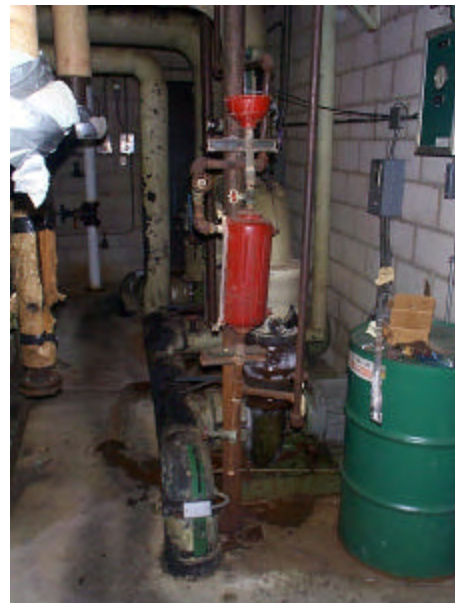
Photo RF-3: Circulating pumps.

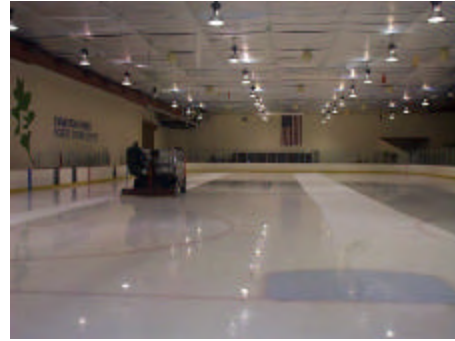
Photo RF-4: Main Ice Rink.

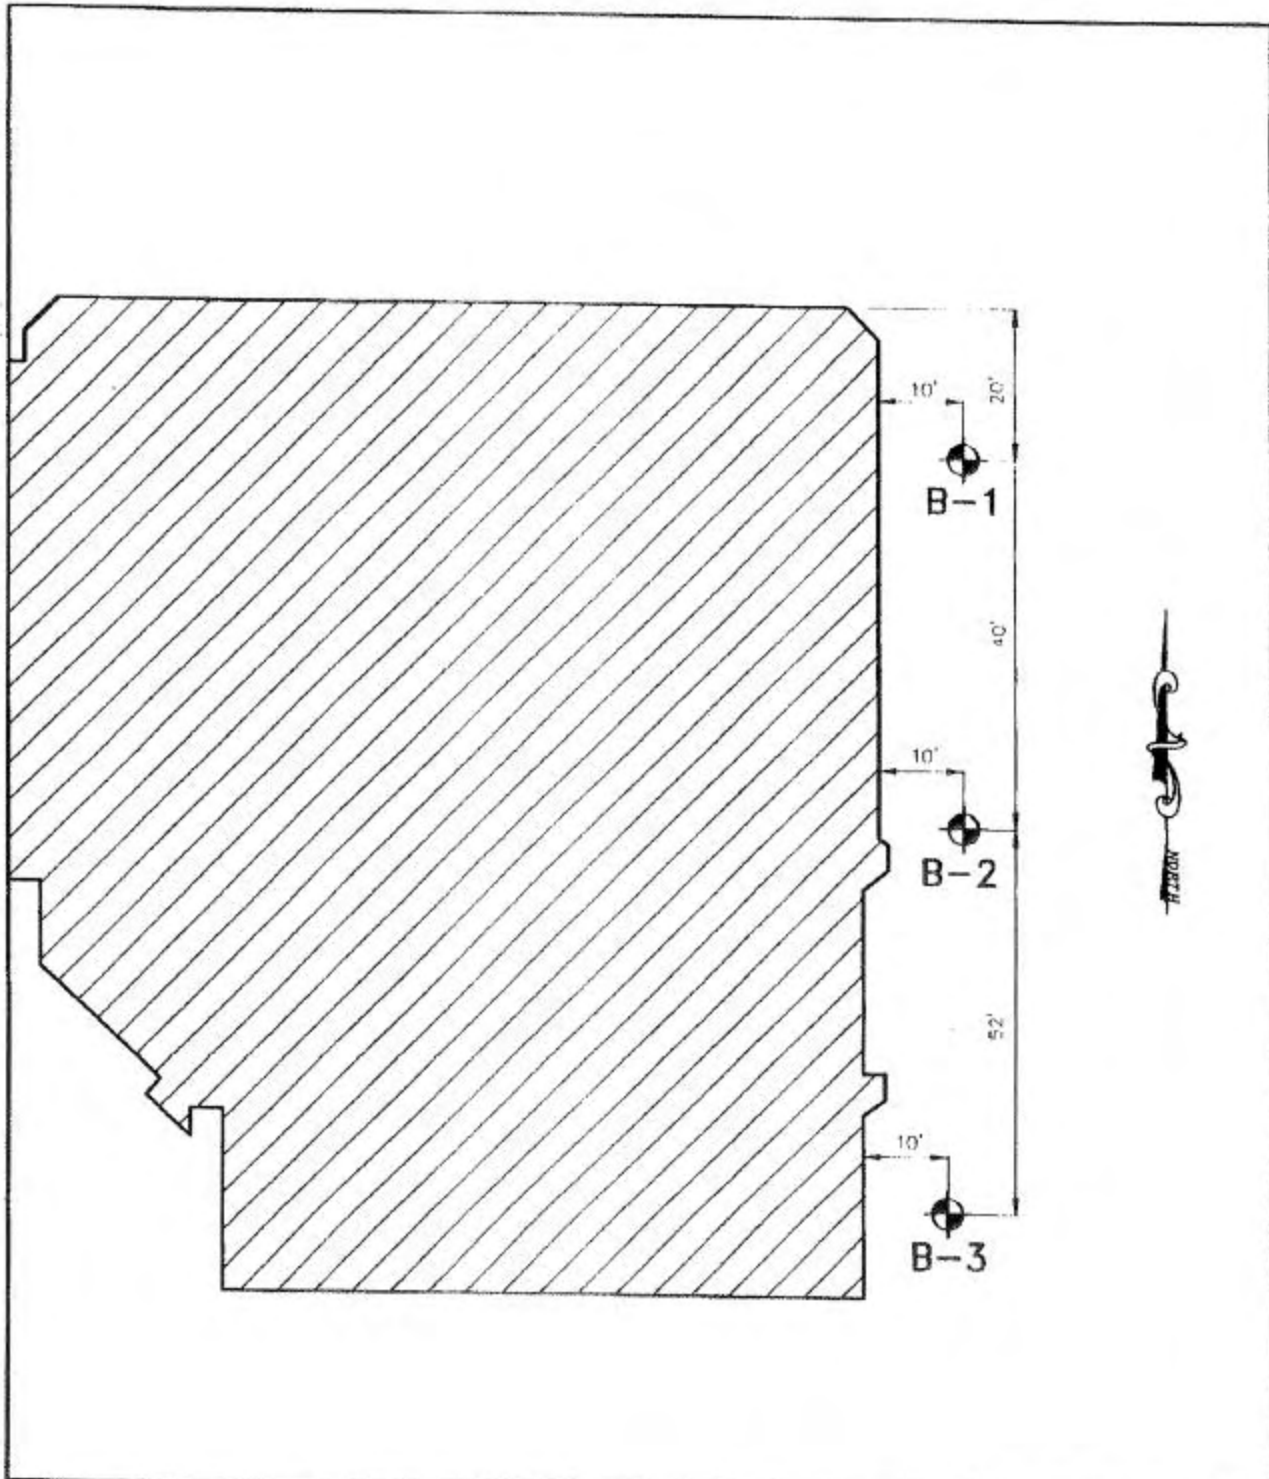
BORING LOCATION DIAGRAM		  O'BRIEN & ASSOCIATES, INC. CONSULTING ENGINEERS 1235 E. DAMS ST./ARLINGTON HTS., IL 60005 (847) 398-1441 • FAX (847) 398-7376	DRAWN BY	RWC
Foundation Wall Investigation for the Robert Crown Center 1701 W. Main Street, Evanston, Illinois			APPROVED BY	DOB
			DATE	8-14-02
			JOB NO.	02255
			SCALE	NTS

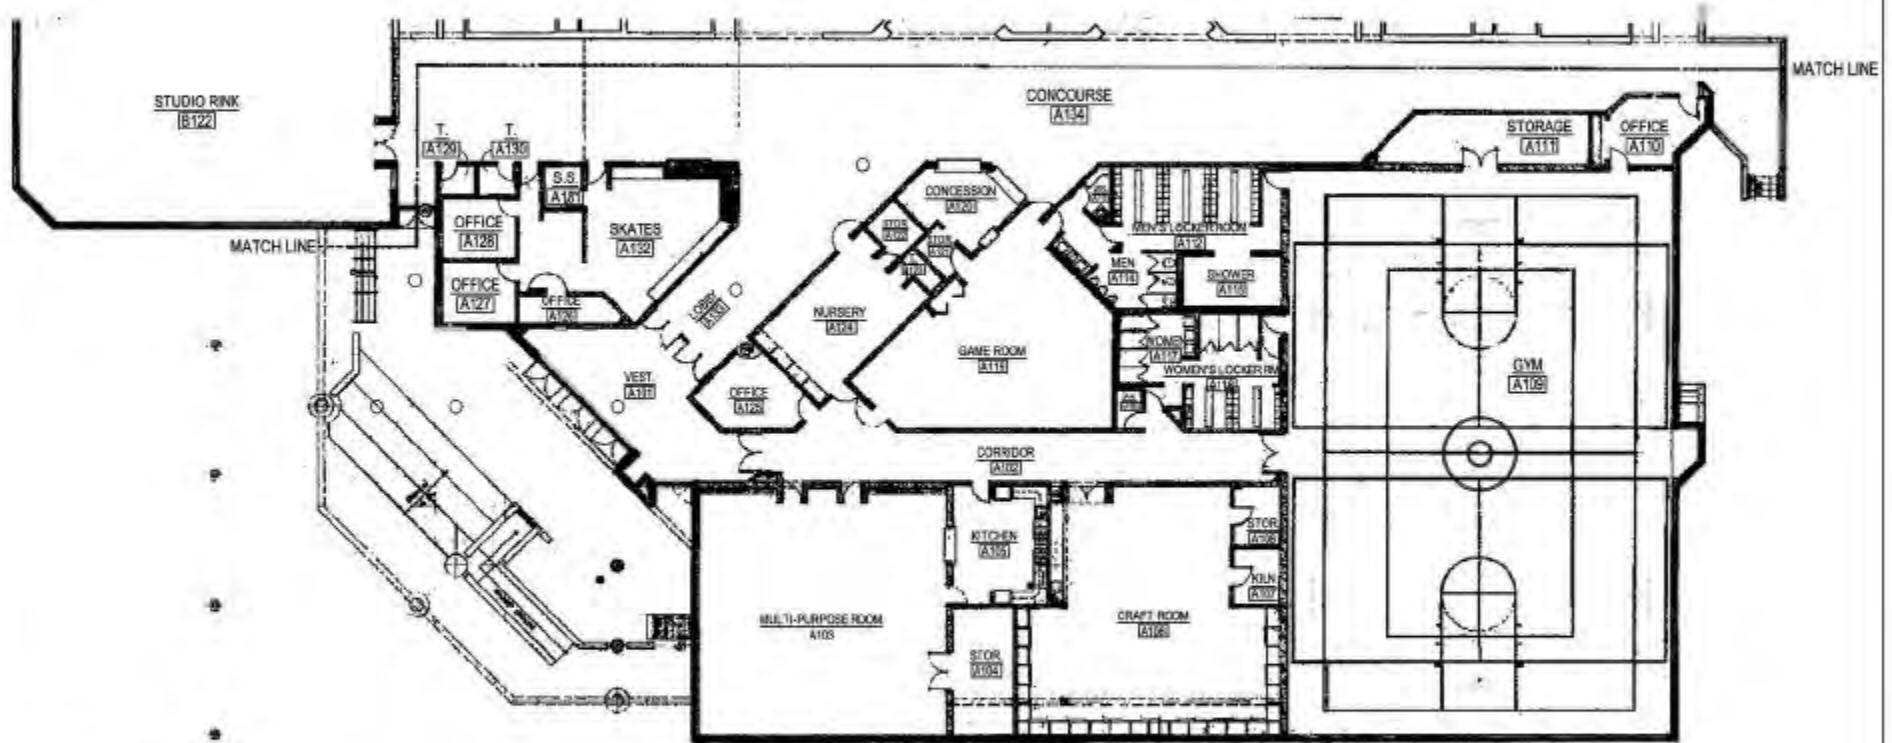
Total for Architectural/Site/Civil				\$1,492,839

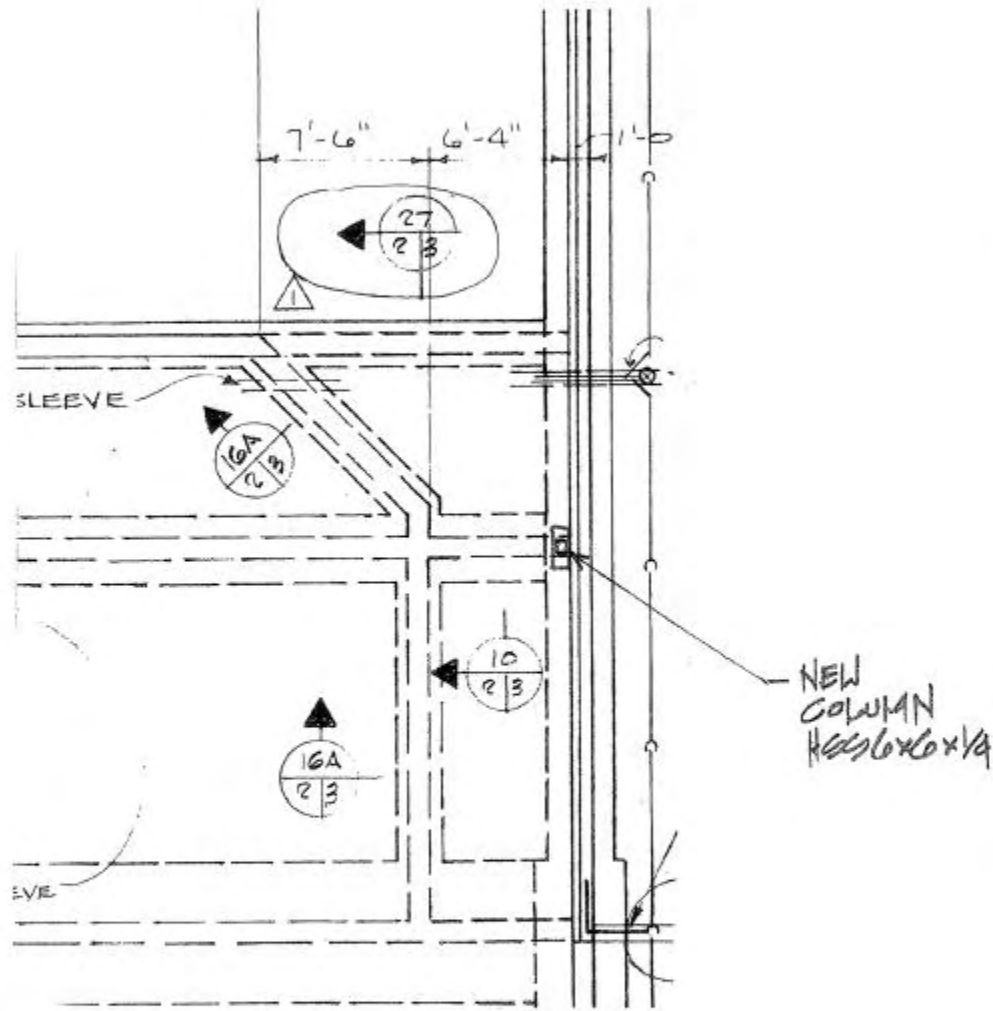
PARTIAL FOUNDATION PLAN
