# **Code Analysis and Conditions Assessment Report**

## **Evanston Arts Center**

2603 Sheridan Road  
Evanston, IL 60201

June 25, 2012

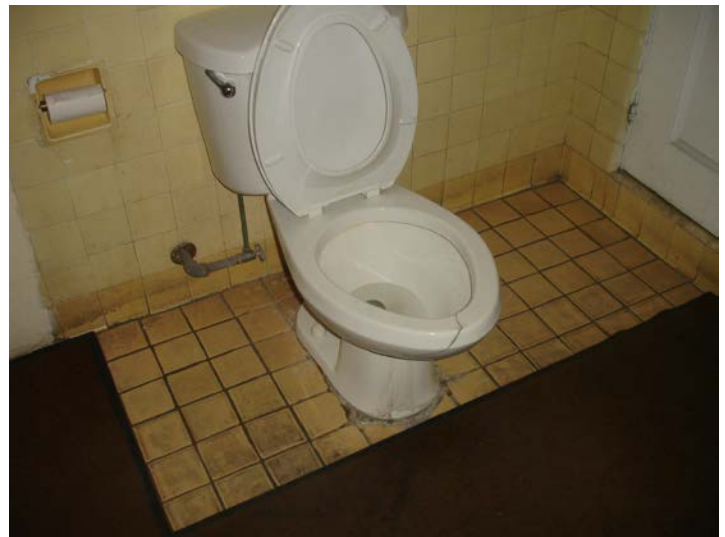
As noted in the Architectural portion of this report the plumbing systems are deficient for a business occupancy. The number of toilet rooms, fixture counts and locations are as they were for the original residence. No changes were made with the conversion to a business occupancy. Also a few fixtures have been removed over the years. All of the bathtubs have been capped over so they cannot be used. A couple of the toilets were noted as being cracked and some of the lavatories were replaced with slop sinks.

3rd floor toilet room (fixture cracked)

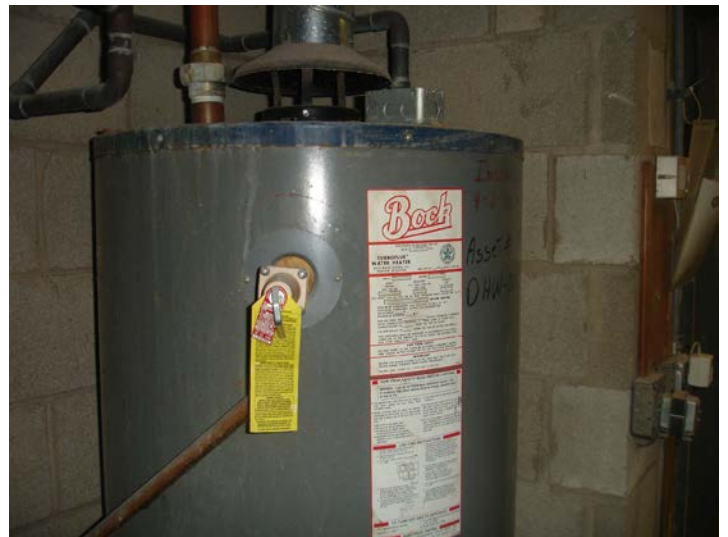
The domestic hot water heater would also be undersized for this upgrade. The heater is over 20 years old so it is at the end of its expected useable life anyway and would be in need of replacement. It is located in the boiler room in the basement.

Domestic hot water heater

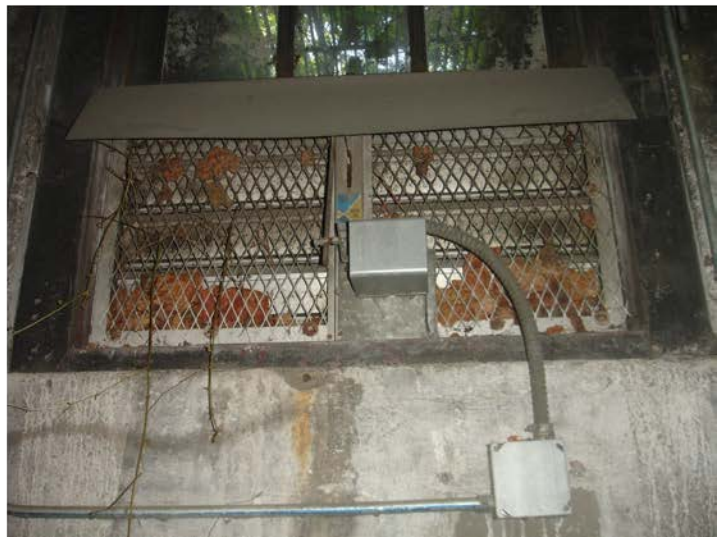
The combustion air intake for the boiler room has a louver and an auto damper approximately 35 x 15 installed in a window opening. The size is marginal for the capacity of gas fired appliances installed, plus it is blocked up with debris, leaves etc. This should be upgraded when the boiler is replaced.

Combustion air intake for boiler room

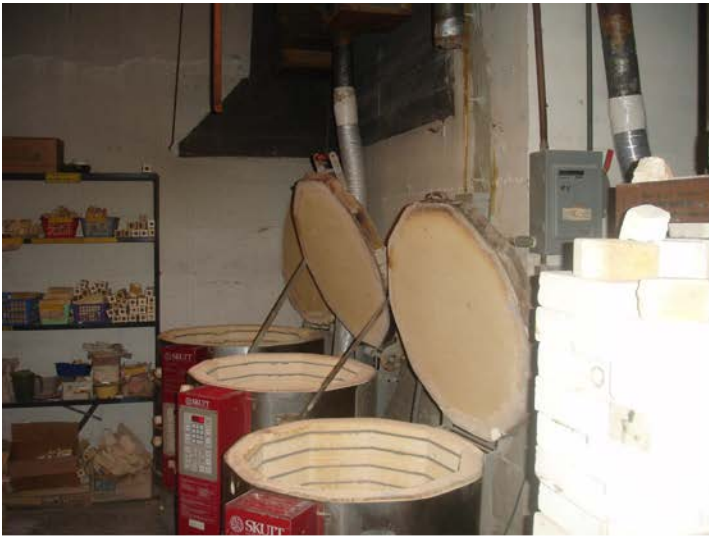
In the basement, there are a number of gas fired ceramics kilns. This space by code needs to be enclosed in a fire rated room. Presently it is open to the rest of the basement. A few of the Kilns have exhaust hoods over them but they appear inadequate in size and location to do an adequate job of exhausting heat and fumes.

Kiln room

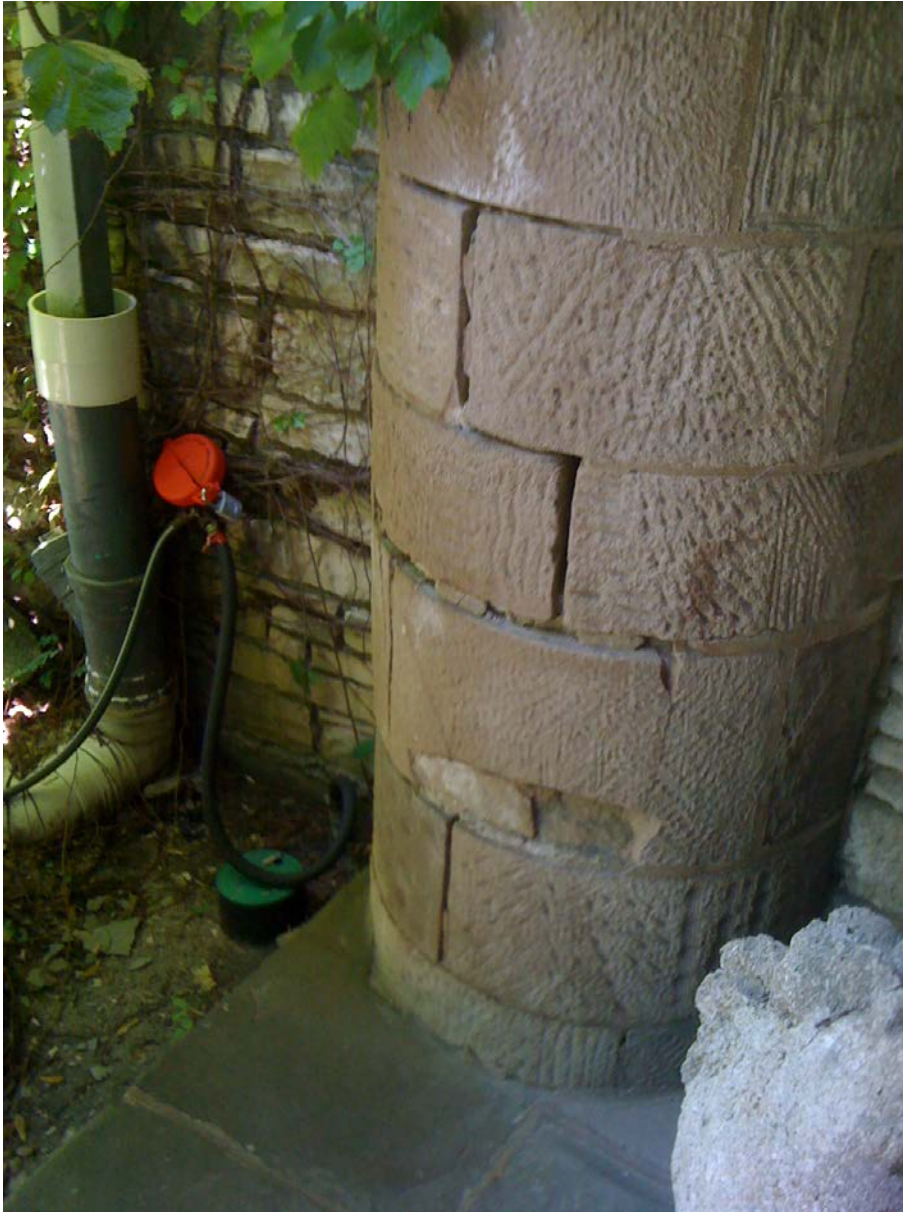
Photo 3 – Mortar deterioration at west porch

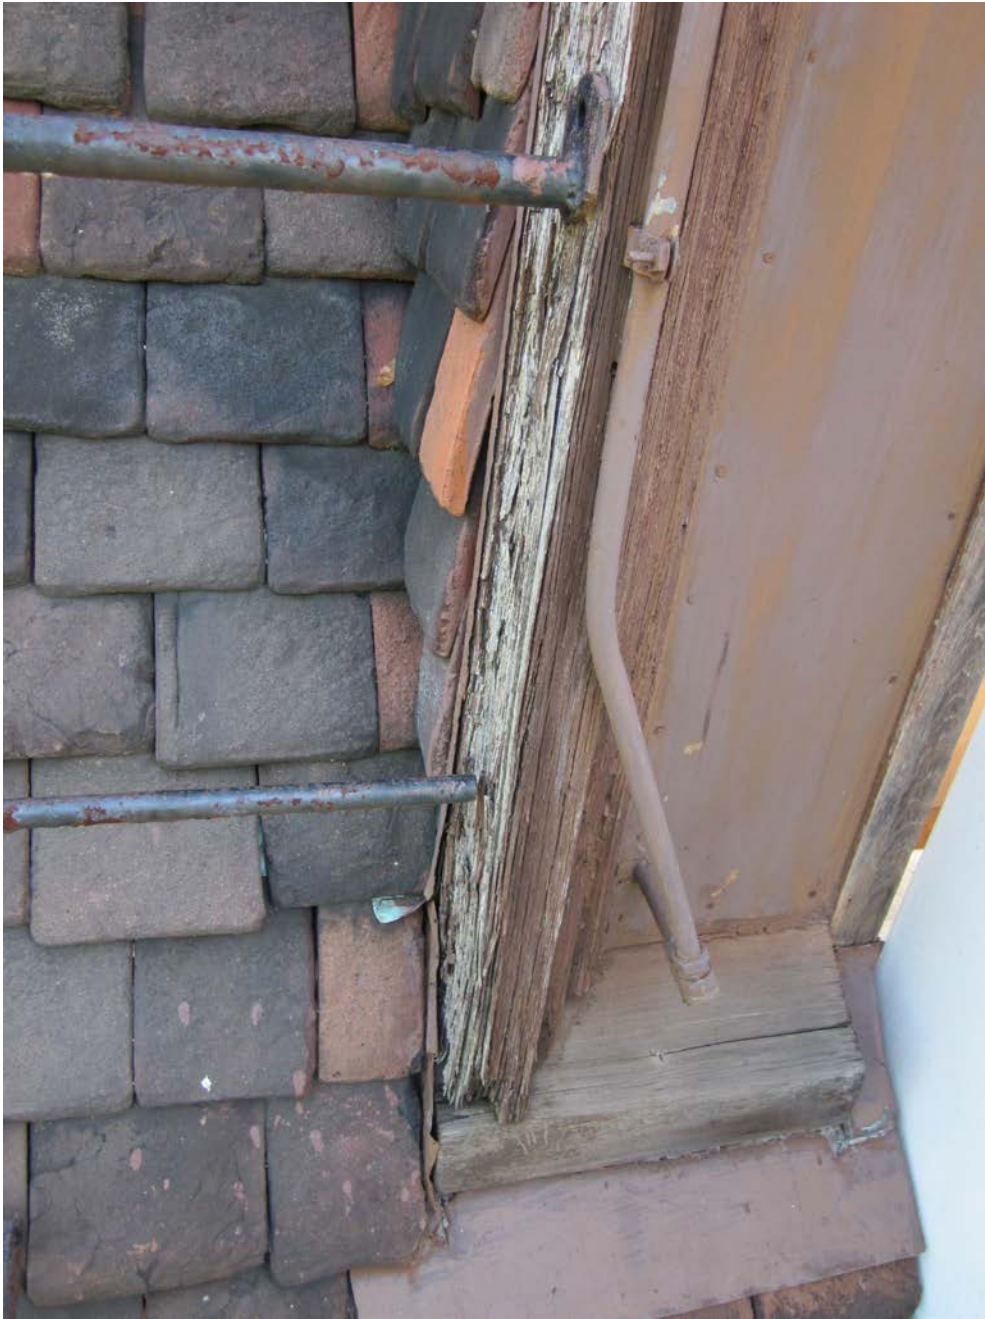
Surface corrosion exists on the steel window sash and frames, which overall are in fair to poor condition. In many locations the wood sills are in poor condition. Wood trim around doors and windows is also in fair to poor condition (Photos 5 and 6).

The clay tile roof is comprised of heavy shingle style units, and appears to be in good condition. Evidence of minor damage and localized repair of individual tiles was observed. The brick masonry chimneys appear to be in fair condition. Localized brick deterioration and cracked mortar joints were observed (Photo 7). Wood trim at dormers and the south fire escape doors is weathered and is in generally fair condition (Photo 6).

Photo 6 – Deteriorated wood trim at south fire escape exit doors.

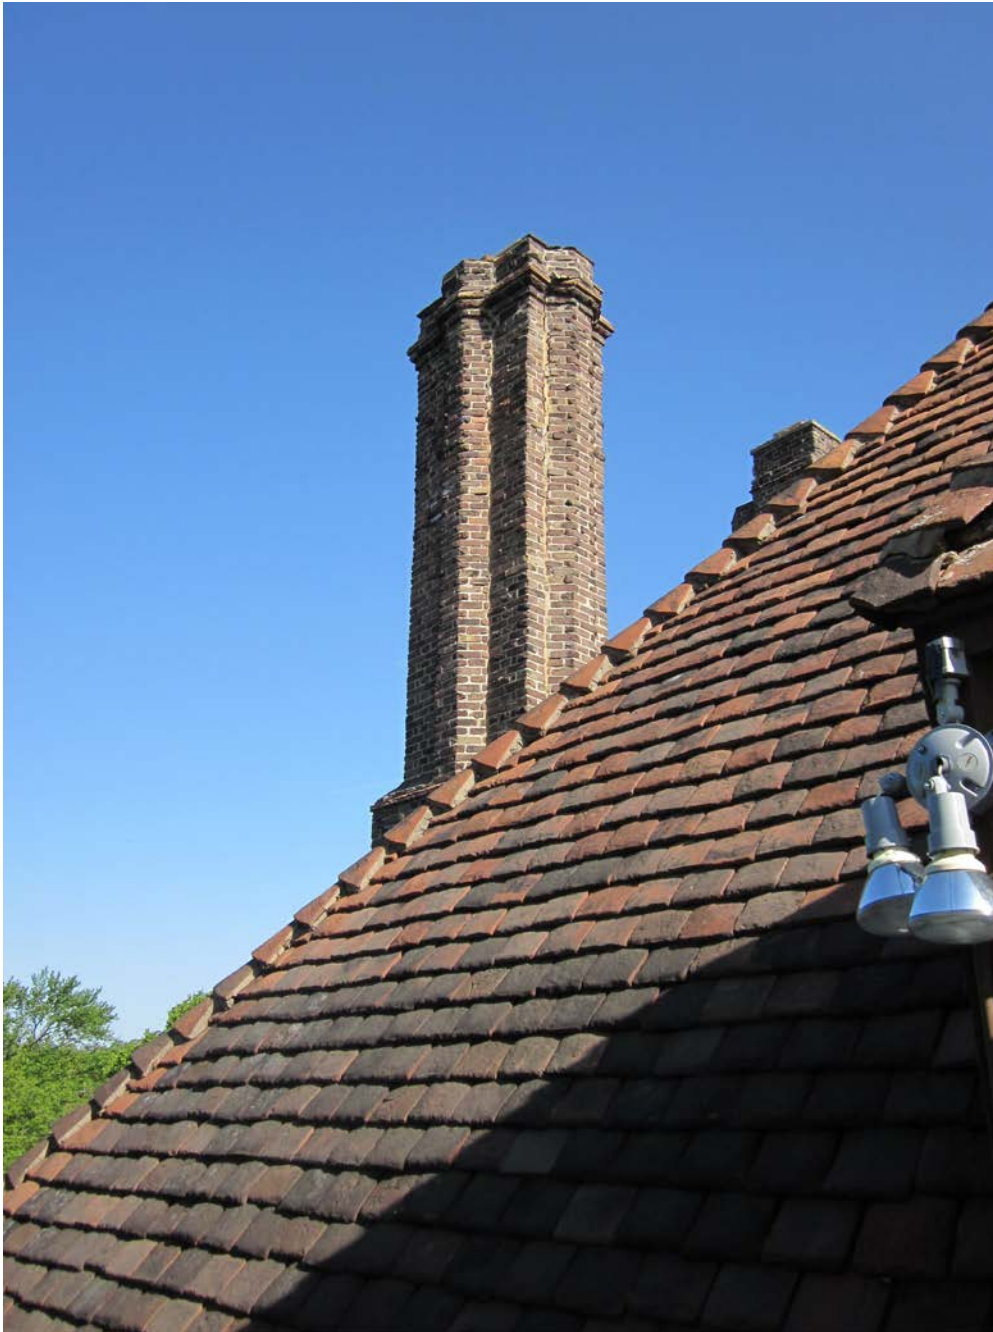
Photo 7 – View of roof tiles and chimney, south elevation.
