**Evanston Arts Center**

## **Harley L. Clarke House and Coach House**

**Facility Assessment Report  
for  
Harley L. Clarke House and Coach House  
2603 North Sheridan Road**

**KJWW #12.0615.00  
October 25, 2012**

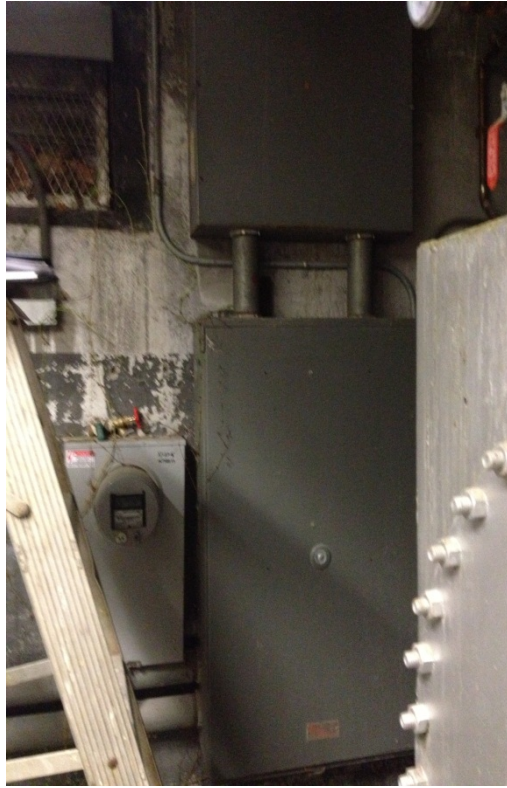
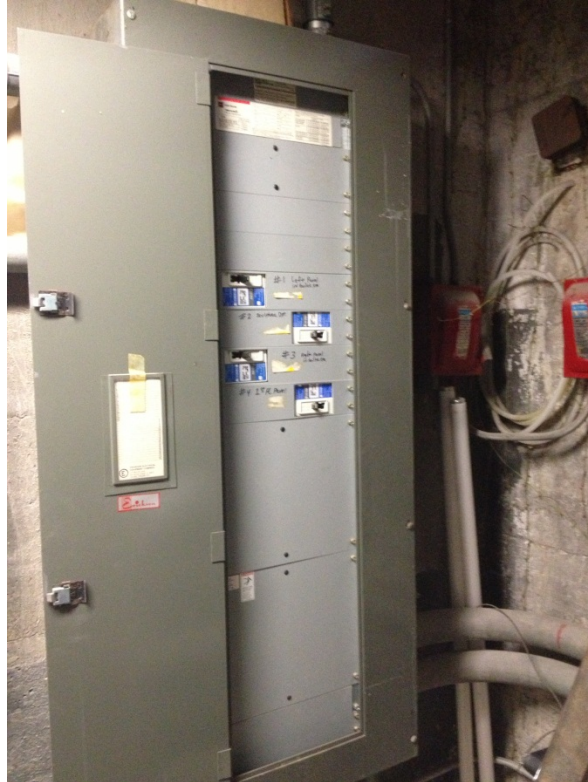
- a. Existing Conditions: The existing electrical service is provided by an underground utility feed which enters the building in the basement on the west side into the mechanical room. The service meter and main distribution panel (MDP) are located in the mechanical room. See photos E1 and E2.

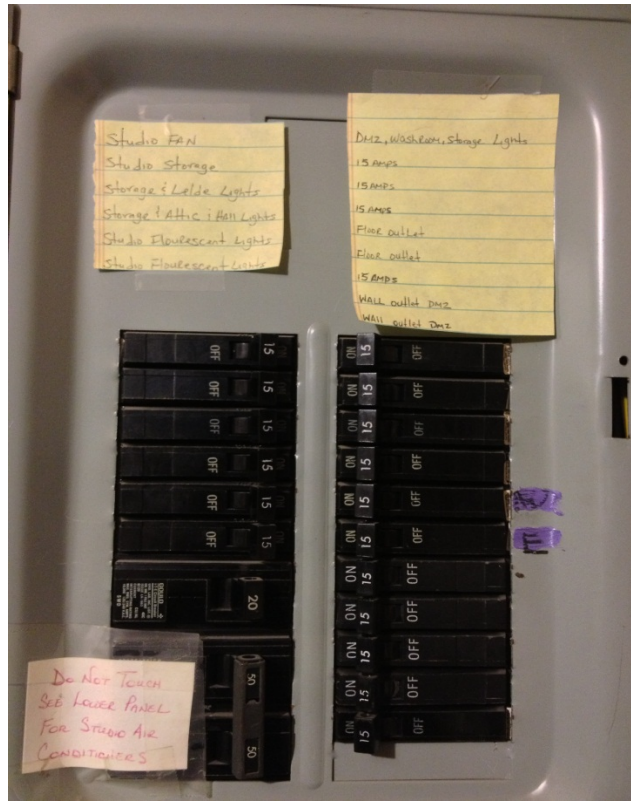
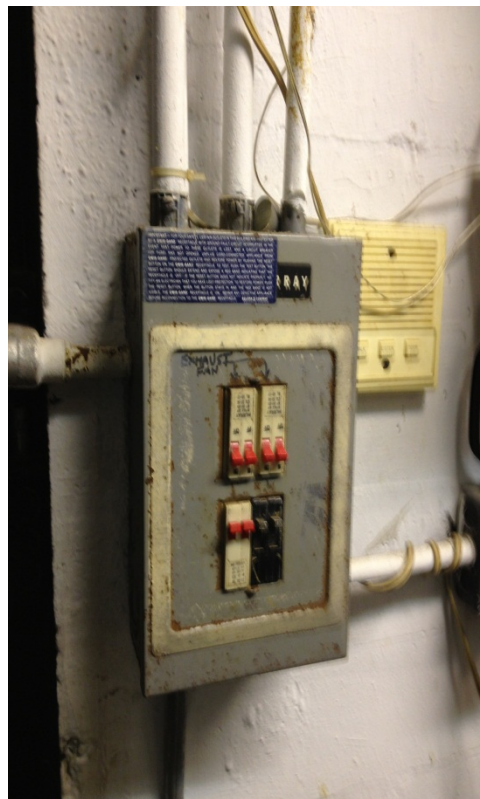
The MDP appears to have been replaced in the 1980's and is in good condition; however, all other branch panels appear to be dated and are in fair to poor condition. Several panels are load centers which are not typically used in commercial applications. One load center on the 3<sup>rd</sup> floor was observed to have "mini" circuit breakers, which is not code compliant. See photos E3 and E4.

- c. The existing distribution system is dated and in poor condition. The majority of the panels are old with limited space to add circuit breakers for additional circuits. Also, the wiring is dated and in some cases cloth insulated which is no longer code compliant.
- d. For a major renovation or conversion, a new electrical service and distribution system including panelboards and feeders would be recommended. For conversion to a hotel, a new 208/120 volt, 3 phase service would be recommended. The estimated size for the new service is 800 amps - 1,000 amps to be confirmed by the engineer of record during the design phase.

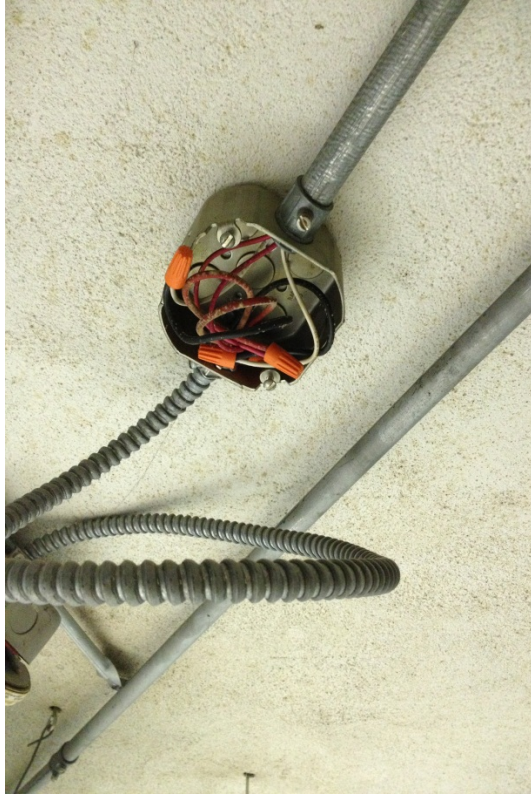
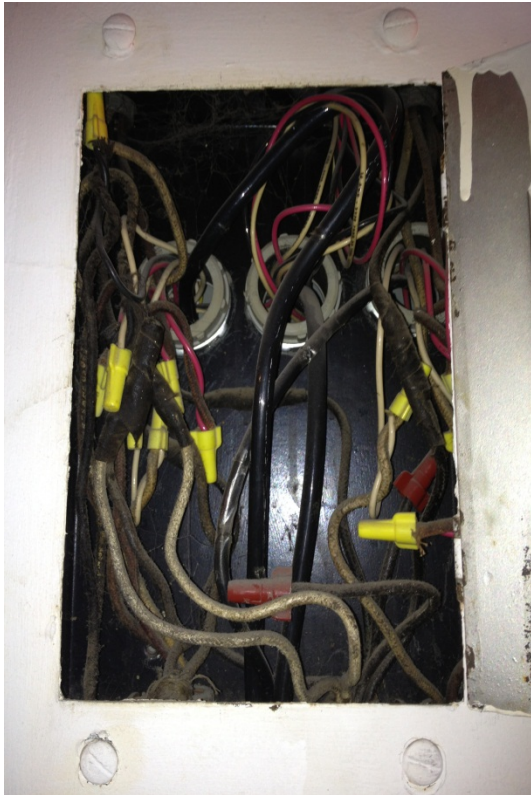
Several open junction boxes with exposed wiring were observed throughout the building. Having open junction boxes is a code violation and presents possible electrical hazard conditions. Cloth insulated wiring was also observed in several locations which indicates that some wiring is original to the building. See photos E5 and E6.

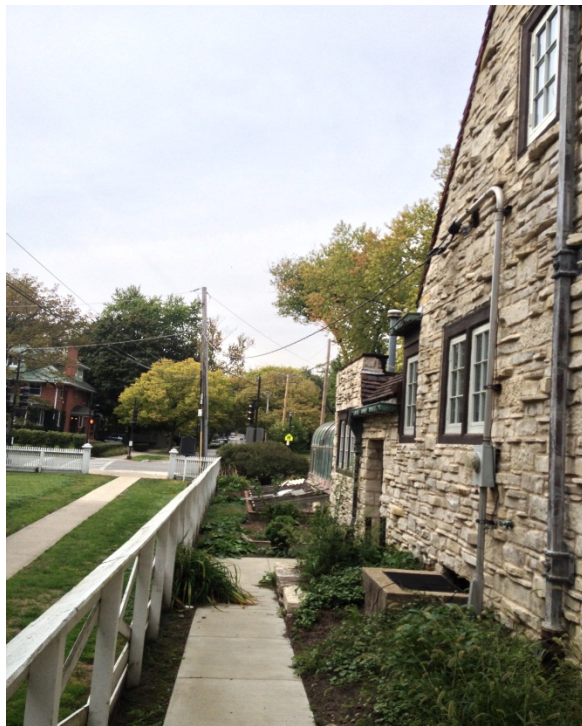
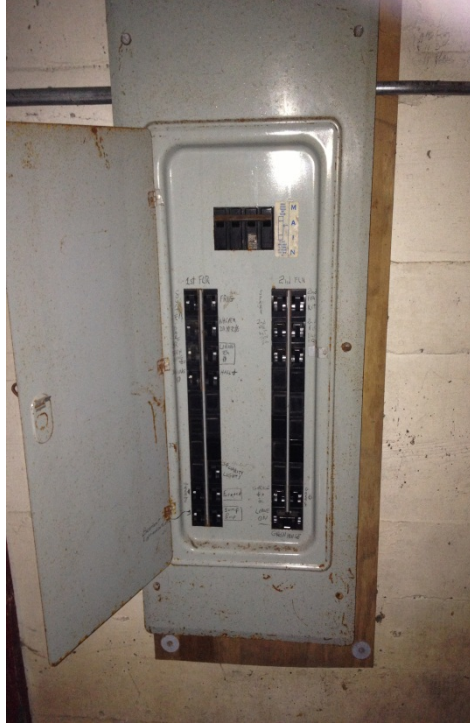
- a. Existing Conditions: The existing electrical service is provided by an aerial drop from a utility pole located on Sheridan Road. The service is rated for 240/120 volts, 1 phase, 200 amps. The aerial feed enters the building on the north side of the building and drops to a main distribution panel in the basement. The MDP feeds all the circuits in the coach house. See photos EC1 and EC2.

The existing MDP is starting show signs of rust and is in poor condition. For a major renovation or conversion, a new electrical service and distribution system including panel boards and feeders would be recommended. For conversion to a restaurant, a new 208/120 volt, 3 phase service would be recommended. The estimated size for the new service is 400 amps - 600 amps to be confirmed by the engineer of record during the design phase.

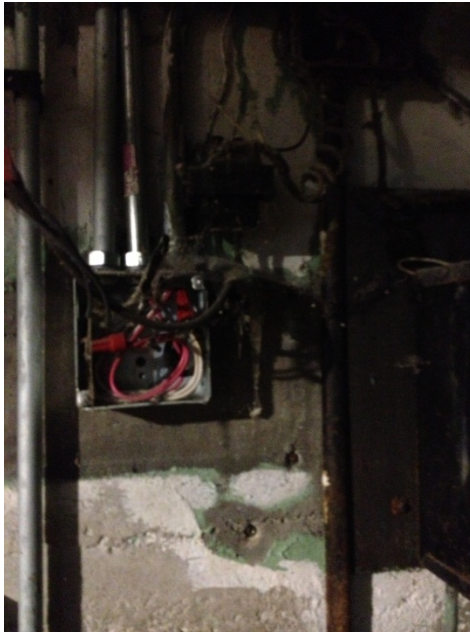
Photo EC3

Several open junction boxes with exposed wiring were observed throughout the building. Having open junction boxes is a code violation and presents possible electrical hazard conditions. See photo EC3.

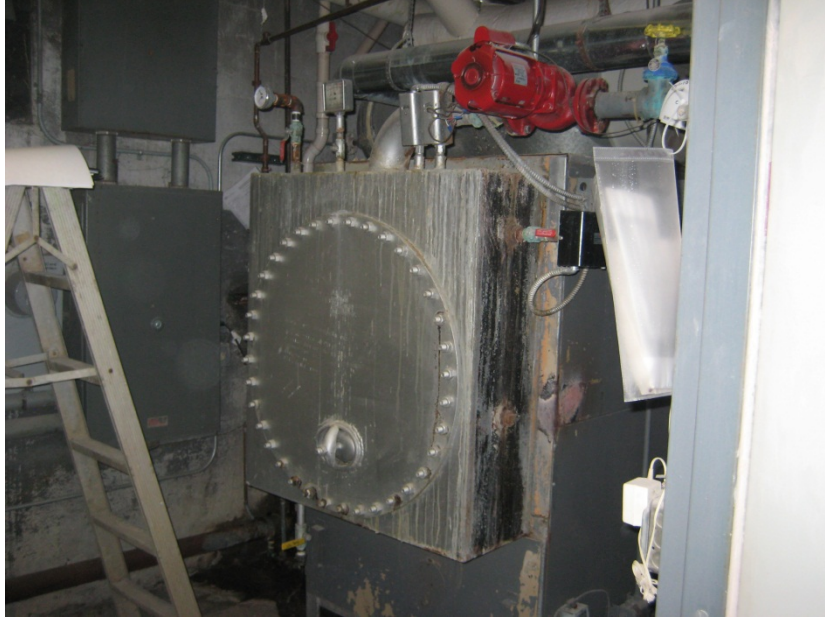
Photo M1

- 1) Heating Systems: A single boiler supplies hot water for heating to the entire building. The boiler was manufactured in 1980 by Hayes Boiler. It has a capacity of 200,800 BTU per hour and is located in the basement boiler room. The boiler feeds hot water to radiation units located around the perimeter of the building. No air handling equipment uses are served from the boiler. The radiation units served by the boiler are steam radiators that are typical of buildings of this vintage. It is likely that a steam boiler once existed in the building and this conversion to hot water happened without converting the radiators. Based on conversations with the building engineer, the boiler system is fully functional and is sufficient to heat the building. However, the 32 year old boiler is approaching its usable lifetime and is not as efficient as modern hot water boilers. See photo M1.

- a) New hot water, condensing style boiler with distribution piping, pumps, controls and piping ancillaries. The boiler would address heating needs at the perimeter and be incorporated into the primary air side HVAC system.

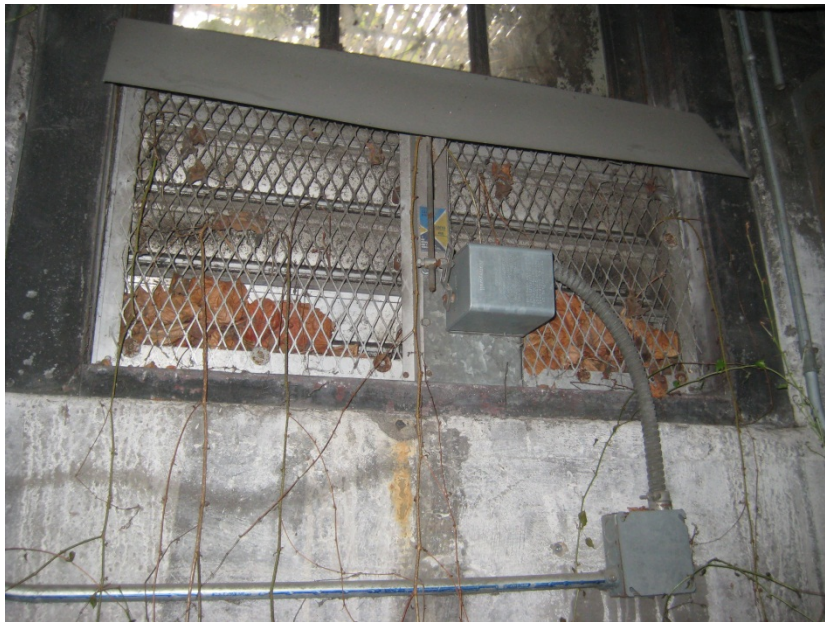
Photo M2

The combustion air for the boiler system is provided by a small louver in the wall of the boiler room. The louver has an automated damper that opens when the boiler is in operation. The size and arrangement of the louver present several issues including the fact that it is smaller than required by code for the proper amount of combustion air and being located in an area well means that it is frequently blocked by leaves and debris. See photo M2.

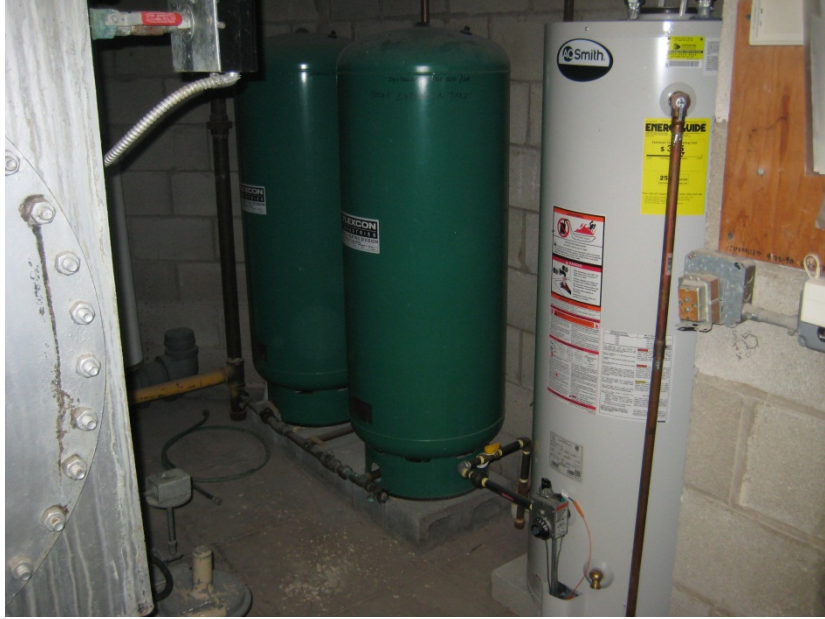
Photo M3

The boiler system expansion tanks appear to have been replaced in 2000 based on the tank tags. See photo M3.

- 2) Hot Water: Domestic hot water for the building is produced by one storage type water heater located in the basement boiler room. Although no documentation for the water heater was located, we believe that the heater is newly installed. The code report authored by WMA Consulting Engineers, dated July 25, 2012 indicates the presence of a 20 year old water heater. The existing water heater is a 50 gallon tank type heater (A.O. Smith Model GCVX) with 65,000 BTU/hr (Input) and is in excellent condition. See photo M3

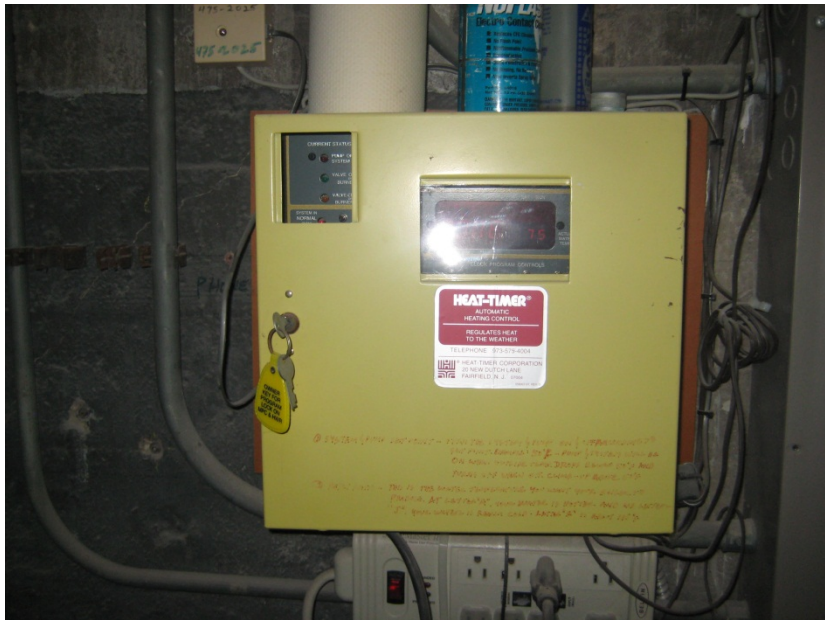
Photo M4

A unitary boiler controller is located on the wall of the boiler room. The controller provides basic hot water reset and control of firing and the circulation pump. See photo M4.

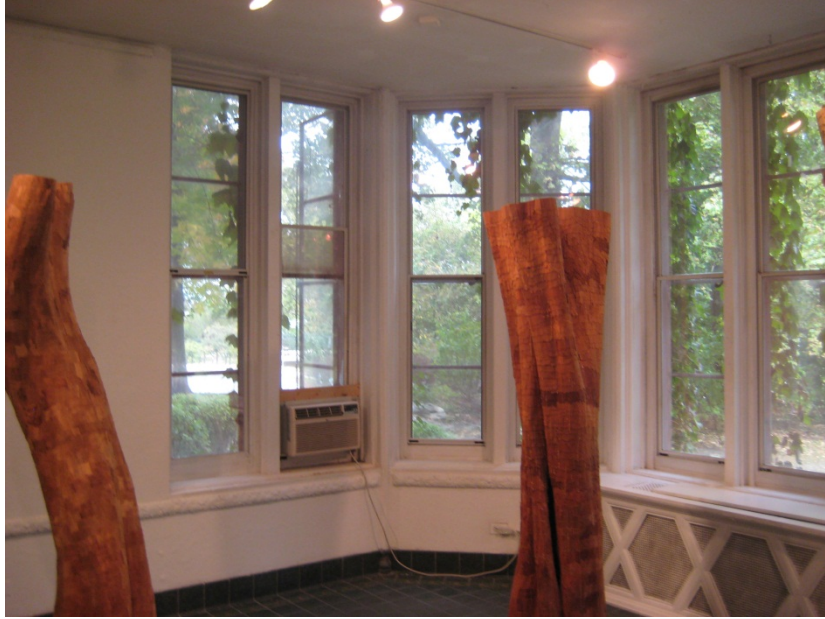
Photo M5

- 2) Air Conditioning Systems: No central air conditioning exists with the building. All cooling for the building originates from window air conditioning units distributed throughout the facility that range in capacity between 8,000 and 18,000 BTU per hour. These units do not provide ventilation to the space, functioning as recirculating units only. See photo M5.

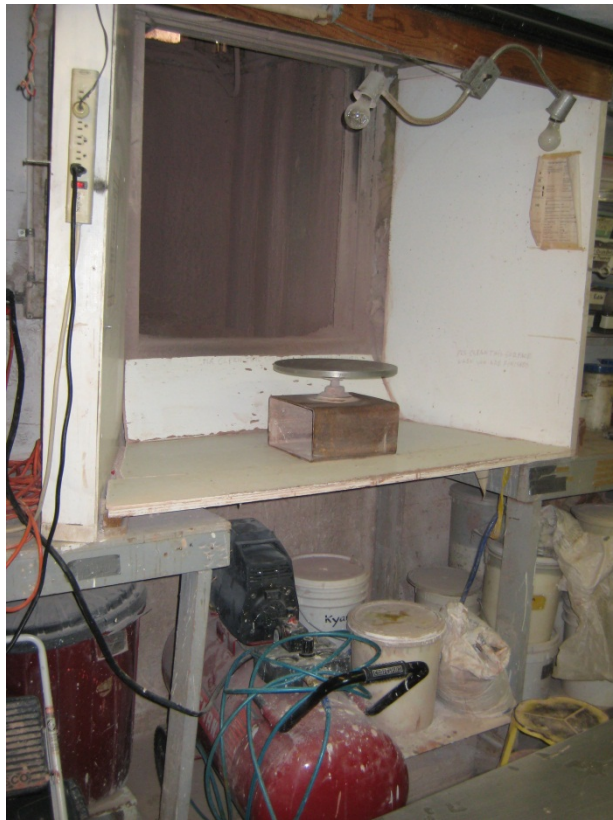
Photo M6

- d) Glaze Room Exhaust: A make-shift paint spray booth has been created in an area well on the eastern side of the building. There are several code issues that are present with this arrangement that include the location of the exhaust discharge with respect to height and proximity to operable windows. See photo M6.

- 2) The process exhaust systems that currently reside in the building are unlikely to be required moving forward. All systems should be removed.

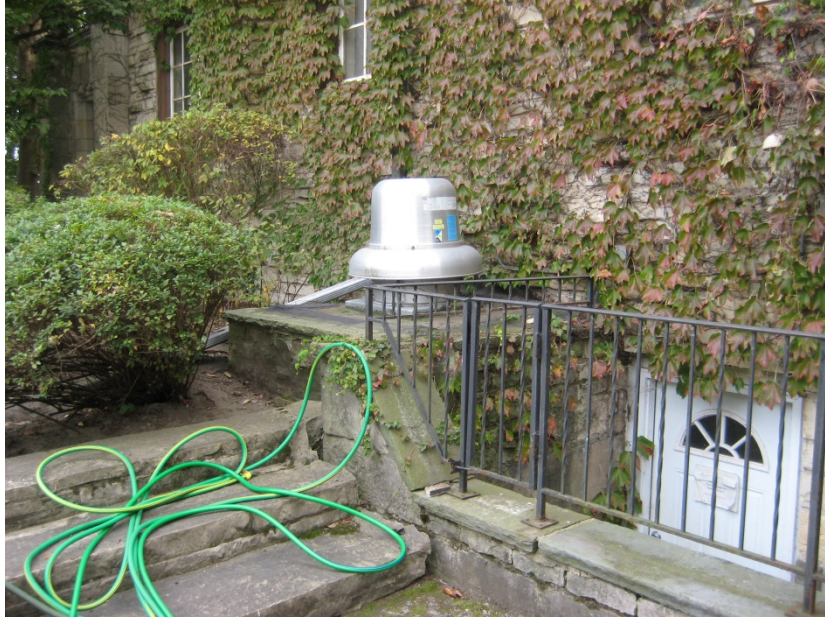
Photo M7

- e) Dark Room Exhaust: The dark room process exhaust system is routed from the lower level to an exhaust fan on grade at the north side of the building. See photo M7.

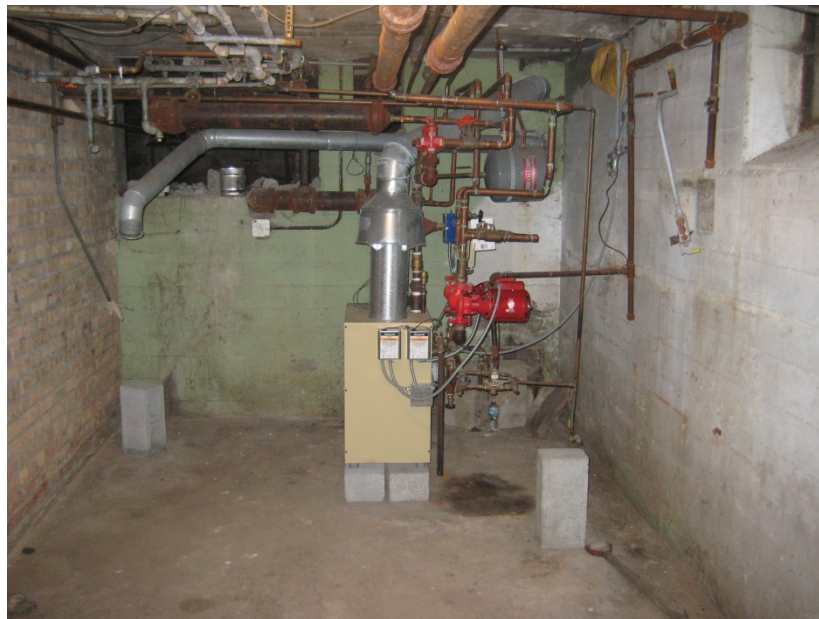
Photo MC3

- 1) Heating Systems: One small boiler supplies hot water for heating to the entire building. The boiler feeds hot water to radiation units located around the perimeter of the building and separate zone pumps exist based on floor. No air handling equipment uses are served from the boiler. The radiation units served by the boiler are steam radiators that are typical of buildings of this vintage. It is likely that a steam boiler once existed in the building and this conversion to hot water happened without converting the radiators. The boiler is in average to poor condition and is not as efficient as modern hot water boilers. See photo MC3.

- 1) The existing HVAC systems are in poor condition and we recommend replacement regardless of the future program for the space. If a hotel occupancy is pursued, a number of primary HVAC systems could be selected based on space requirements, ability to incorporate the systems into the historic residence, cost and efficiency. At a minimum, the following requirements should be included:

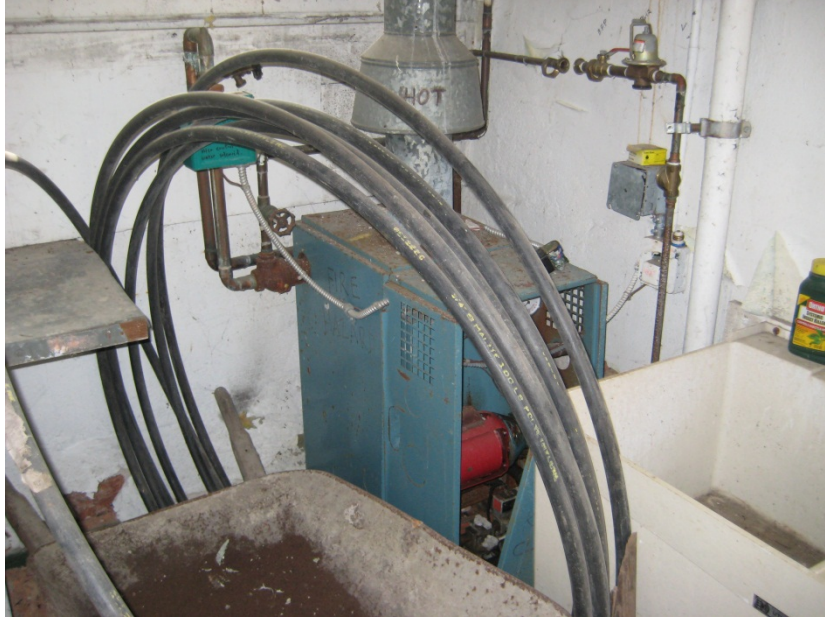
Photo MC4

The greenhouse area of the coach house is equipped with a separate small boiler that feeds unit heaters and other terminal heating equipment. These systems are in poor condition and in need of replacement. See photo MC4.

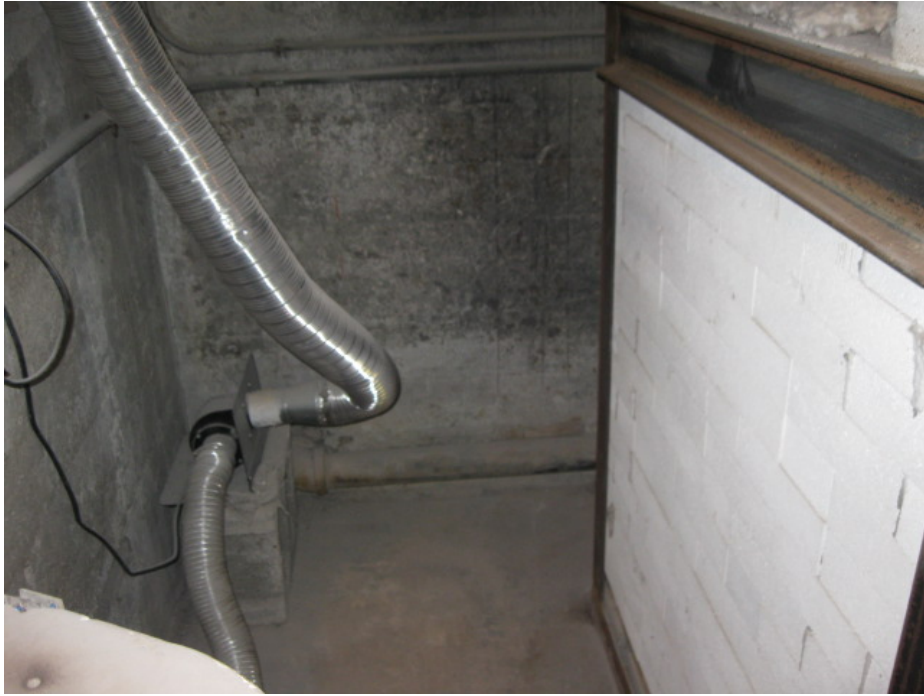
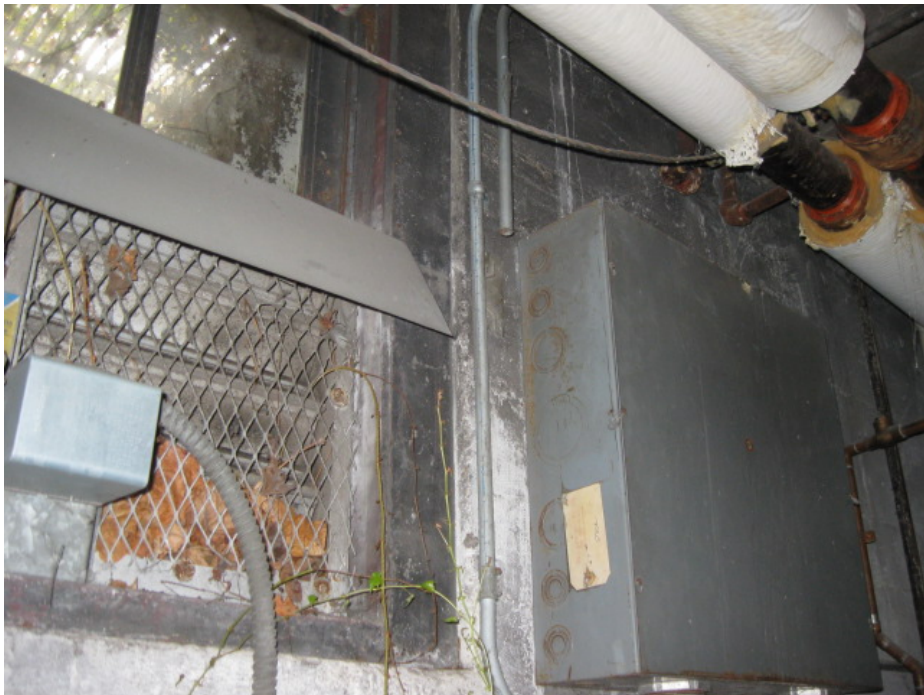
- a. The basement is in good condition and relatively dry. No signs of significant foundation issues were discovered. The floor slab is in good condition. The perimeter basement walls were dry and very little cracking is present in the cast in place concrete walls. See photos S1 and S2.

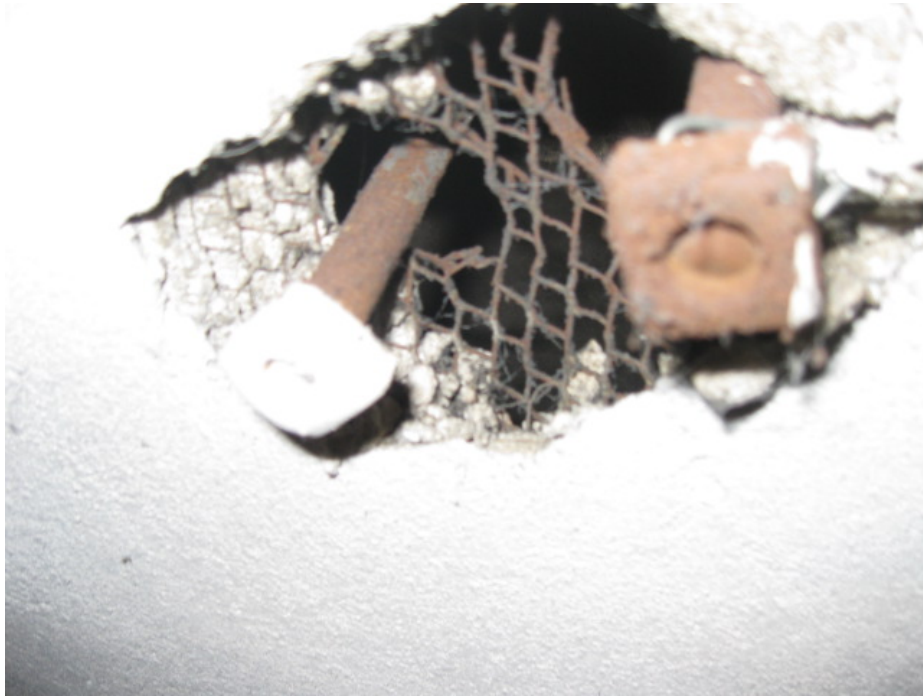
Photo S3

- b. The 1<sup>st</sup>, 2<sup>nd</sup> and 3<sup>rd</sup> floor framing in general is not visible. At the basement level, at one or two locations there was an abandoned MEP penetration. Through the abandoned opening the framing is visible and consists of wood floor joists. See photo S3.

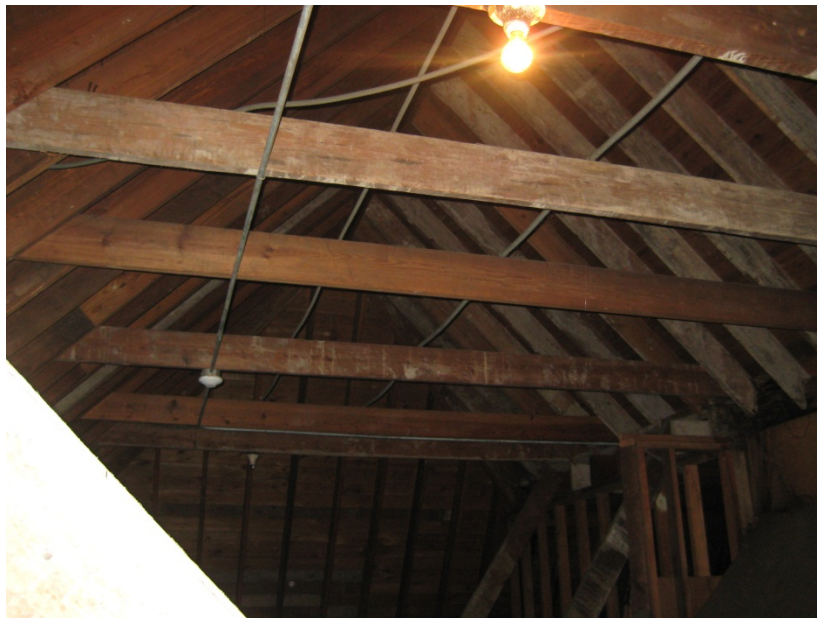
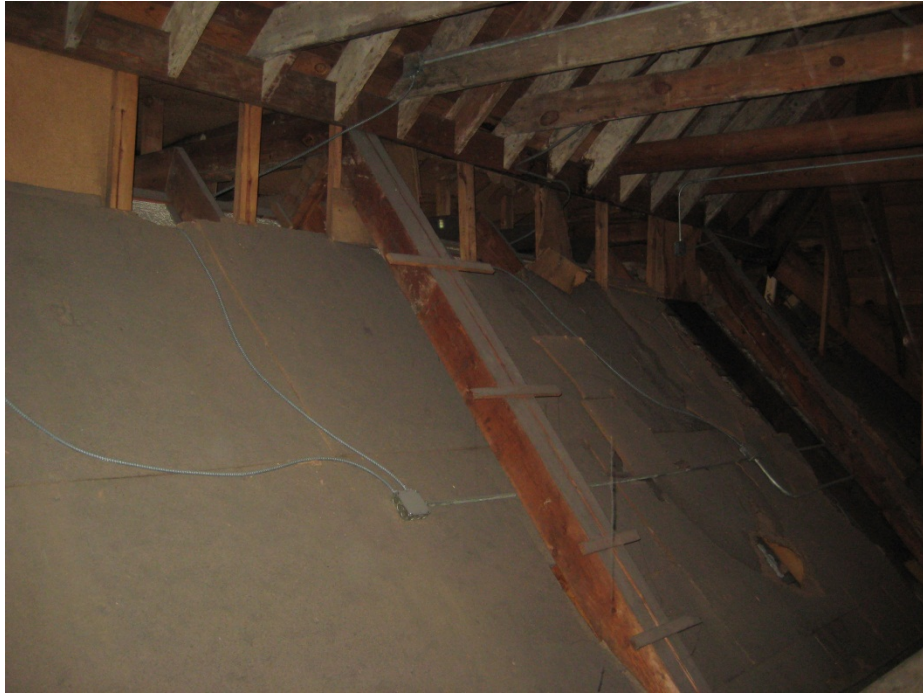
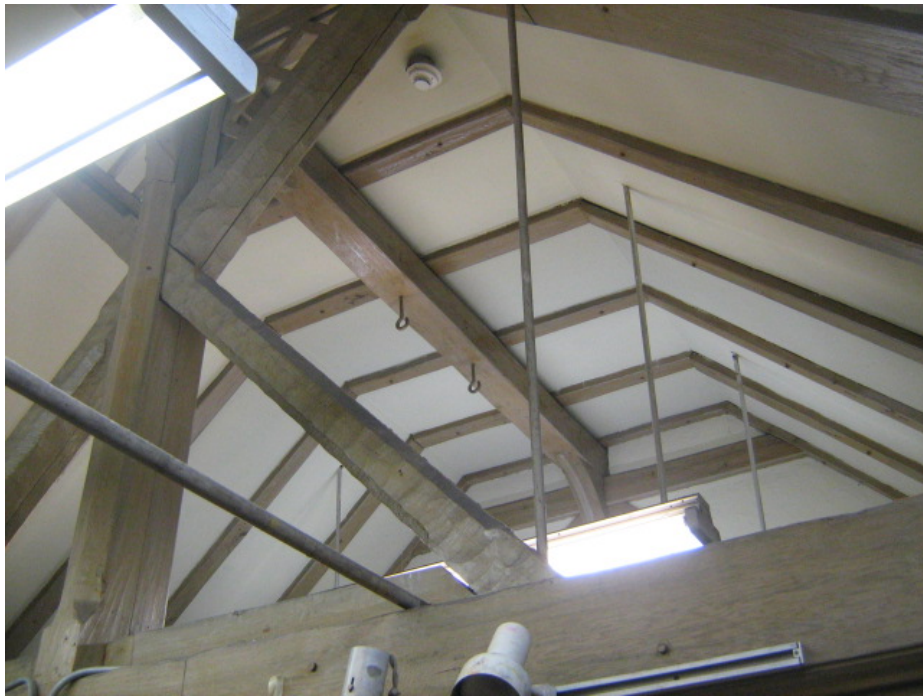
- d. From the 3<sup>rd</sup> floor, some of the roof framing is visible in the storage room, and from the attic above. At both areas, the roof is framed with sawn lumber. The attic has a partial area where timber trusses are utilized to clear span the studio. See photos S4-S6. No significant structural issues were observed.

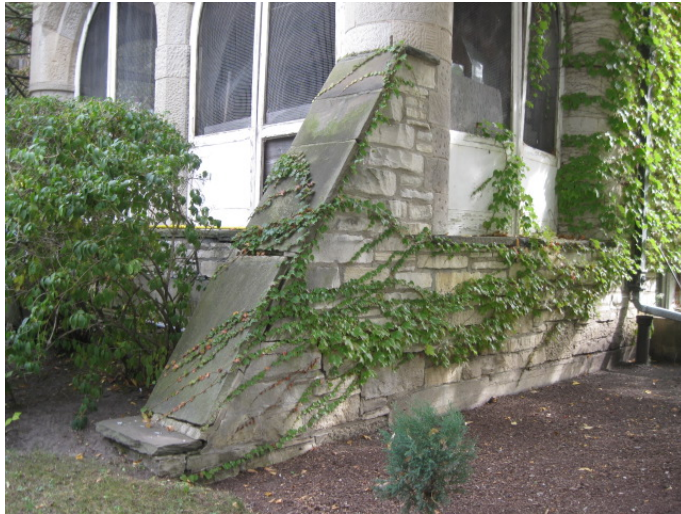
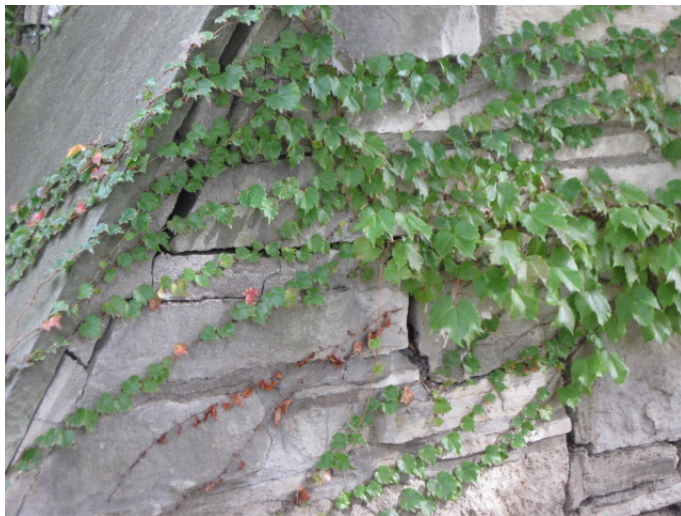
- 1) The stone work and veneer are in need of tuck pointing. Due to the amount of ivy and vegetation growing on the façade, the amount of mortar joint deterioration is unknown. See photo S7 and S8.

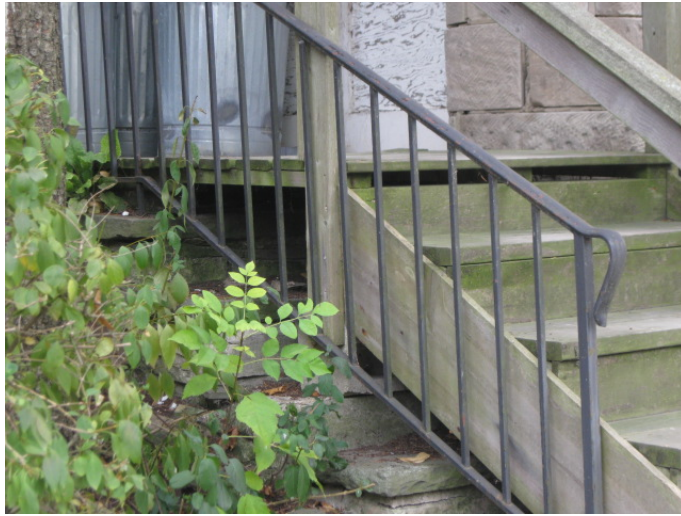
Photo S9

- 2) The porch and entry stair at the NW corner of the building have significant issues. It appears the stair has settled. It also appears a repair was performed and a wood stair was constructed as a remedial solution. See photo S9.

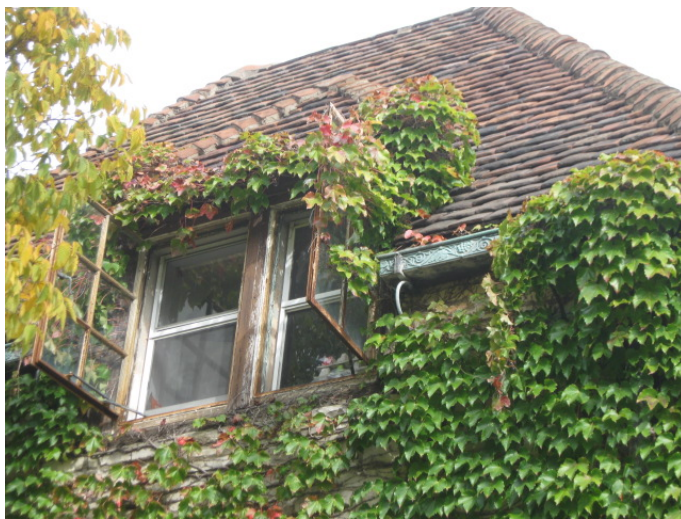
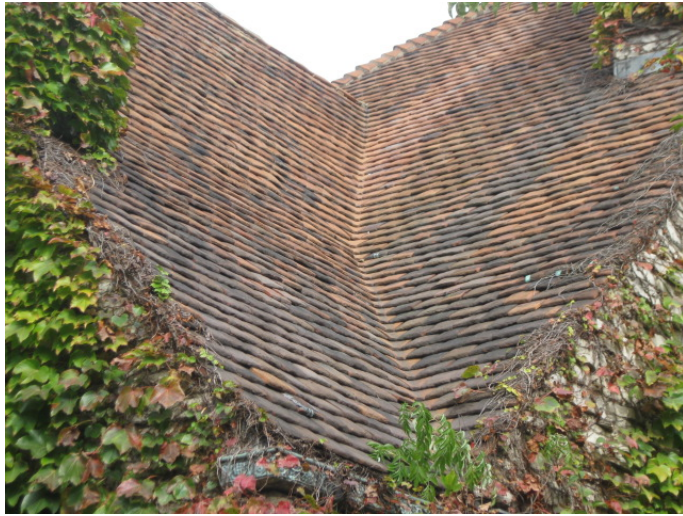
- 3) The windows appear to be original construction. The trim around the windows, and caulk joints appear to be in poor condition. See photo S10.
  - 4) The roof is a clay tile type shingle on top of sloped roofs including gable, hip, and flat roof sections. There are areas where clay tiles are missing. See photo S11.

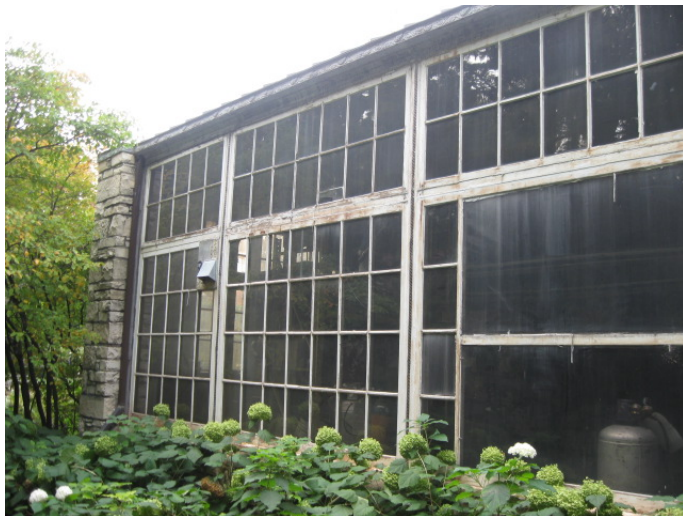
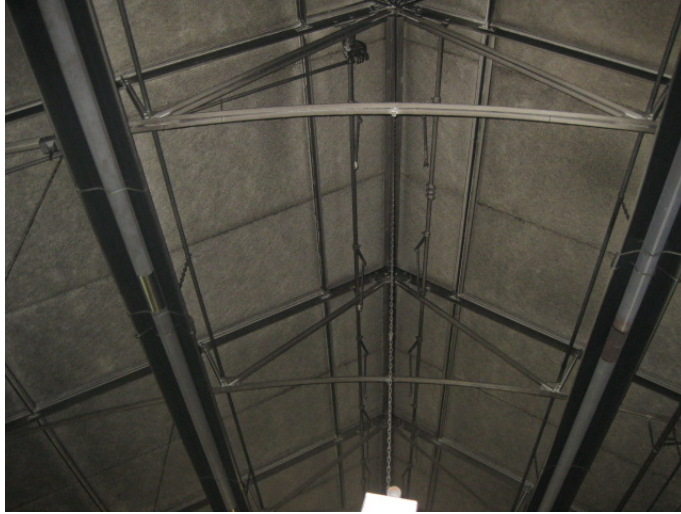
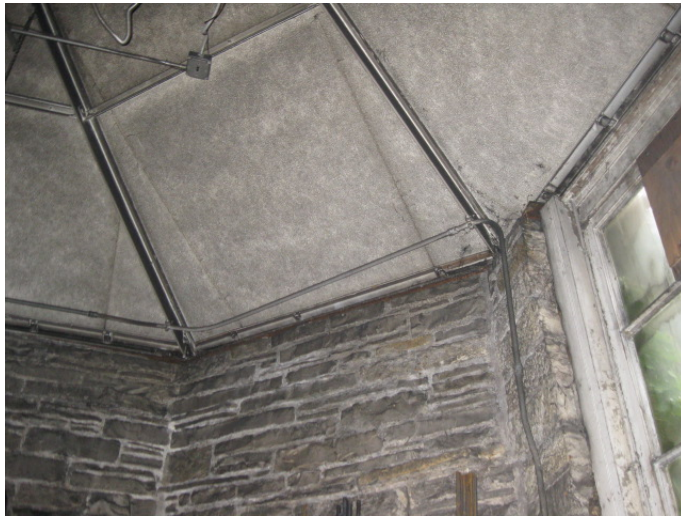
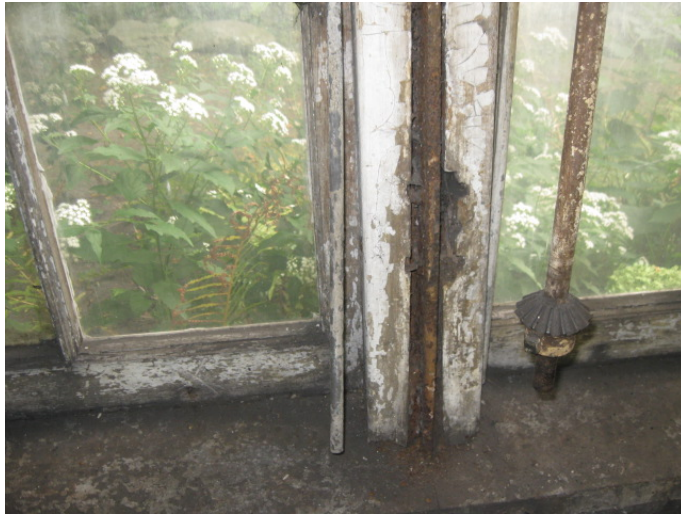
- g. The weld shop (conservatory) is a steel framed structure consisting of custom steel trusses and custom steel columns. There is some masonry infill and glass infill between the steel columns. The structure appears to be in fair condition, but some signs of steel corrosion are visible. The corrosion appears to be cosmetic in nature. The corrosion should, at a minimum, and be cleaned with a wire brush, primed and painted as a part of the renovation. The roof appears to be some type of gypsum/formboard roof deck. See photos S12 through S15.

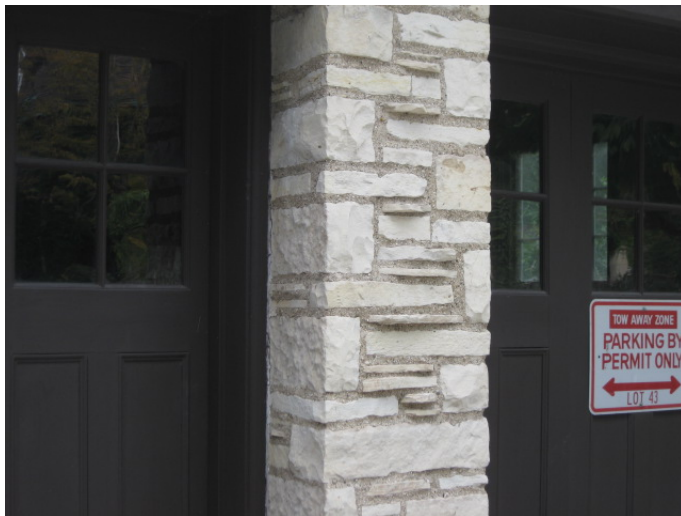
Photos SC1

are in much better condition. See photos SC1. Some exterior slabs at the driveway have settled and are need of maintenance. See photos SC 2.

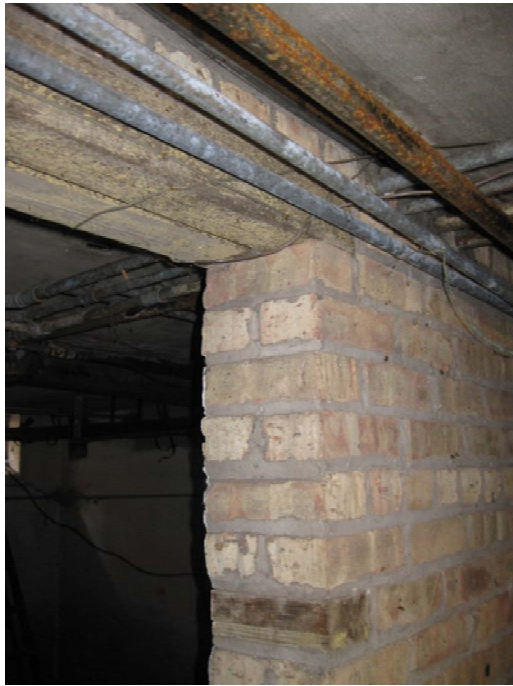
Photo SC3

- b. The basement is dry and no signs of excessive foundation settlement exist. There is an interior bearing wall in the space and consists of 2 wythe brick. See photos SC3. The exterior basement walls are mostly cast in place concrete and the floor is a cast in place concrete slab.

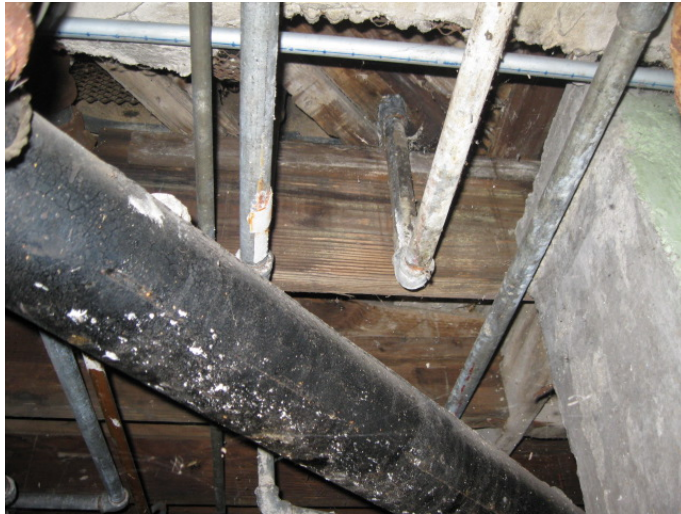
Photo SC4

- c. The 1st floor framing is visible within the crawl space. The floor framing is 2x wood joists and wood decking. It appears humidity has been a major issue in this house. The framing does appear to have some deterioration and some of floor joists have water/moisture damage. See photos SC4.

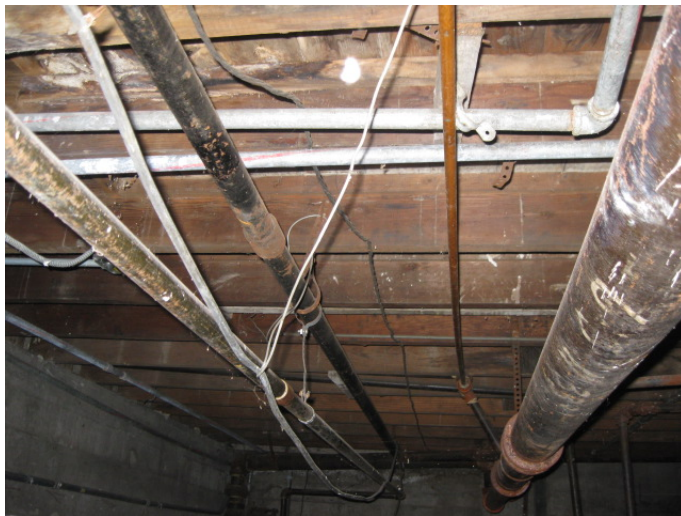
Photo SC5

- d. The 1st floor framing has excessive vertical deflection, and is very noticeable. See photos SC5. Depending on the cause of the “sag”, this area may require replacement. If replacement is not required, the floor will likely need to be shimmed to provide a more level elevation.

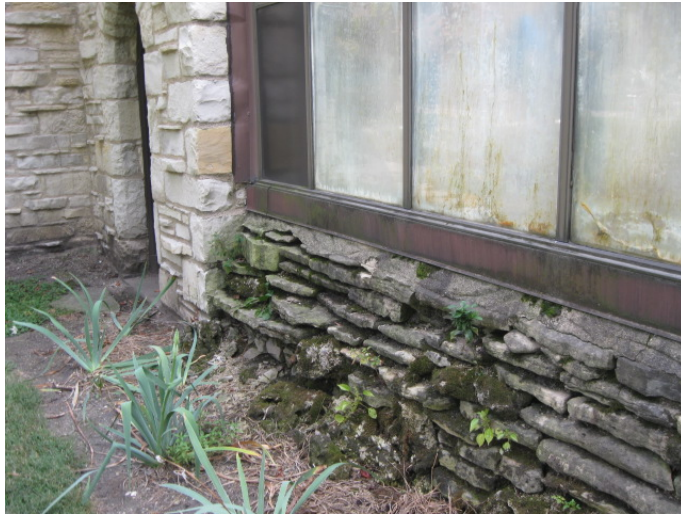
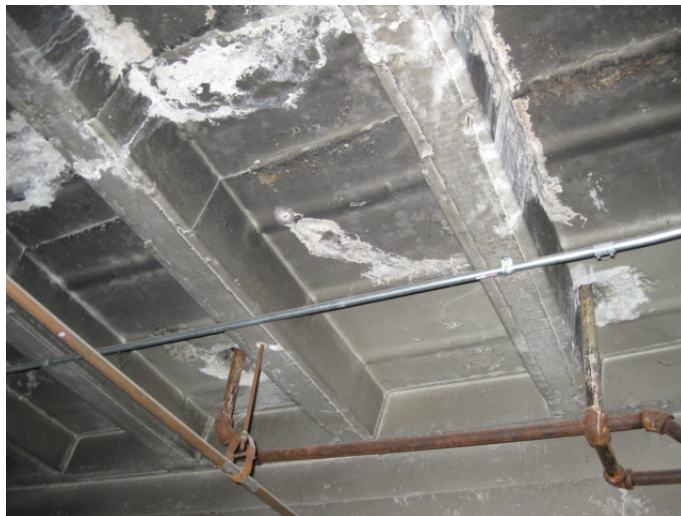
- e. The partial height masonry stone wall around the green house is in very poor condition. See photos SC6.
- f. The attic floor space above the garage is cast in place concrete and has some signs of distress including efflorescence and spalling. See photo SC7.
