# **Code Analysis and Conditions Assessment Report**

## **Evanston Arts Center**

2603 Sheridan Road  
Evanston, IL 60201

June 25, 2012

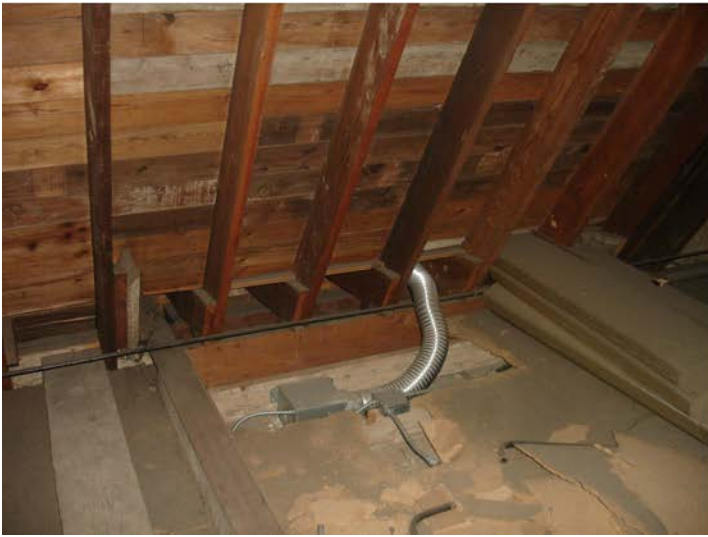
3rd floor toilet exhaust ducted through attic

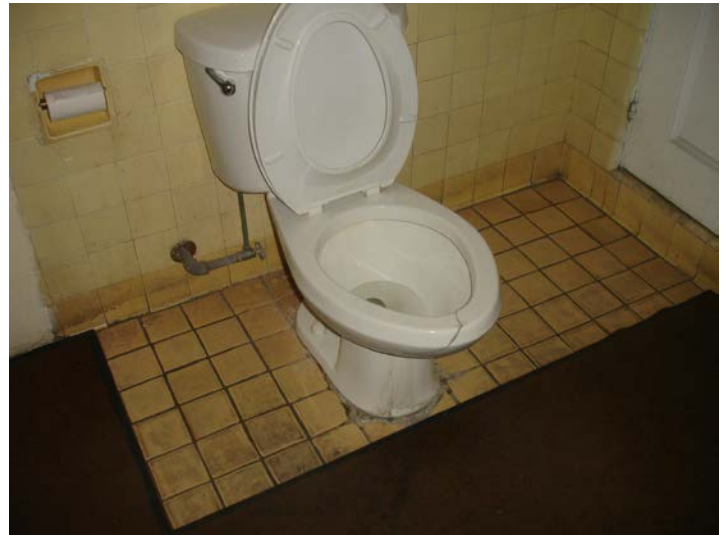
As noted in the Architectural portion of this report the plumbing systems are deficient for a business occupancy. The number of toilet rooms, fixture counts and locations are as they were for the original residence. No changes were made with the conversion to a business occupancy. Also a few fixtures have been removed over the years. All of the bathtubs have been capped over so they cannot be used. A couple of the toilets were noted as being cracked and some of the lavatories were replaced with slop sinks.

3rd floor toilet room (fixture cracked)

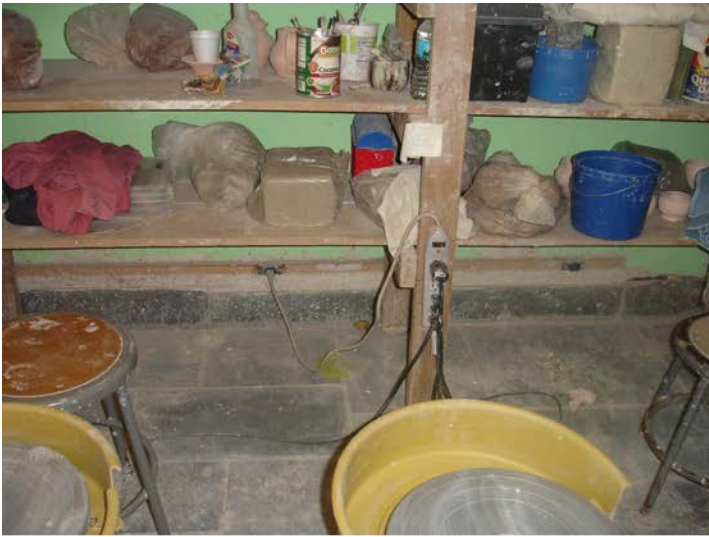
Plug strips used in studio

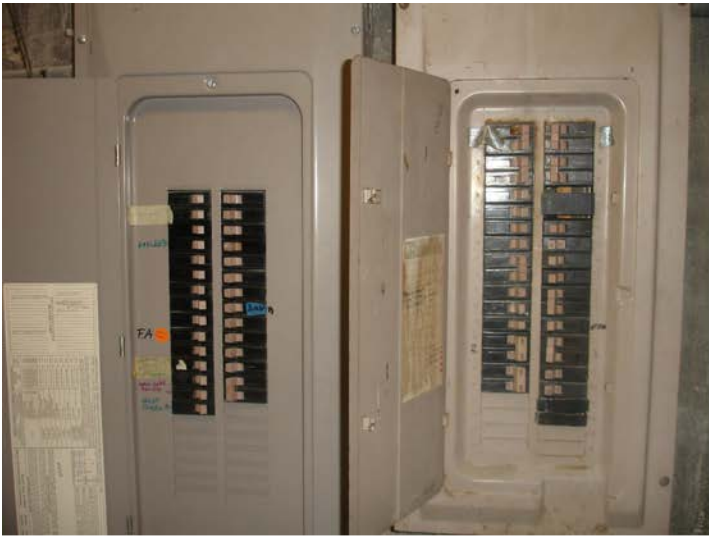
The buildings incoming electric service appears to have been replaced in the 1980's however many of the branch panels were reused, are older and in fair to poor condition.

Older electric panels

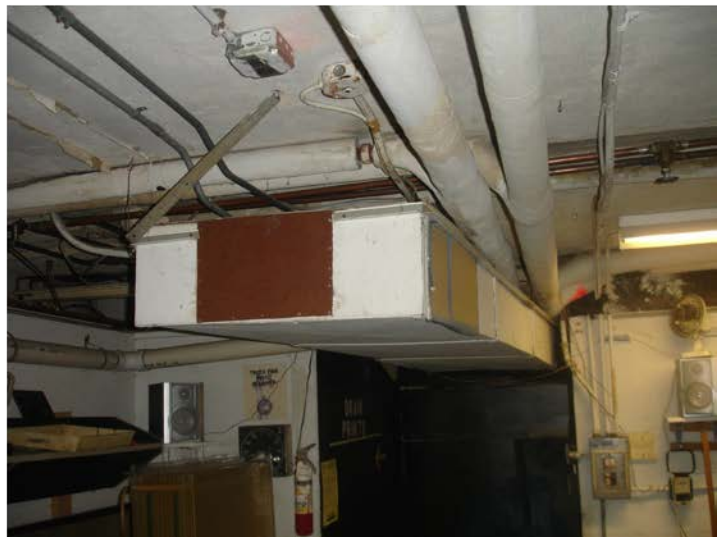
Photo lab blanked off grilles

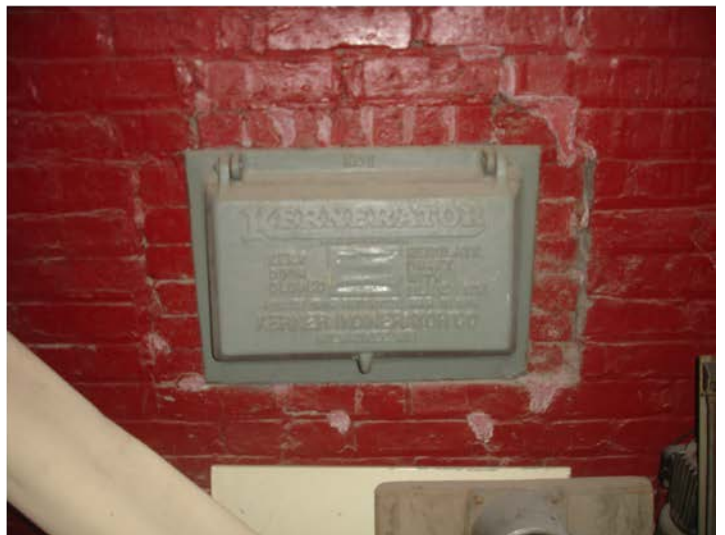
Abandoned incinerator

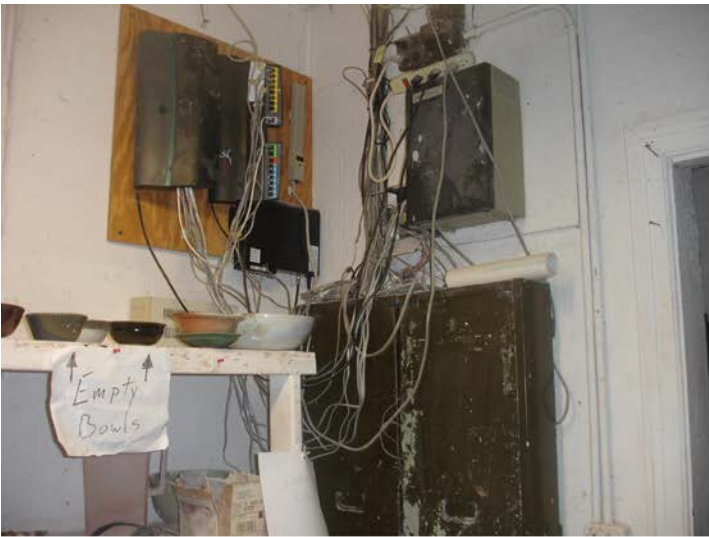
Old telephone and open electrical boxes

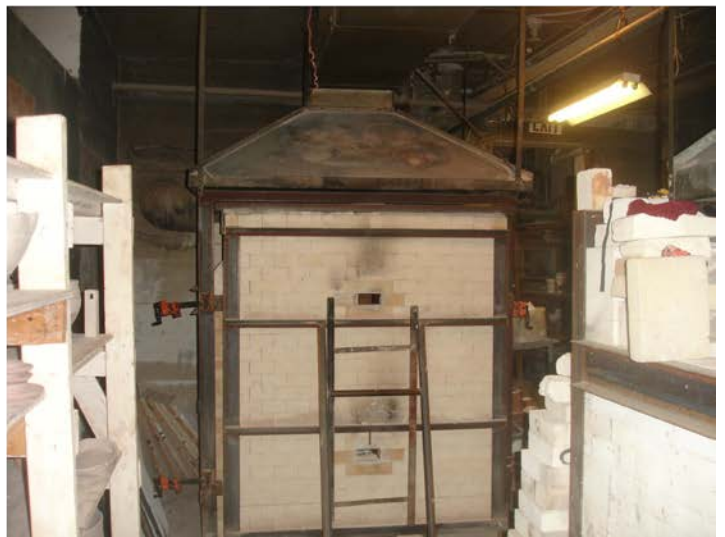
In the basement, there are a number of gas fired ceramics kilns. This space by code needs to be enclosed in a fire rated room. Presently it is open to the rest of the basement. A few of the Kilns have exhaust hoods over them but they appear inadequate in size and location to do an adequate job of exhausting heat and fumes.

Kiln room

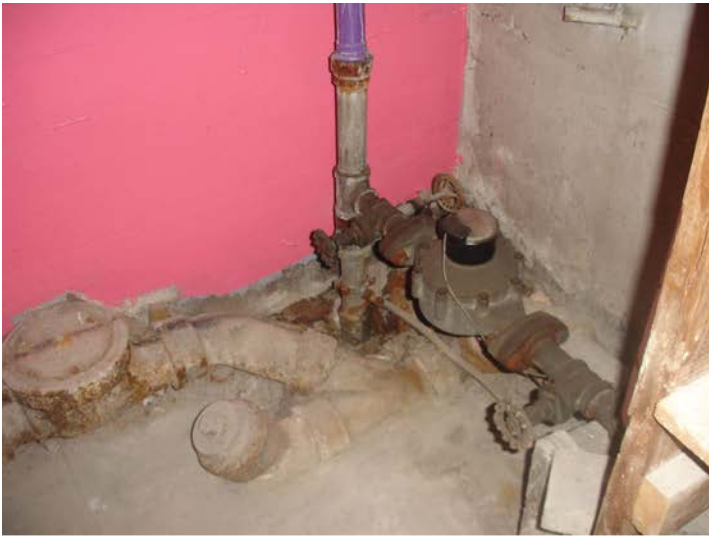
If this were done, the incoming water service may need to be replaced. Presently there is a 1 ½" supply pipe and a 1" water meter. The new requirement would be for at least a 2" possibly larger. Also, if flush valve fixtures were to be used instead of tank type which is normal for business uses a domestic water booster pump may be needed.

Incoming water service

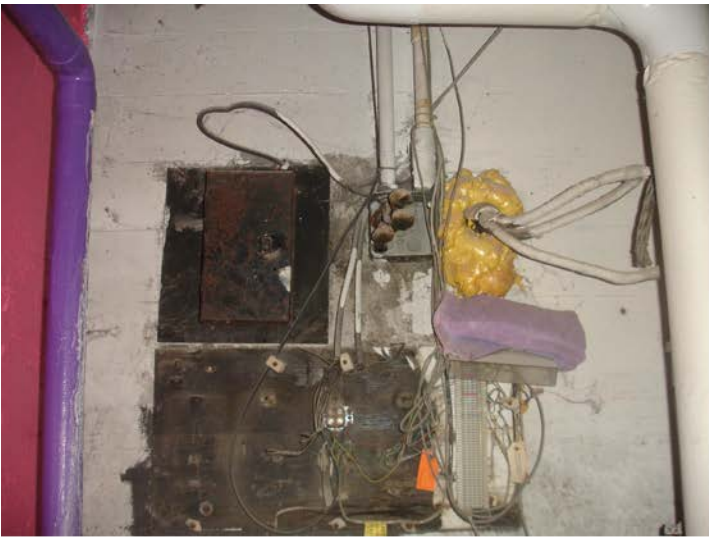
There are a number of open electrical junction boxes in the basement and it looks like an old abandoned service. This all needs to get cleaned up and removed.

Old electrical open boxes

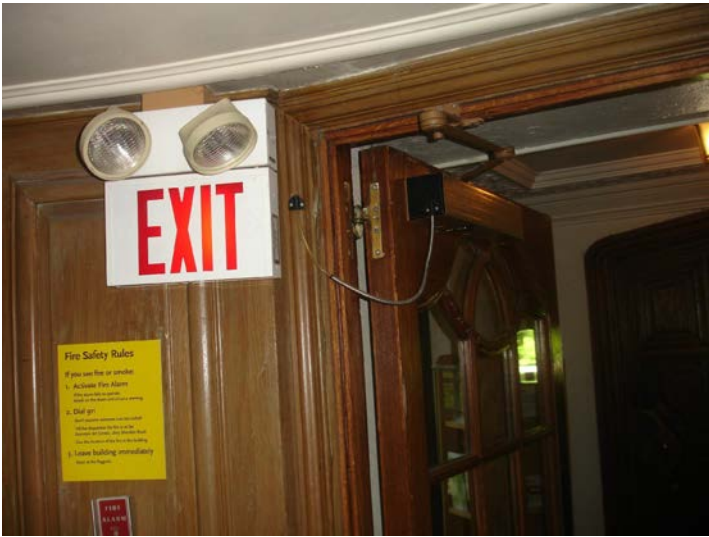
Accessible entrance not working

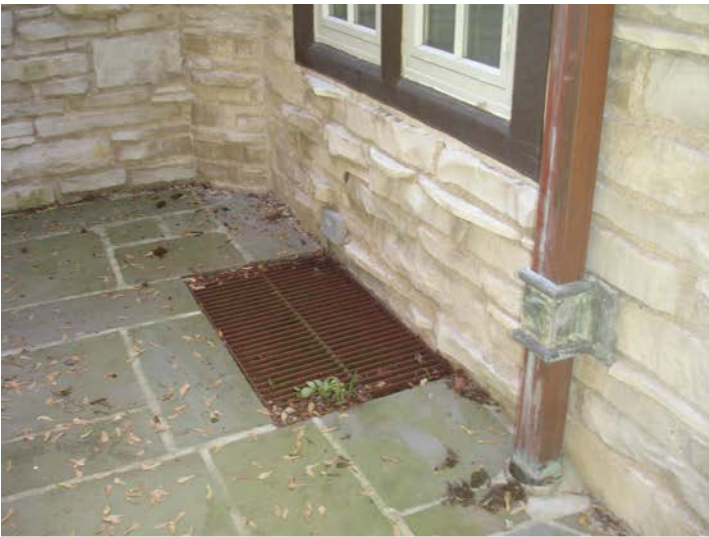
The combustion air intake for the boiler room has a louver and an auto damper approximately 35 x 15 installed in a window opening. The size is marginal for the capacity of gas fired appliances installed, plus it is blocked up with debris, leaves etc. This should be upgraded when the boiler is replaced.

Combustion air to basement

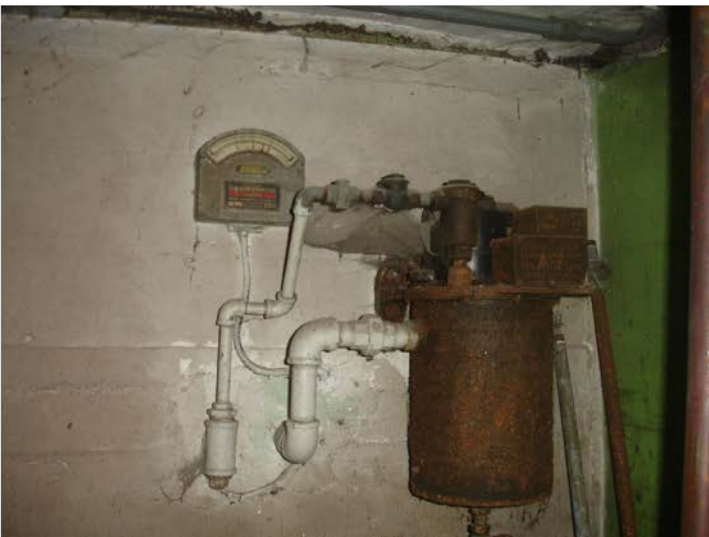
UG tank level equipment (abandoned)

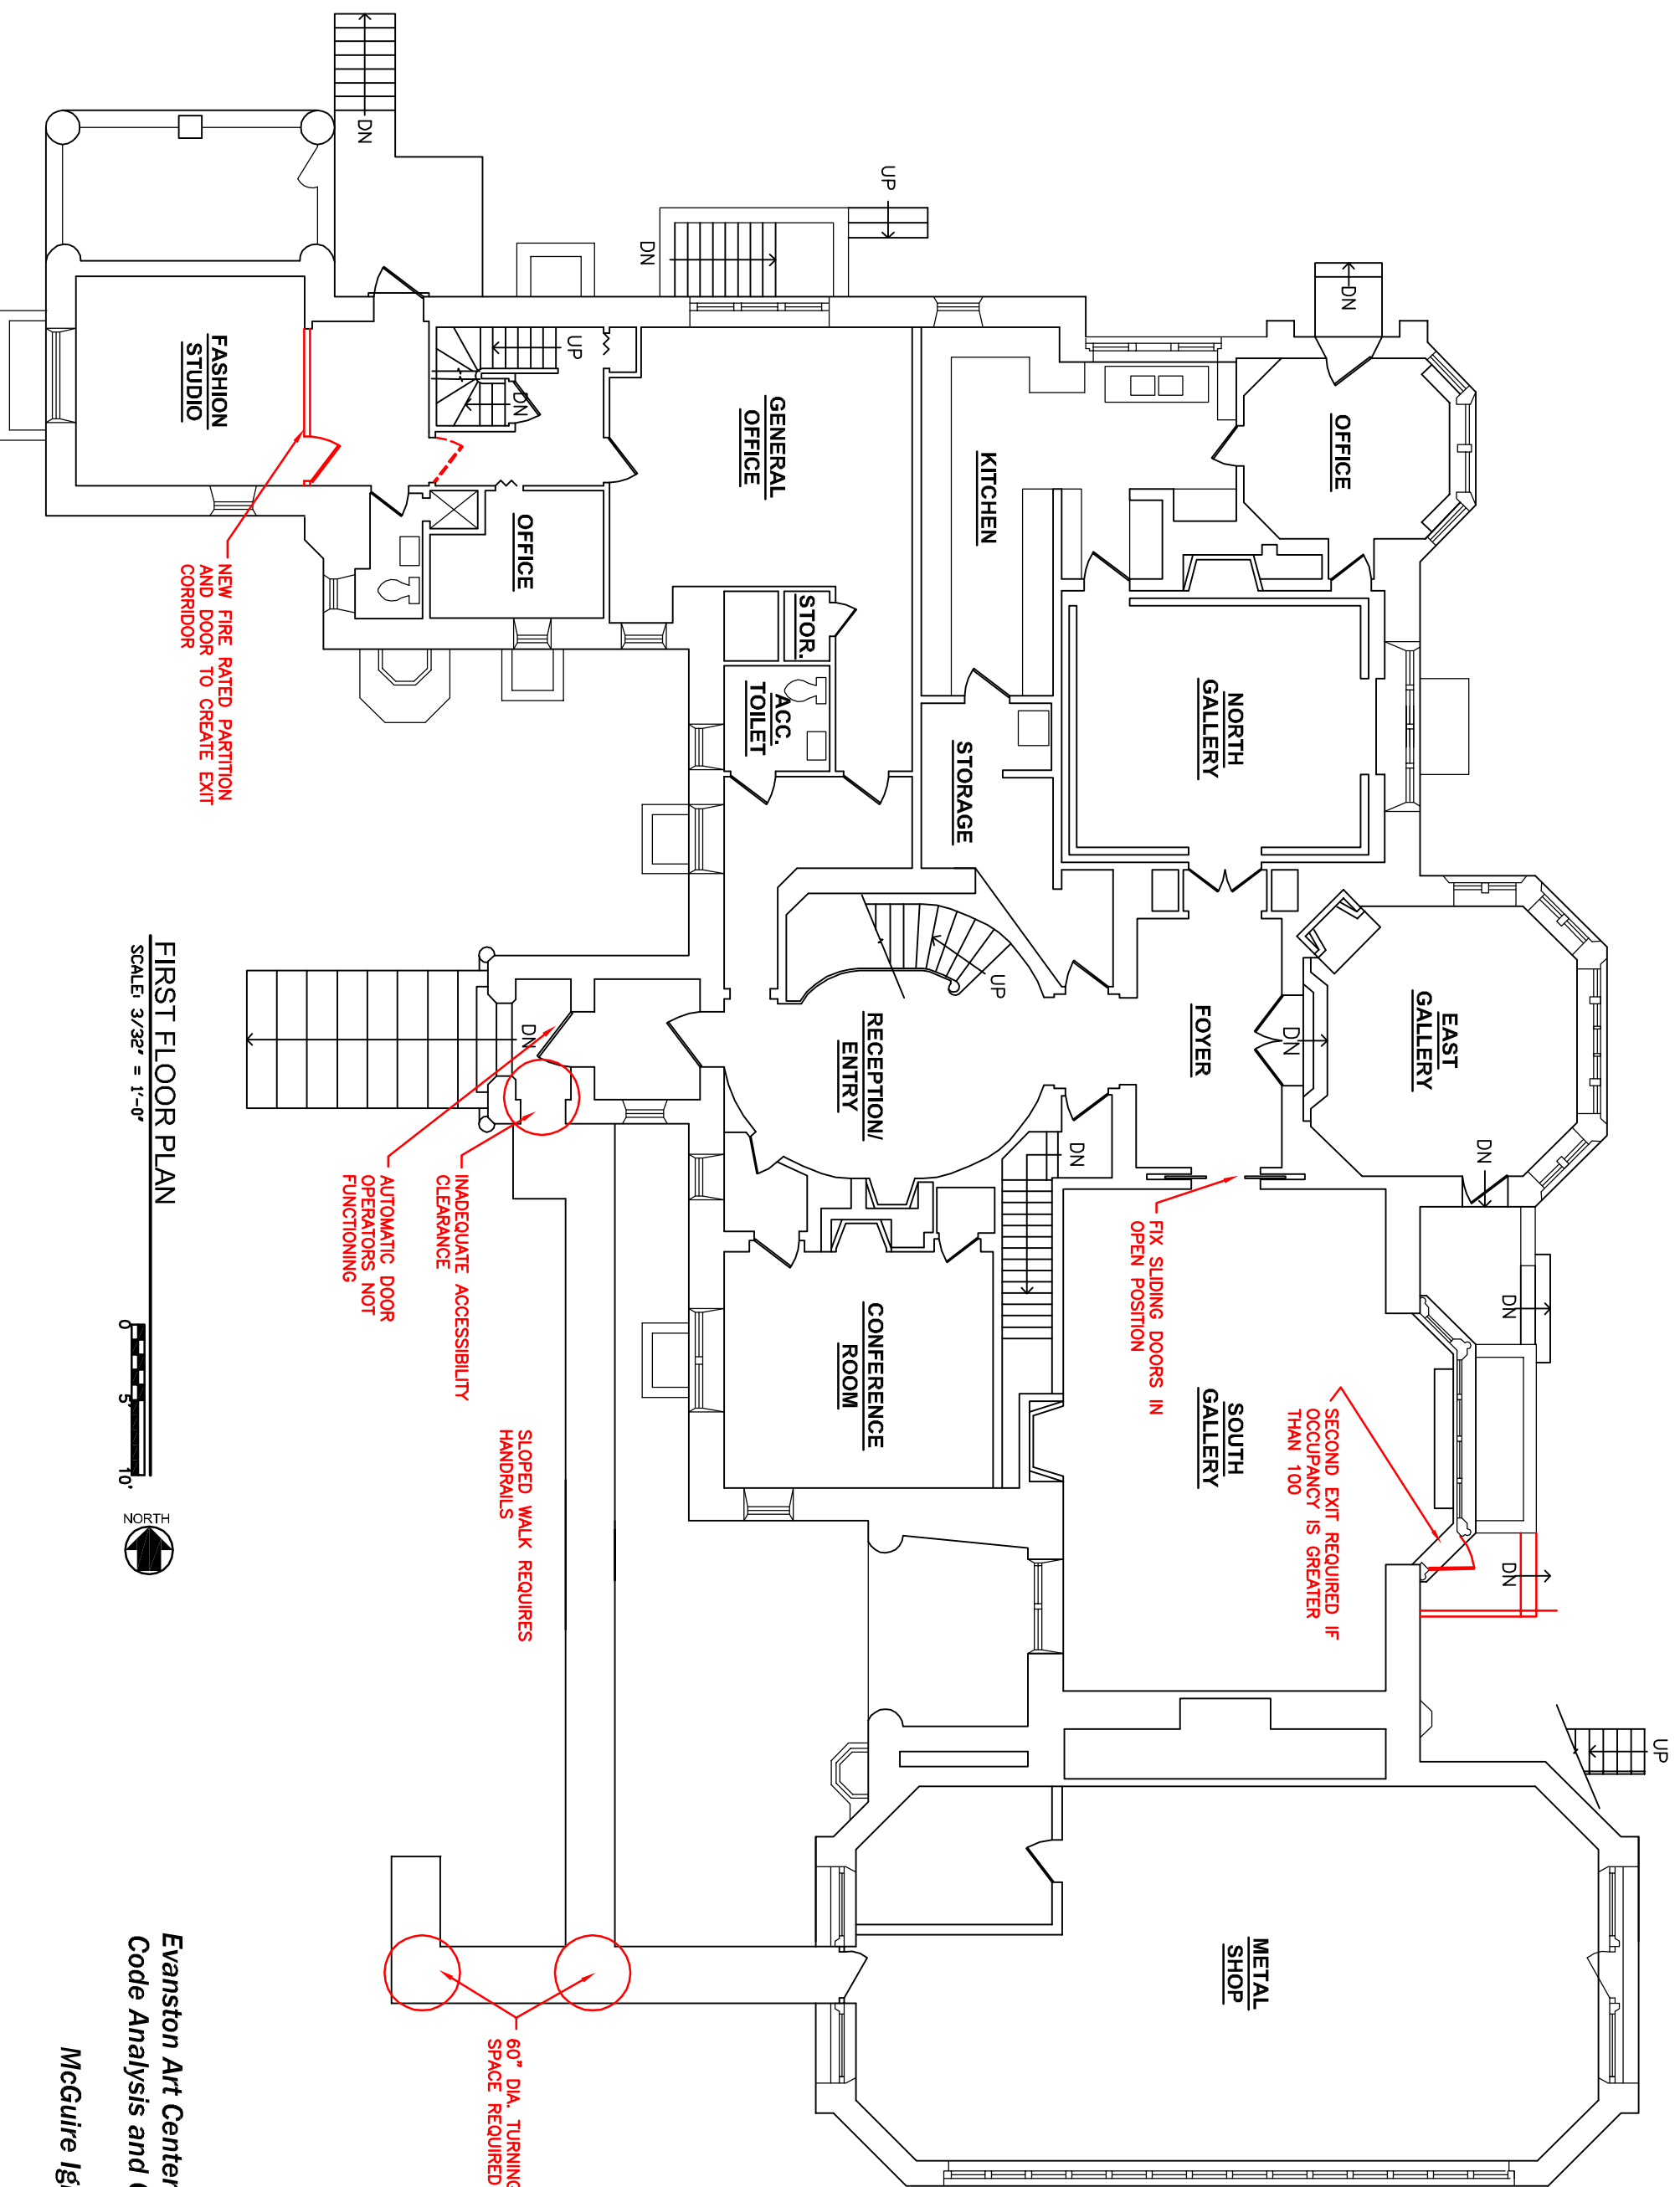
INADEQUATE ACCESSIBILITY CLEARANCE

NEW FIRE RATED PARTITION AND DOOR TO CREATE EXIT

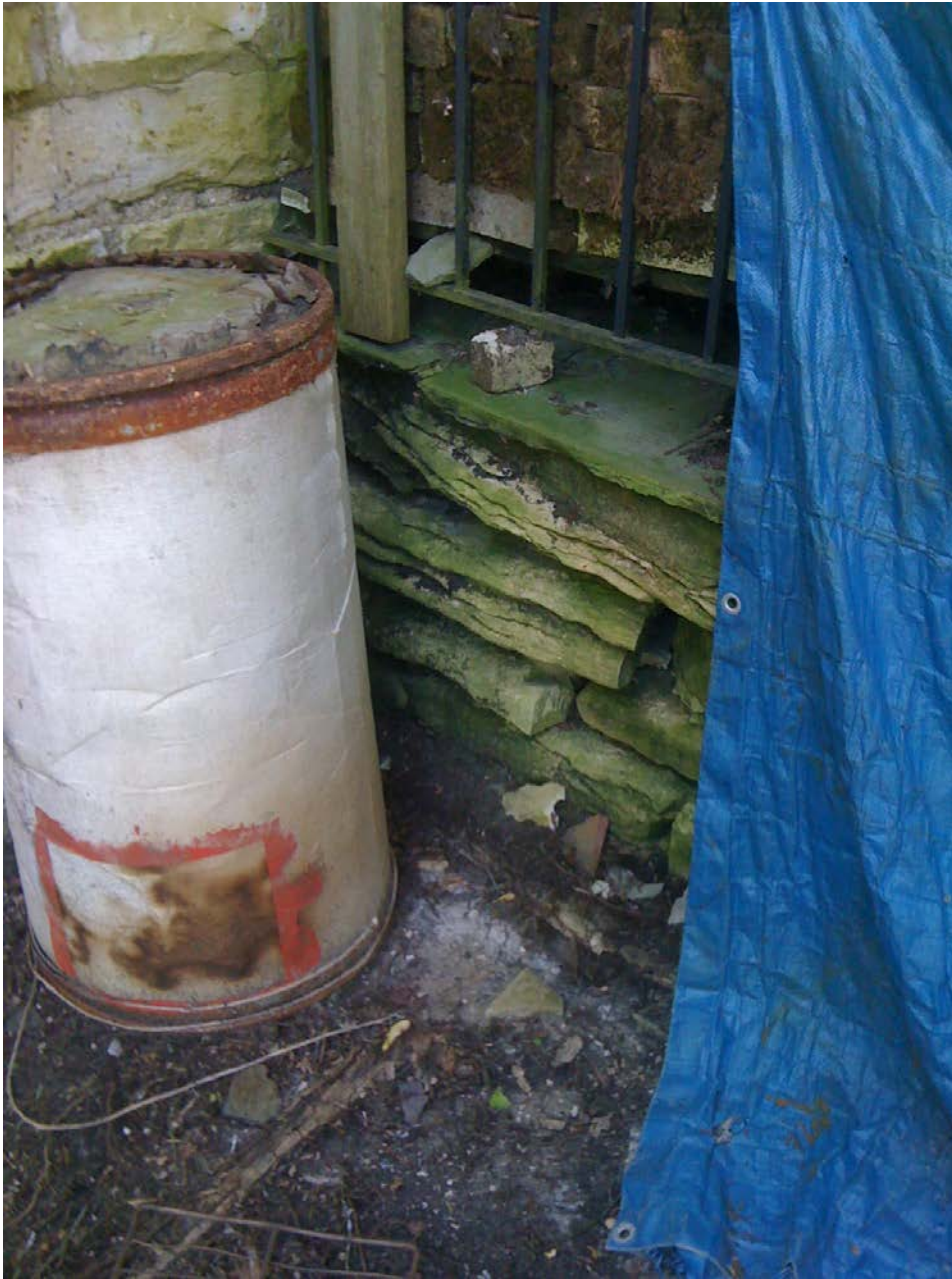
No major structural deficiencies were observed in the EAC; the conditions observed are generally a result of deferred maintenance, with exterior resulting in varying states of material degradation. The majority of exterior stone is covered by ivy and plant growth, which has a tendency to trap and hold moisture against the masonry. The density of the plant growth is so heavy that the stonework cannot be assessed (Photos 1 and 2). Mortar joint deterioration was observed in many locations (Photo 3). The stone walls supporting the original north exterior stair are in very poor condition (Photo 4). A new wood stair has been constructed over the original construction.

Photo 4 – Masonry at original north stair.

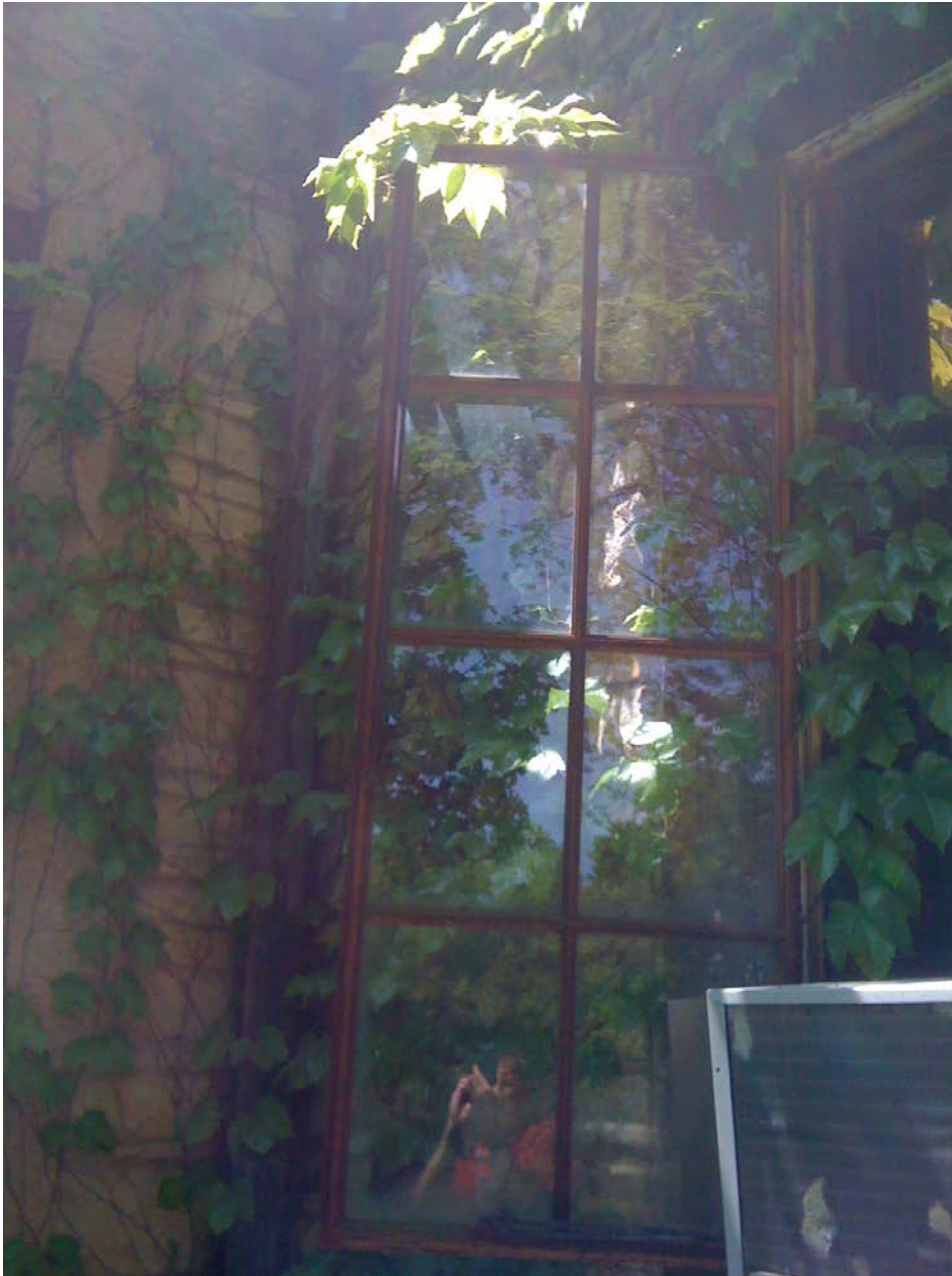
Surface corrosion exists on the steel window sash and frames, which overall are in fair to poor condition. In many locations the wood sills are in poor condition. Wood trim around doors and windows is also in fair to poor condition (Photos 5 and 6).

Photo 5 – Surface corrosion on steel windows.

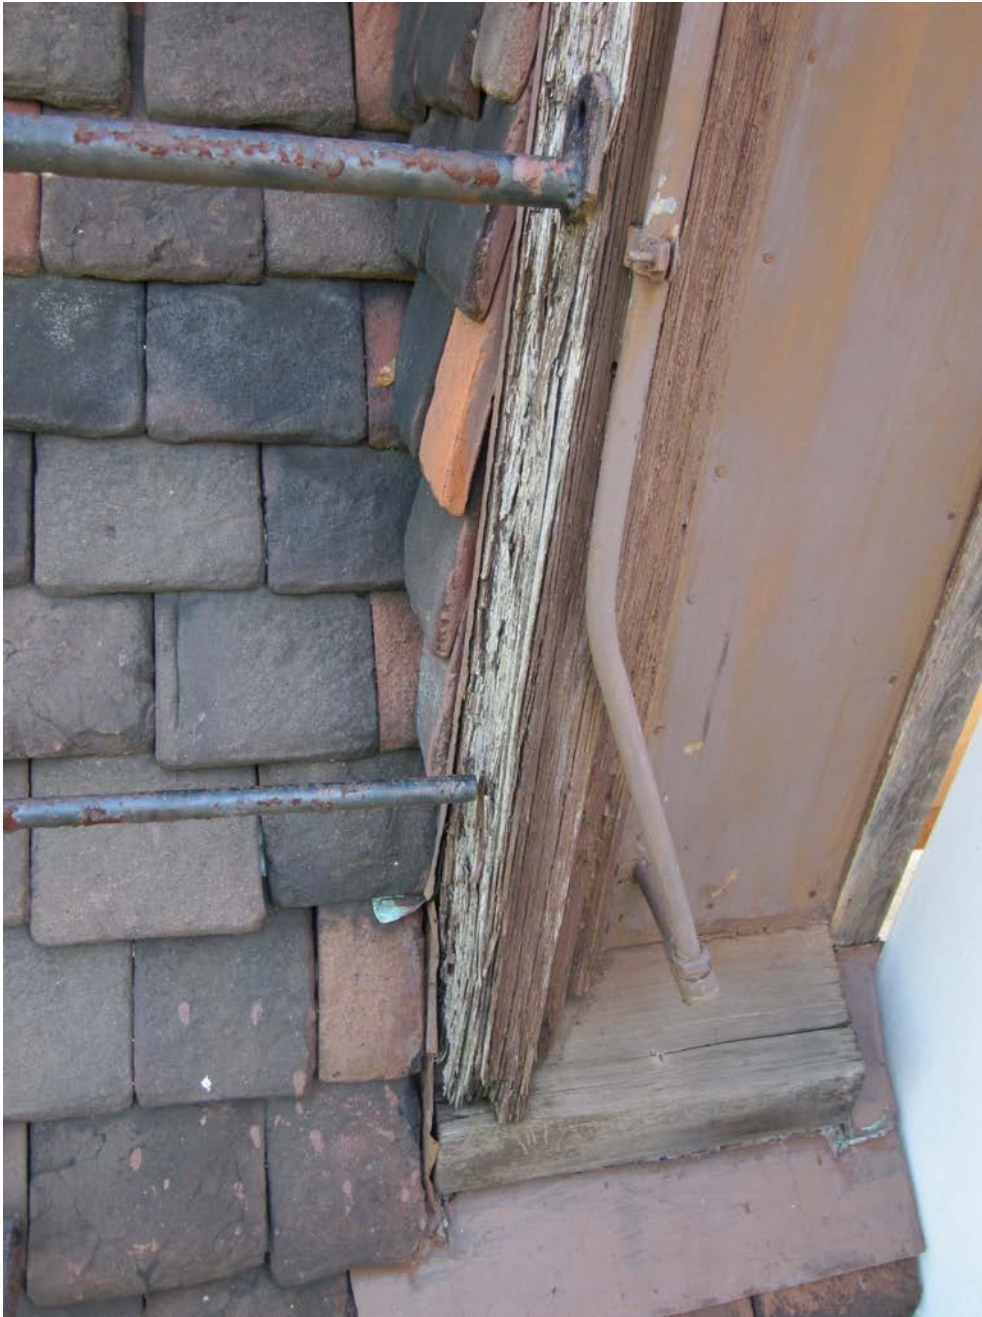
The clay tile roof is comprised of heavy shingle style units, and appears to be in good condition. Evidence of minor damage and localized repair of individual tiles was observed. The brick masonry chimneys appear to be in fair condition. Localized brick deterioration and cracked mortar joints were observed (Photo 7). Wood trim at dormers and the south fire escape doors is weathered and is in generally fair condition (Photo 6).

Photo 6 – Deteriorated wood trim at south fire escape exit doors.

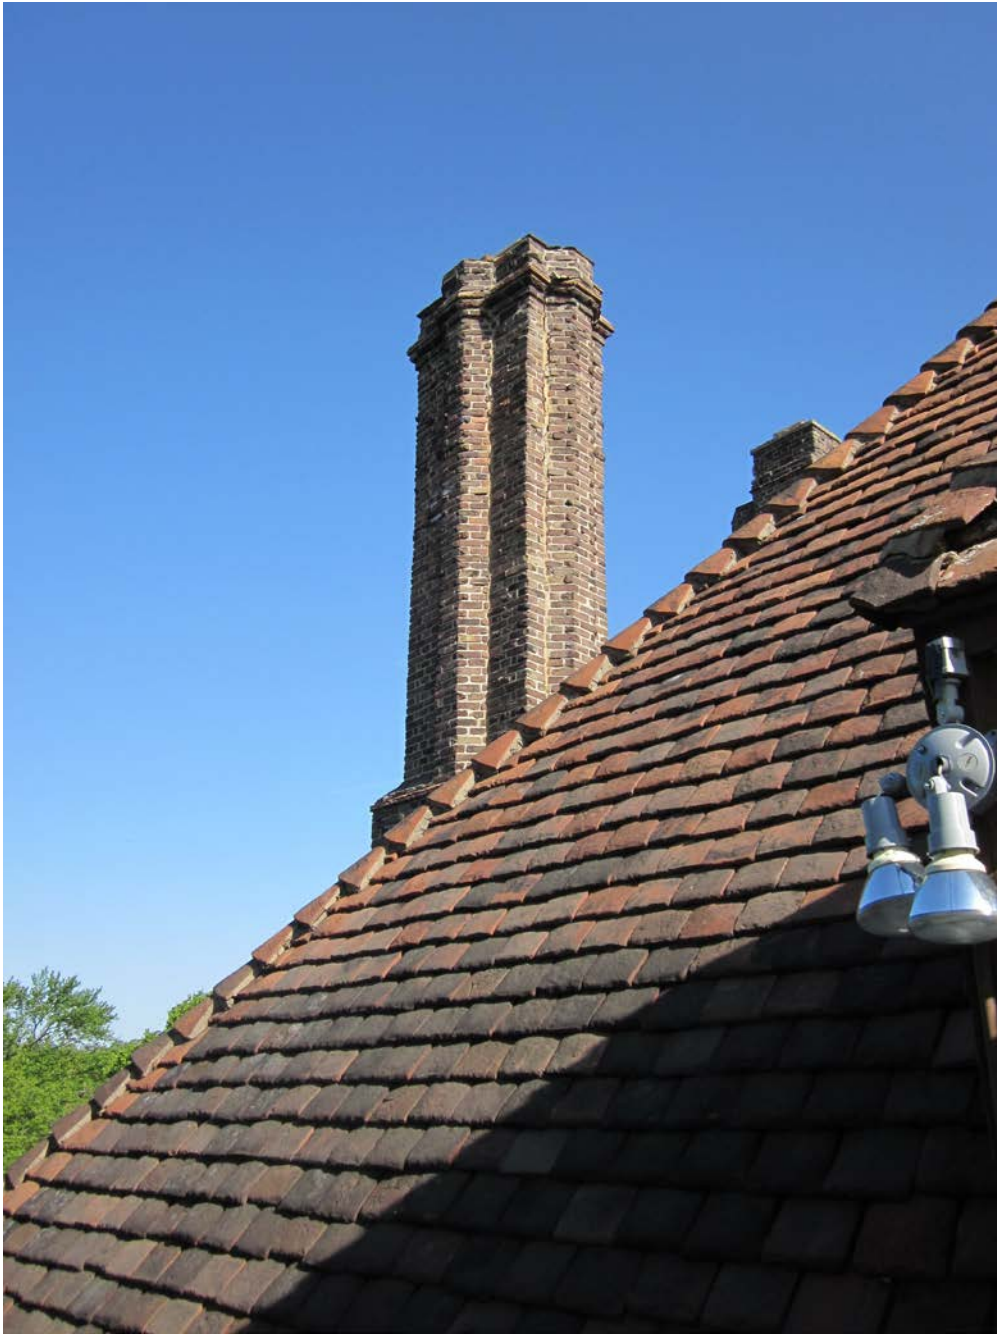
Photo 7 – View of roof tiles and chimney, south elevation.

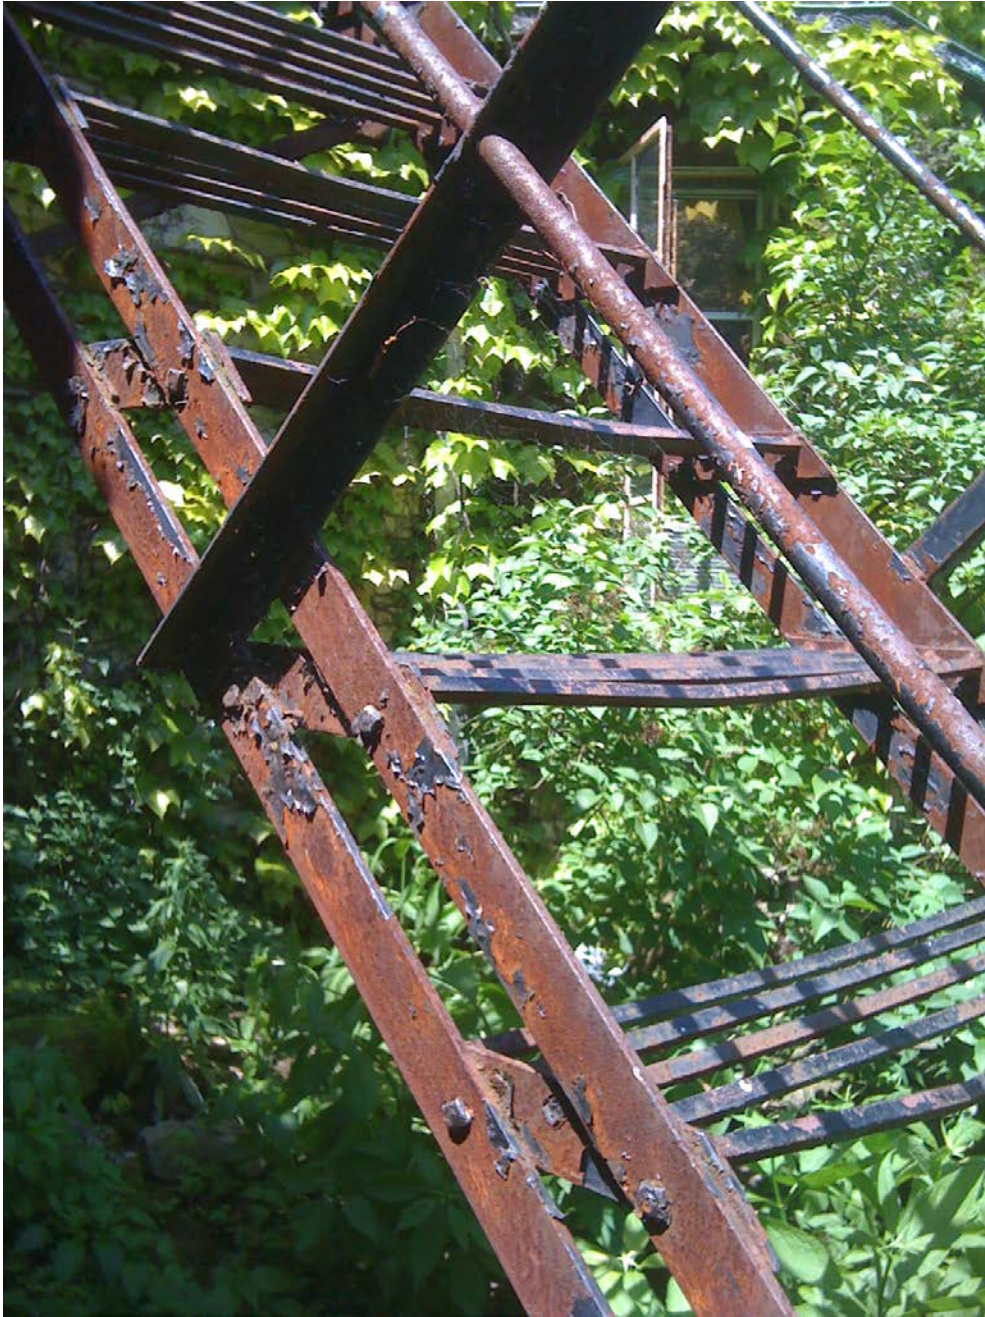
The fire escape is fair condition. Paint failure and surface corrosion were observed throughout. No loose structural elements were discovered (Photo 8).

Photo 8 – Surface corrosion and tread deterioration on fire escape.

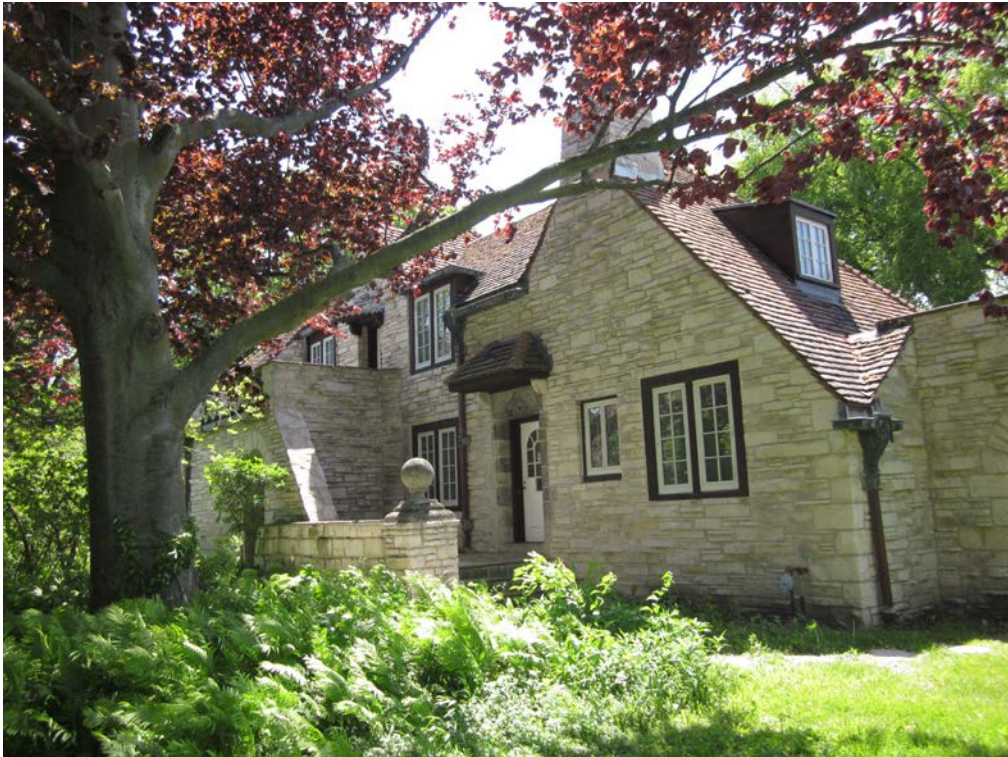
The exterior of the coach house is in good condition, due to the recent repair work. Ivy has been removed, mortar joints tuckpointed, and windows replaced (Photo 9). There is extensive moisture infiltration where the greenhouse addition meets the east exterior wall (Photo 10). This may be due to poor flashing conditions between the wall and greenhouse. It is not clear if the problem was addressed as part of the recent rehabilitation.

Photo 9. North Elevation of Coach House.

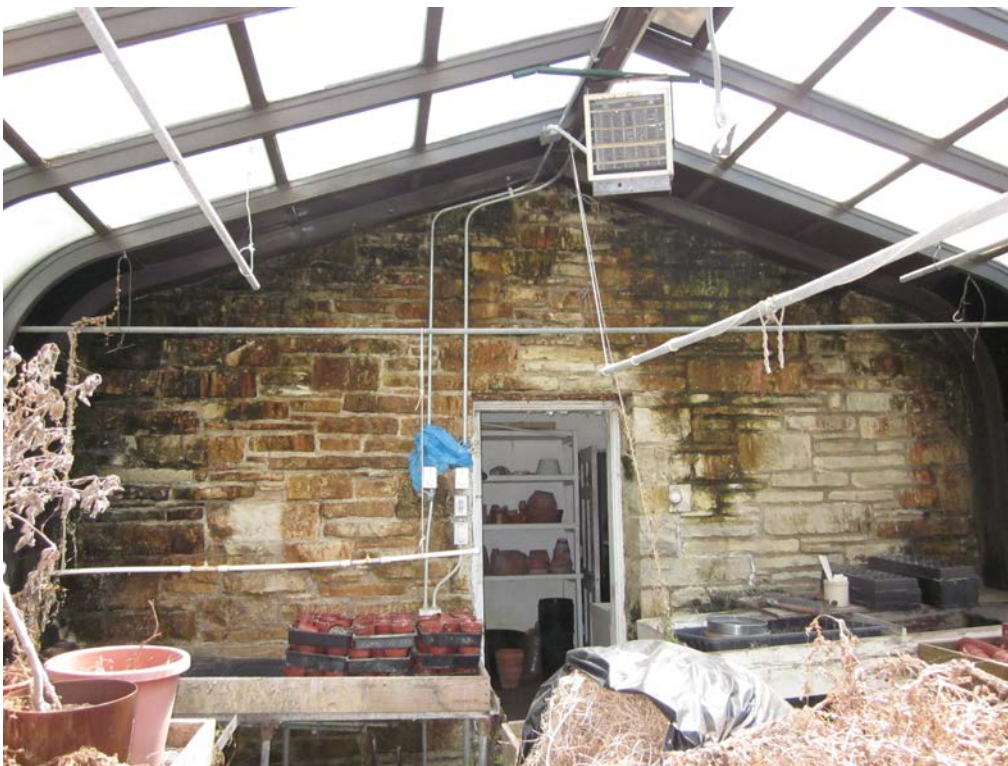
Photo 10. Interior of greenhouse, looking east.
