HARLEY CLARKE MANSION Condition Assessment

2603 Sheridan Road
Evanston, Illinois 60201

Final Report

September 11, 2019
WJE No. 2019.1266.4

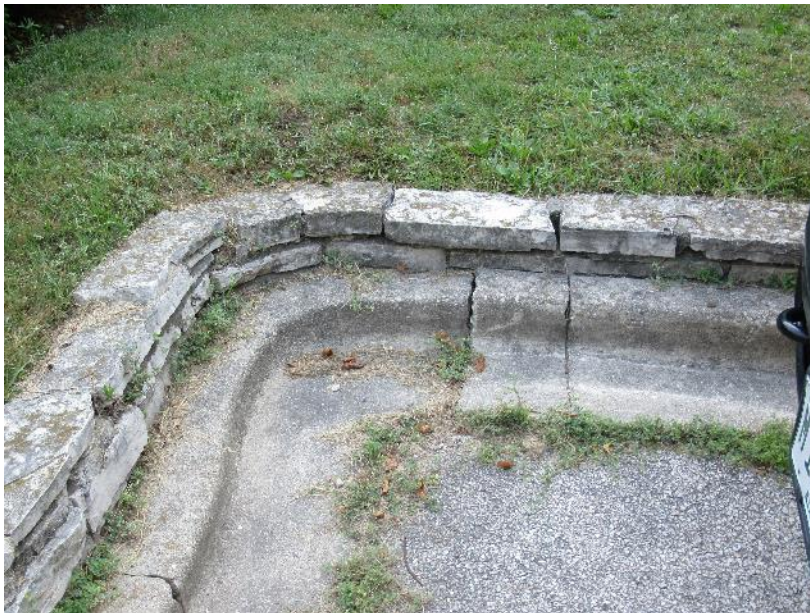
1. Loose and displaced masonry units with open joints on the site wall and retaining wall located on the west (Figure 16 and Figure 17).
2. Localized damage at the entry stairs, including cracked stone, spalled stone and missing mortar (Figure 18).

Figure 16. Site wall

11. Scrape, clean, and paint the fire escape. Replace buckled treads.
 - Estimated cost: \$10,000
12. Rebuild site walls.
 - Estimated cost: \$15,000

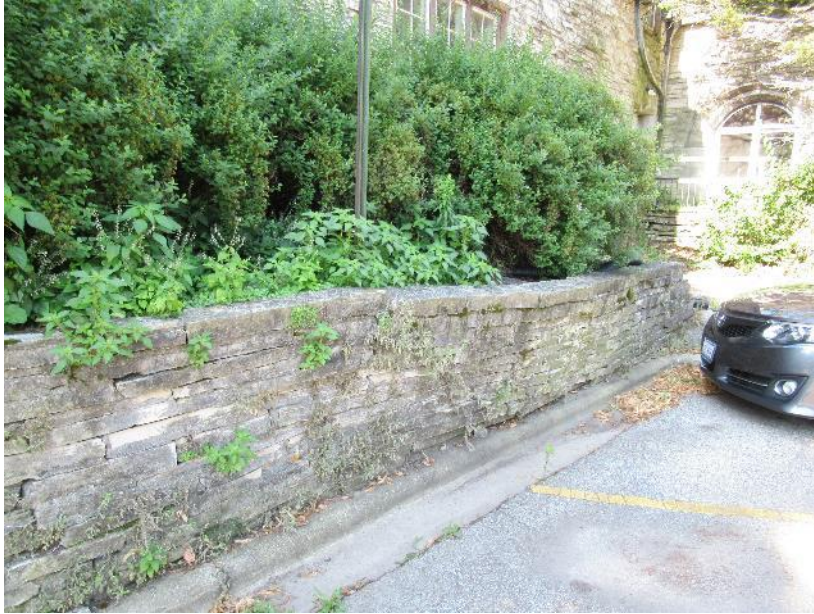
Figure 17. Retaining wall

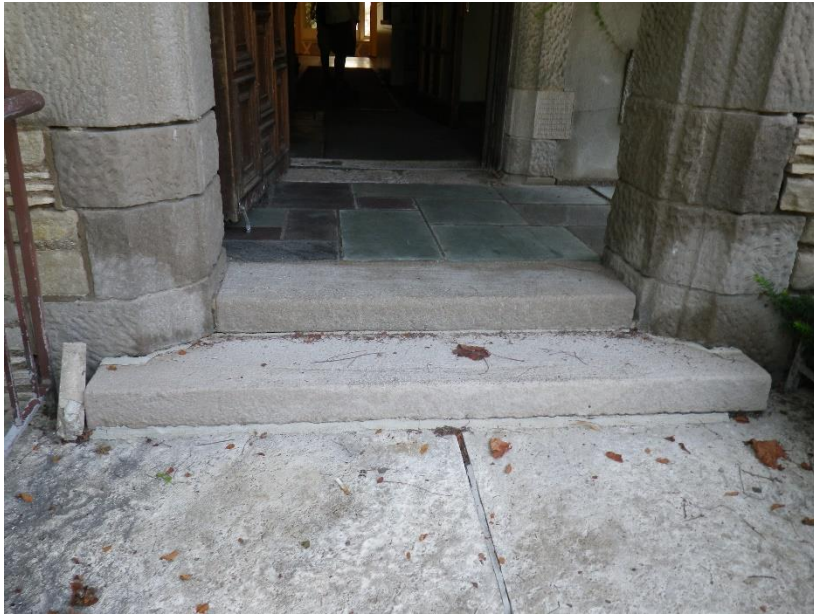
Figure 18. Front entry steps (2016)

- Estimated cost: \$5,000
- 3. Identify and repair leaks in the basement
 - Estimated cost: \$5,000 allowance
- 4. Remove vines and overgrown landscaping
 - Estimated cost: \$5,000
- 5. Repair stone at main entrance
 - Estimated cost: \$10,000

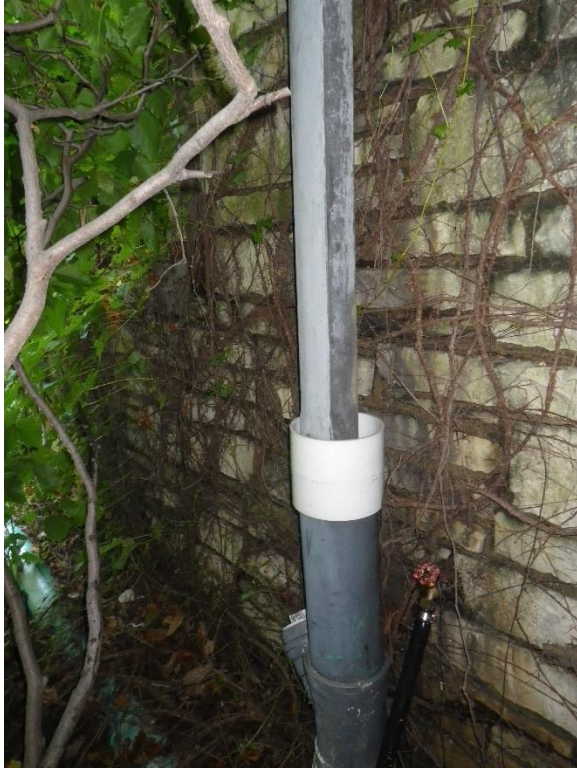
3. Vines are present on the majority of the exterior masonry. As a result, the condition assessment of the masonry was limited (Figure 19).
4. Cracked and missing mortar joints between the limestone units throughout the house at visible areas (Figure 20).

Vines on the exterior walls have the potential to reduce the rate of drying of the stone. This could increase deterioration related to freeze-thaw cycles. Further, the vines may lead to cracking of masonry. The overgrown landscaping may also be causing damage to the exterior enclosure. The vines and overgrown vegetation should be removed.

Figure 19. Vines on limestone (2016)

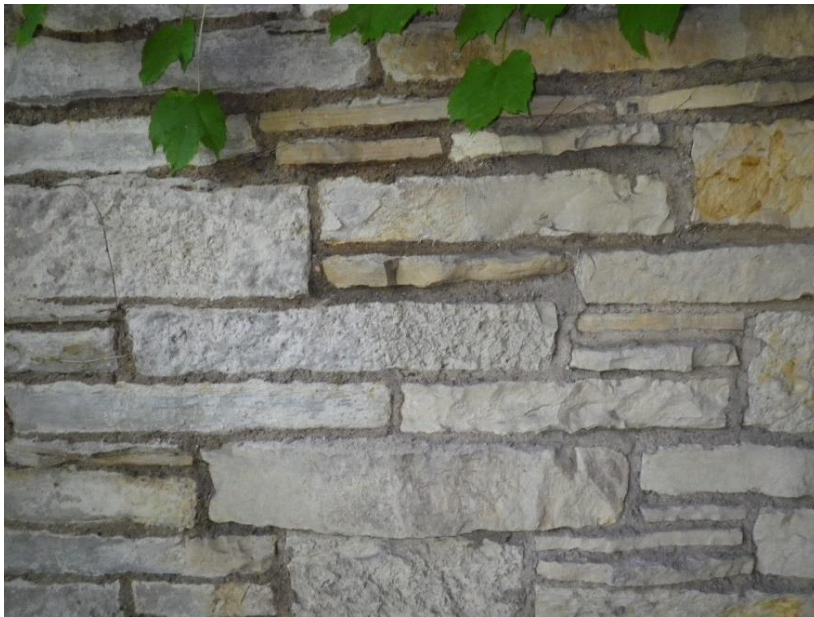
While in need of maintenance, the Harley Clarke Mansion is generally in serviceable condition. The masonry damage, including missing mortar, debonded mortar, and cracked mortar joints and damaged masonry, is likely a result of seasonal movements, water infiltration into the masonry assembly, cyclic freeze-thaw damage, deferred maintenance, overgrown vegetation, and corrosion of embedded metals. The distress was generally consistent with a building of this age. The cracked and spalled limestone balusters above the sun room may create falling hazards and should be rebuilt. Rebuilding should include disassembly, removing, and replacing any ferrous pins with new stainless-steel pins. Cracked, missing or

Figure 20. Detail of cracked mortar joints limestone cladding (2016)

1. Repoint deteriorated mortar.
 - Estimated cost: \$100,000 allowance
2. Inspect the tile roof and perform repairs, as needed, to include resetting or replacing tile.
 - Estimated cost: \$3,000 annually
3. Repair damaged gutters and downspout.
 - Estimated cost: \$10,000
4. Clean algae from masonry.
 - Estimated cost: \$3,000

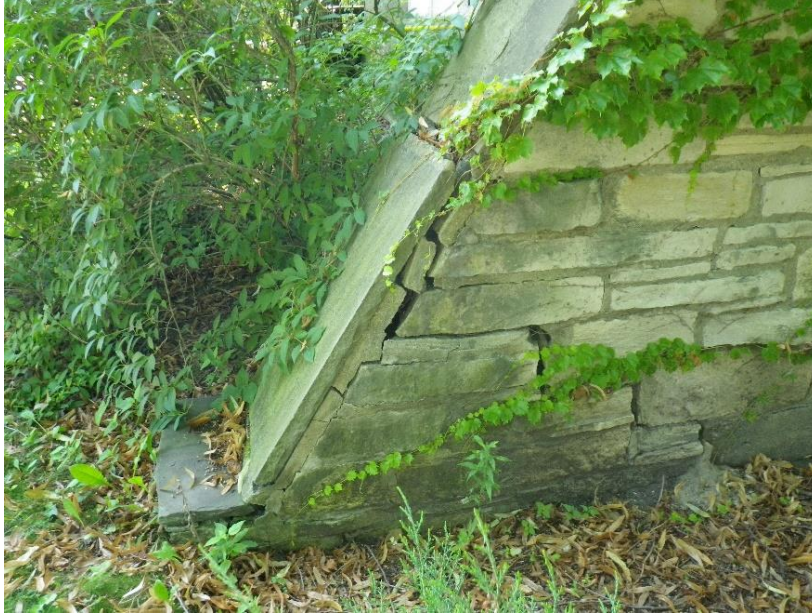
5. Localized displacement, and loose limestone units and cracked mortar joints at the wing wall on the northwest corner side (Figure 21).
6. Step cracks of mortar joints above the basement door at north facade (Figure 22).

Figure 21. Wing wall at northwest corner of mansion (2016)

1. Repoint severely deteriorated mortar, including the sun room and the chimneys.
 - Estimated cost: \$50,000 allowance
2. Rebuild areas of displaced stone at wing wall.

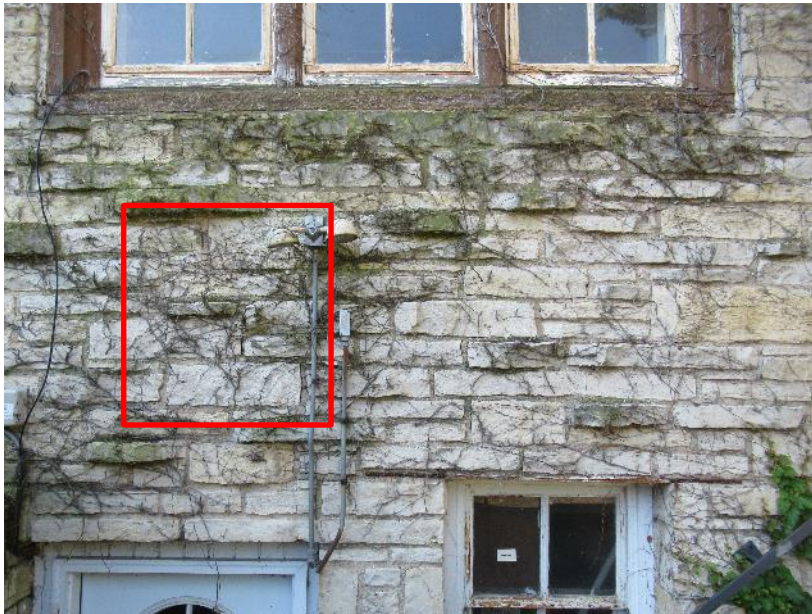
Figure 22. Step cracking of mortar joints above basement door

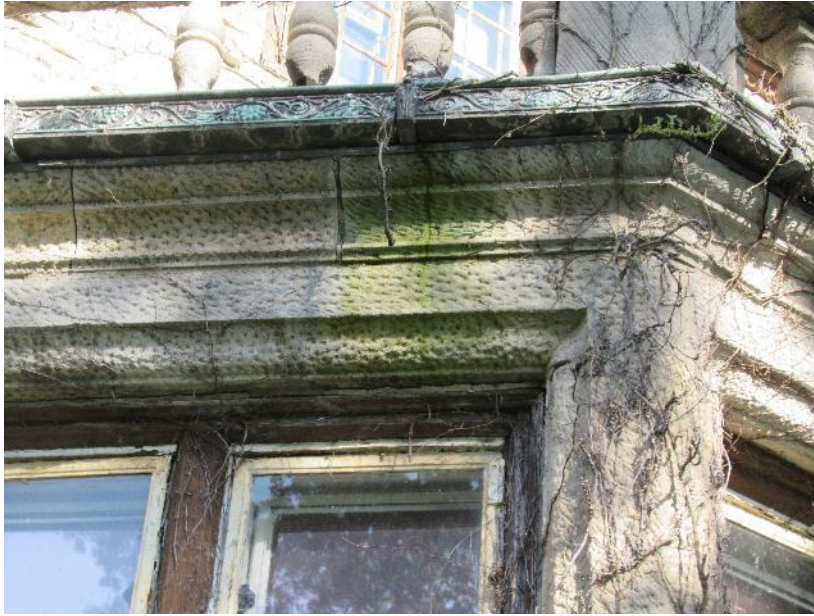
7. Cracked limestone cladding at sun room on east facade (Figure 23).
8. Missing limestone balusters and spalled limestone balusters exposing corroded ferrous pins above the sun room on the east (Figure 24 and Figure 25).

Figure 23. Cracking of limestone cladding at sun room and algae staining

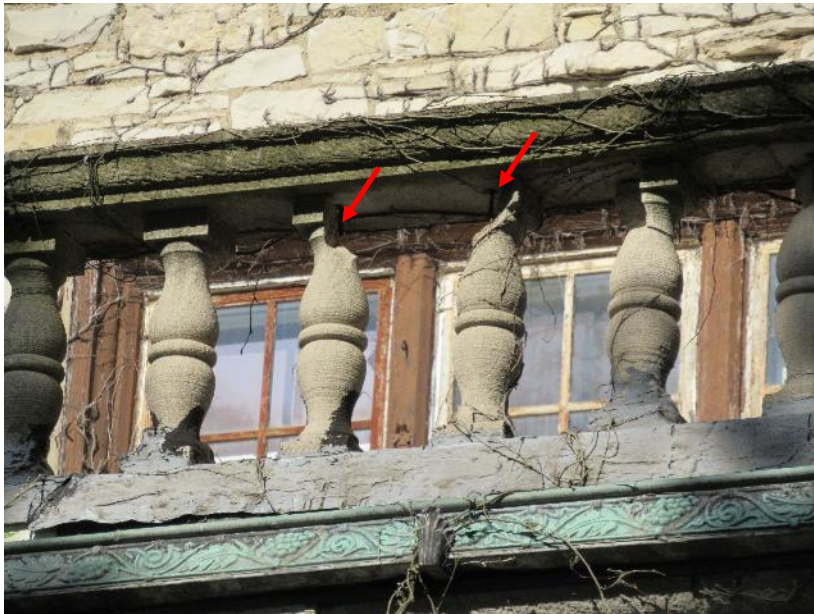
Figure 24. Spalled balusters above sun room

1. Remove and replace or salvage and rebuild balusters and railing above sun room.
 - Estimated cost: \$20,000
2. Replace balcony roof at coach house

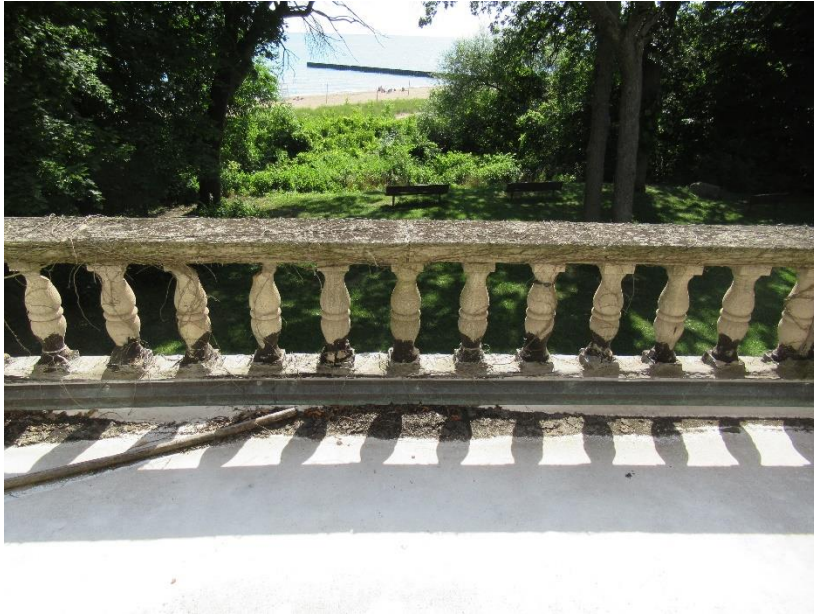
Figure 25. Limestone balusters at second floor balcony above sun room

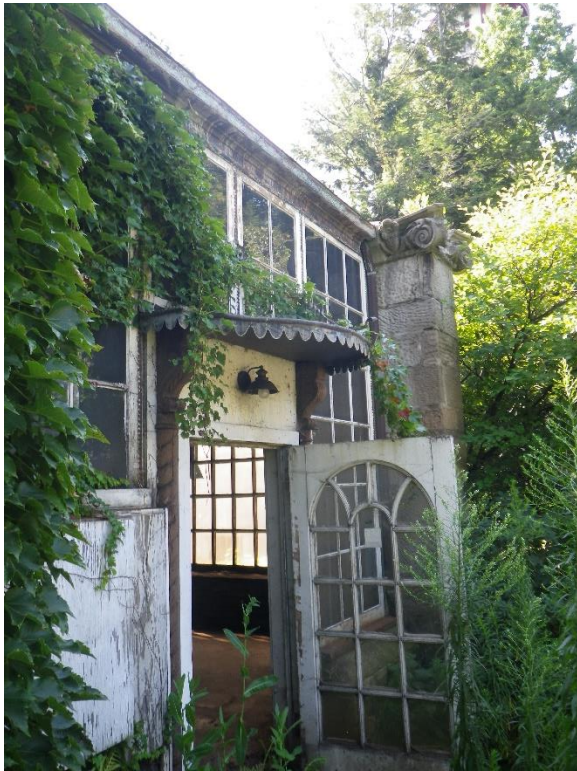
9. Exfoliation of the limestone was evident at several locations, particularly at water shedding elements of the facade.
10. Limited exfoliated limestone and missing mortar on the west facade of the conservatory (Figure 26).

Figure 26. West facade of conservatory (2016)

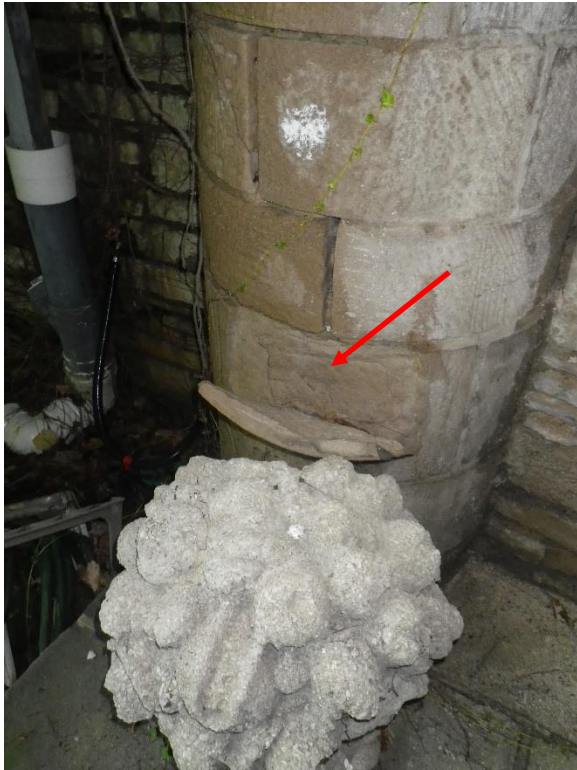
11. Isolated limestone spalls at the alcove on the west facade (Figure 27).
12. Areas of algae growth are evident on portions of the stone and mortar at areas of the vine covered facades.

Figure 27. Spalling limestone (2016)

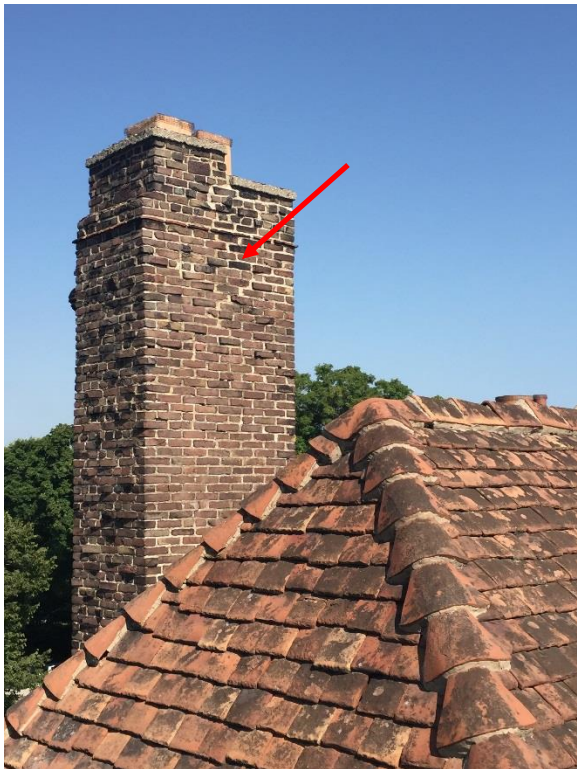
13. Missing mortar and isolated cracks of the brick masonry near the tops of the chimneys (Figure 28).
14. Window wood jambs at west facade exhibited checks and isolated wood rot at the base. Window glazing was cracked, missing and replaced with plastic glazing at several locations (Figure 29).

Figure 28. Isolated cracking in chimney (2016)

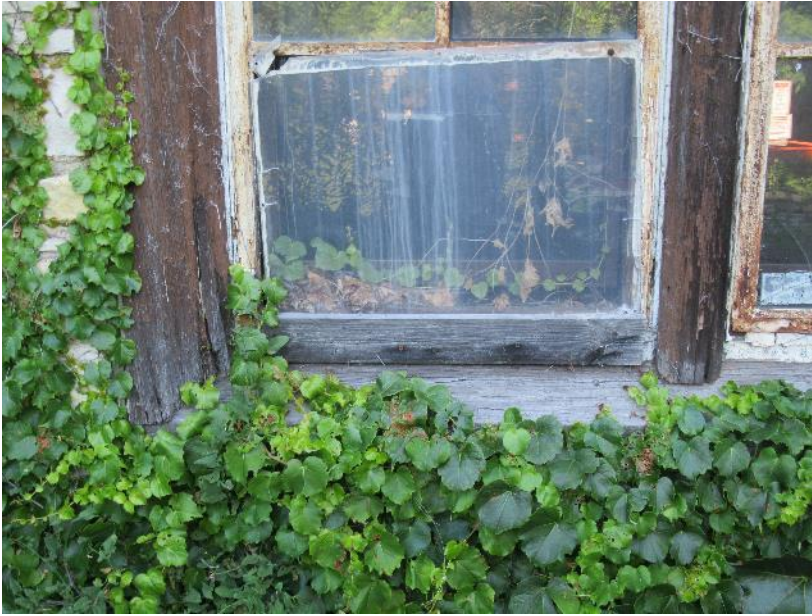
Figure 29. Window wood jambs and glazing at west facade

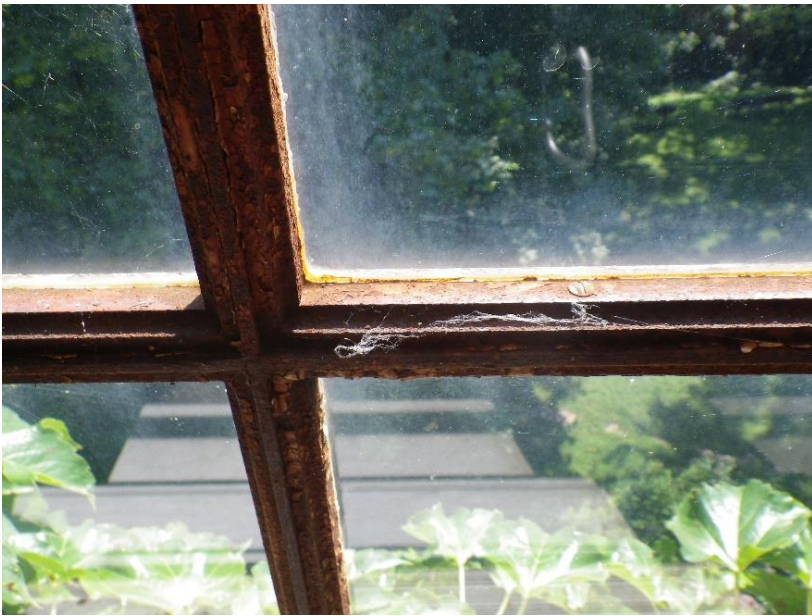
15. Cracked, missing and debonded glazing putty and debonded perimeter window sealant at most windows.
16. Peeling paint and surface corrosion of the steel window frames. Surface corrosion on the steel sash and frames of the windows throughout the house (Figure 30). Window stops displaced at some window locations.

Corrosion of the steel window frames and sash are consistent with performance for windows of this vintage with deferred maintenance. Corrosion generally is limited to surface corrosion resulting in peeling and cracked paint with no significant section loss of the window components. The wood window components exhibit more deterioration with areas of cracked and peeling coatings, as well as checks and rot. Glazing putty and deteriorated sealant at the window perimeters is indicative of deferred maintenance. Isolated replacement elements or Dutchman can be installed and the wood elements prepared and recoated. Perimeter sealant should be removed and replaced at all windows.

Figure 30. Surface corrosion on steel window mullions (2016)

- Estimated cost: \$2,000 allowance
3. Scrape and paint the existing steel window frames and sash. Replace aged glazing putty as glass lites are replaced. Evaluate the leaded glass and perform in-situ repairs, when possible.

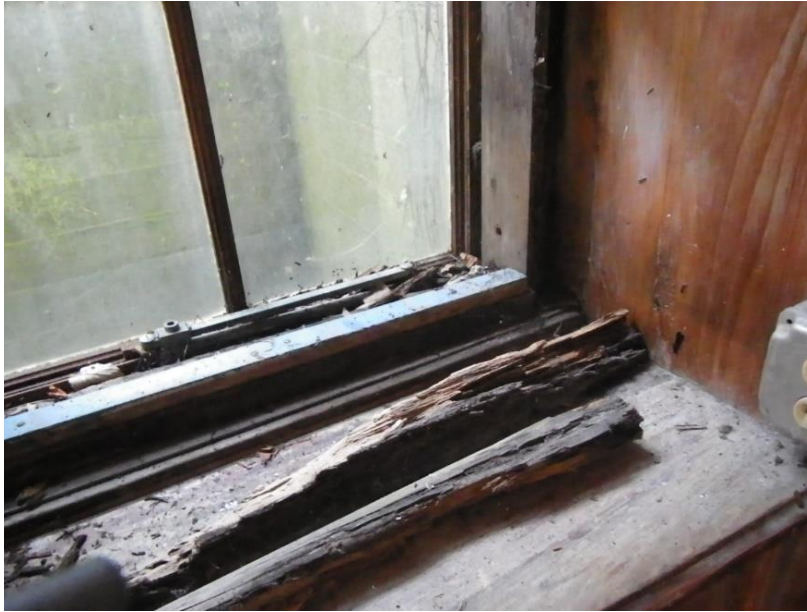
17. Peeling paint on areas of the wood frames and sills, as well as some localized damage from long term water exposure (Figure 31).
18. Localized cracking of the plaster at entrance porch ceiling and walls (Figure 32).

Figure 31. Deterioration wood sill in basement (2016)

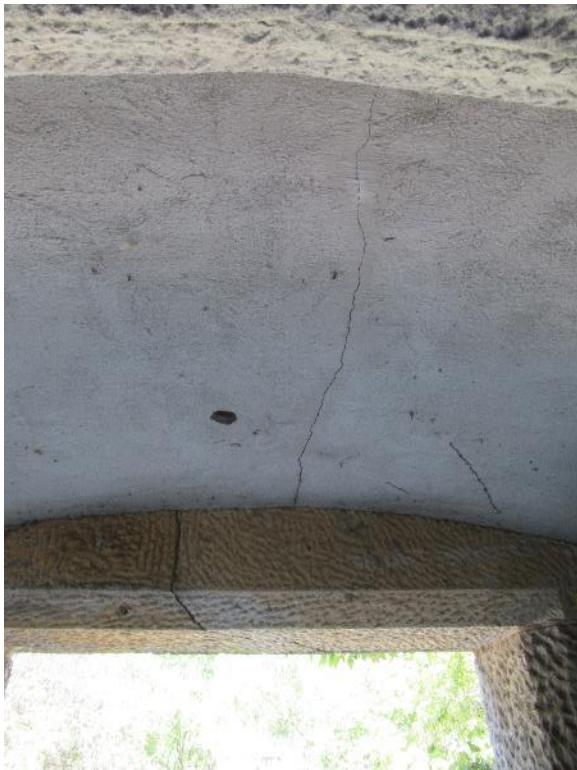
Figure 32. Cracked ceiling at entrance porch

6. Repair cracked plaster and water damaged plaster on the interior of mansion.
 - Estimated cost: \$5,000 allowance
7. Repair cracked plaster at entrance.

- Estimated cost: \$2,500 allowance
8. Repair cracked plaster and water-damaged plaster on the interior of coach house.
 - Estimated cost: \$10,000 allowance

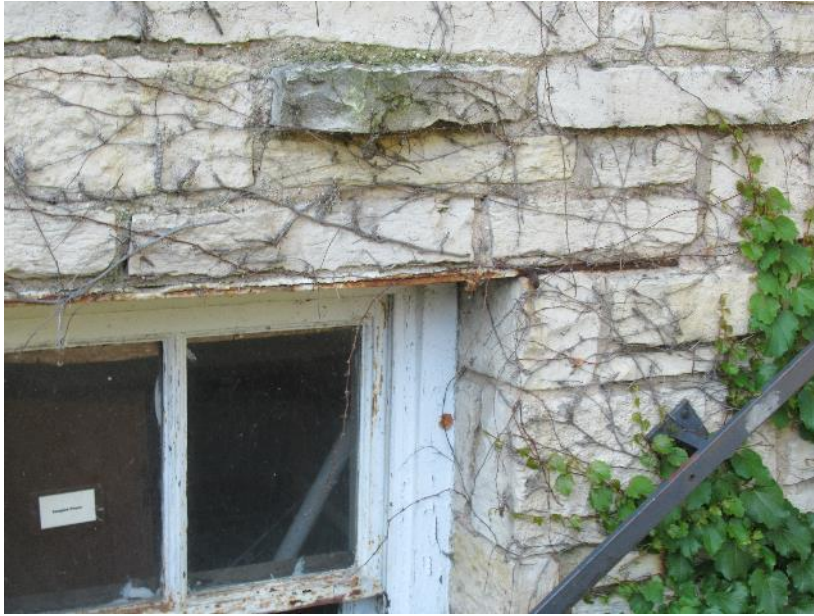
19. Surface corrosion of basement window lintel at north facade (Figure 33).
20. Cast iron Juliette balcony railing at south facade was cracked (Figure 34).

Figure 33. Surface corrosion of window lintel

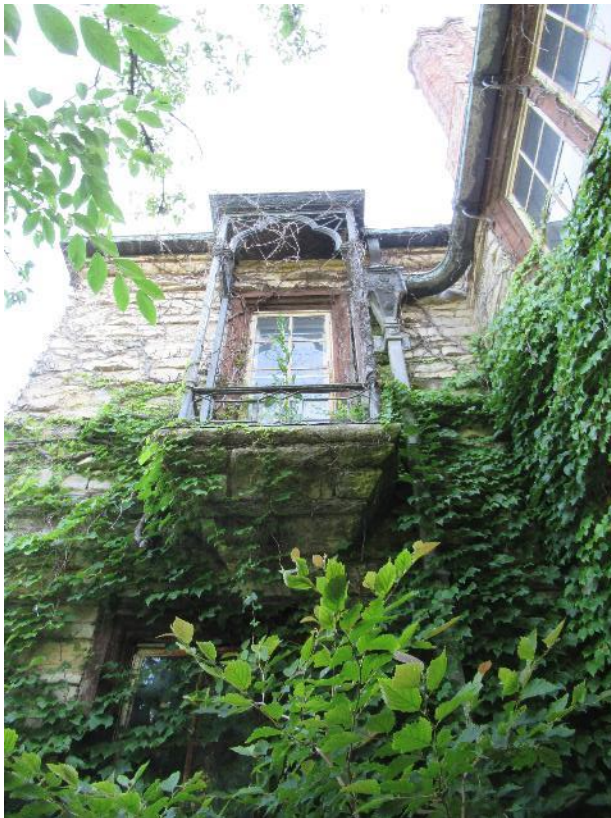
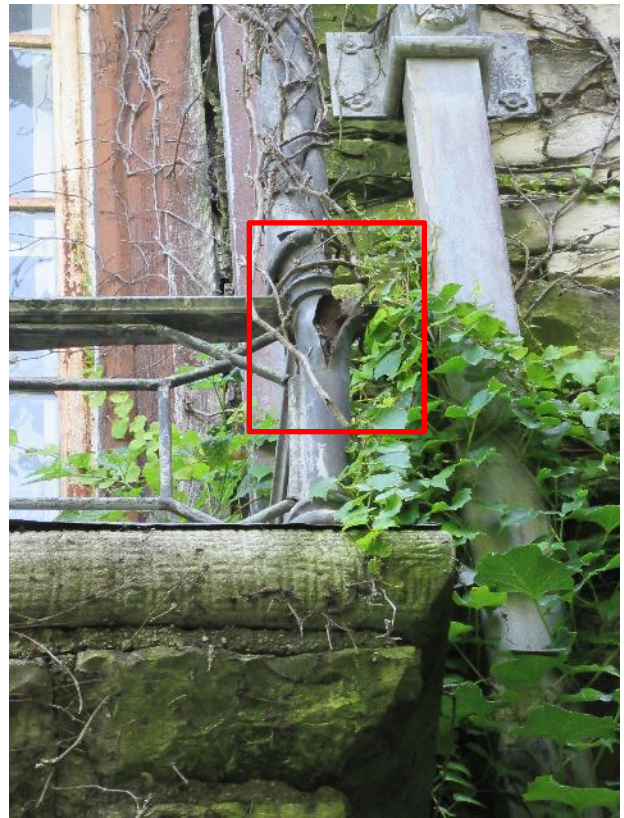
Figure 34. View of Juliette balcony (left) and cracked cast iron (right)

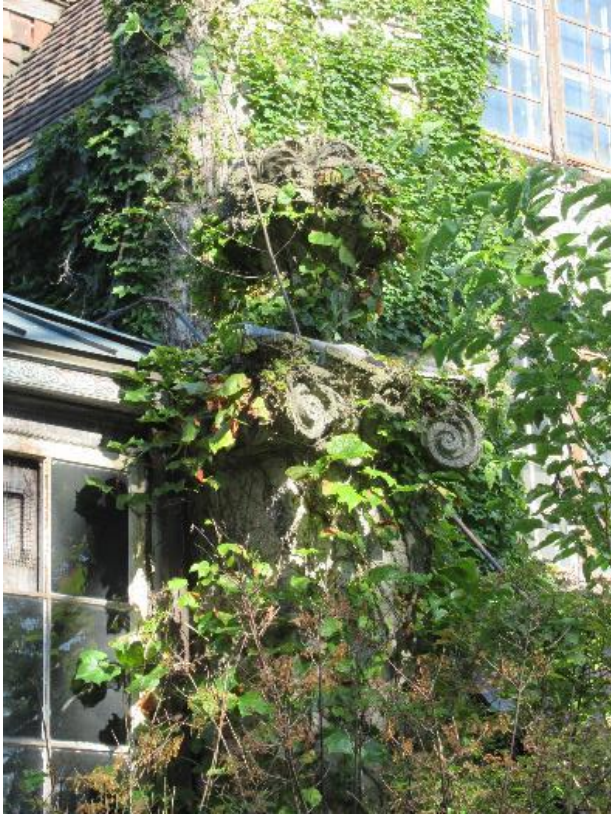
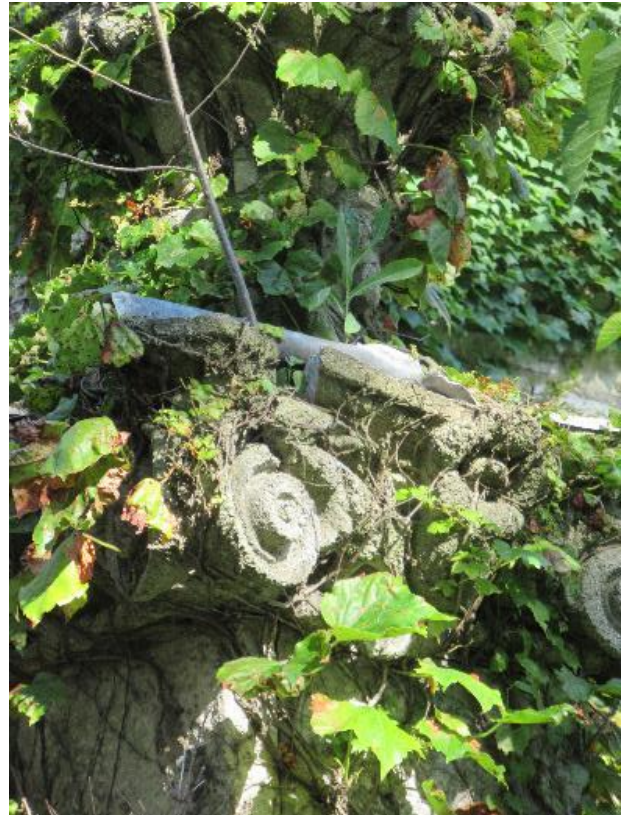
21. Bent sheet metal flashing between the cast stone urn and capital at the east facade (Figure 35).
22. Missing roof tiles were noted at one location at a valley and the ridge (Figure 36).

Figure 35. Flashing between urn and ornamental cast stone capital east facade

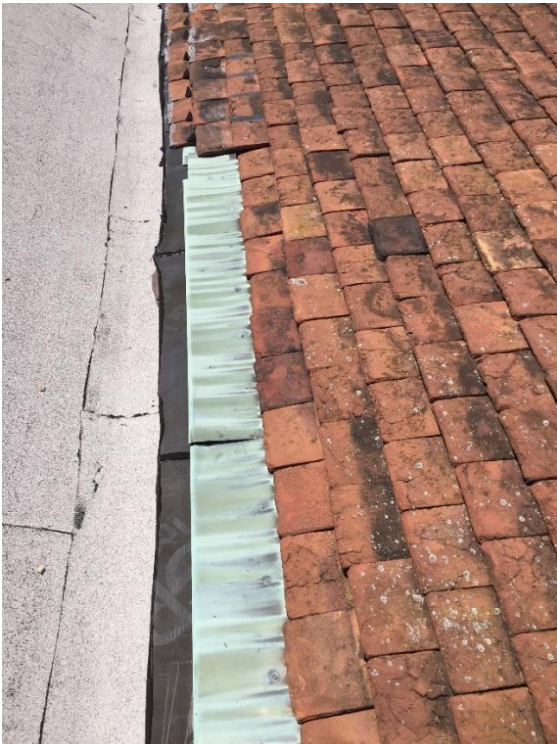
Figure 36. An area of missing roof tiles (2016)

- Estimated cost: \$2,000 allowance
10. Inspect the tile roof and perform repairs, as needed, to include resetting or replacing tile.
 - Estimated cost: \$15,000 allowance

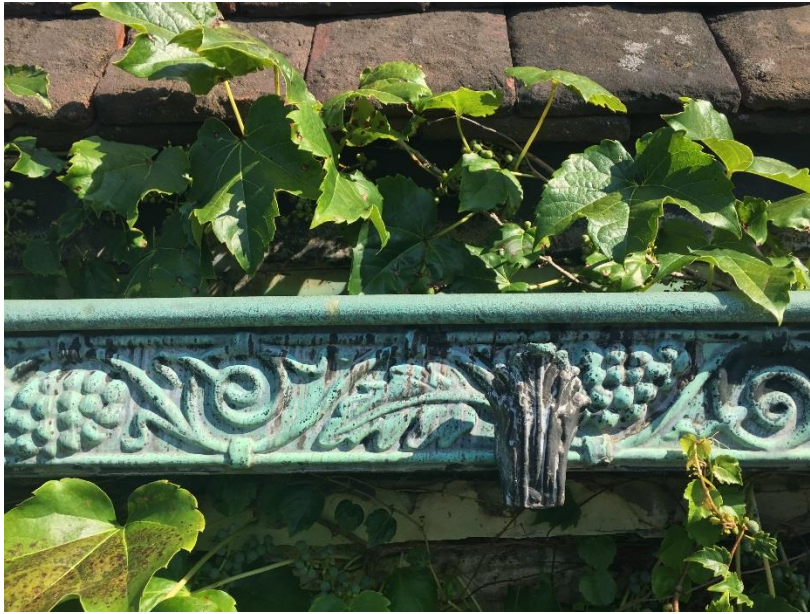
23. Decorative copper gutters and downspouts are generally intact with some areas of impact damage. Vines are growing in some of the gutters (Figure 37).

Figure 37. Vines growing in the gutter (2016)

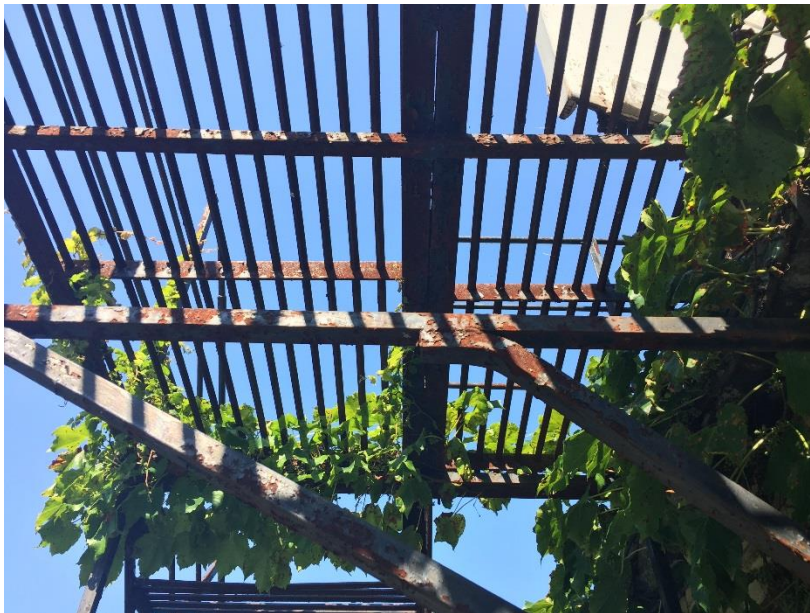
24. Peeling paint and areas of paint loss on the steel fire escape (rails, treads, and platforms) on the south facade. Surface corrosion was identified at the steel elements at areas of missing paint. (Figure 38).

The peeling paint and surface corrosion of the metal elements is a result of deferred maintenance. These elements should be prepared and painted.

Figure 38. Surface corrosion and peeling paint and areas at the fire escape (2016)

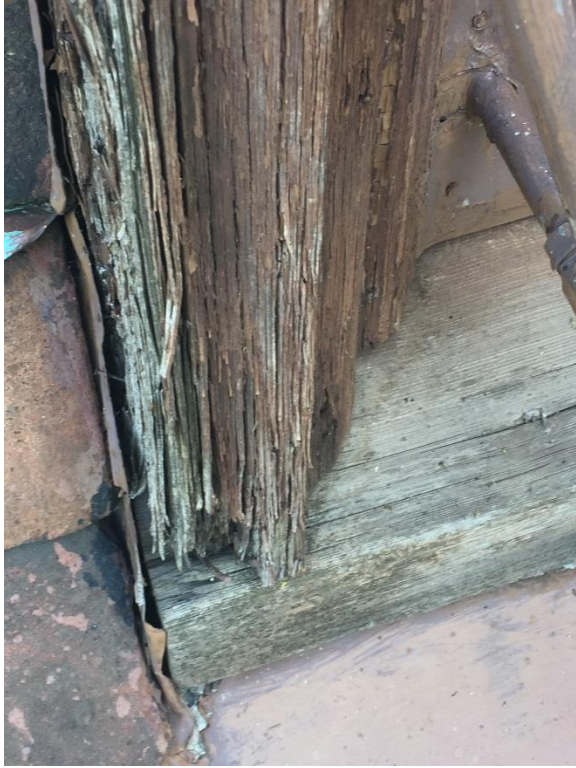
25. A limited number of treads on the fire escape were buckled and displaced.
26. The wood trim of the door to the fire escape exhibited significant checking and rot (Figure 39).

Figure 39. Checks at wood door trim at fire escape (2016)

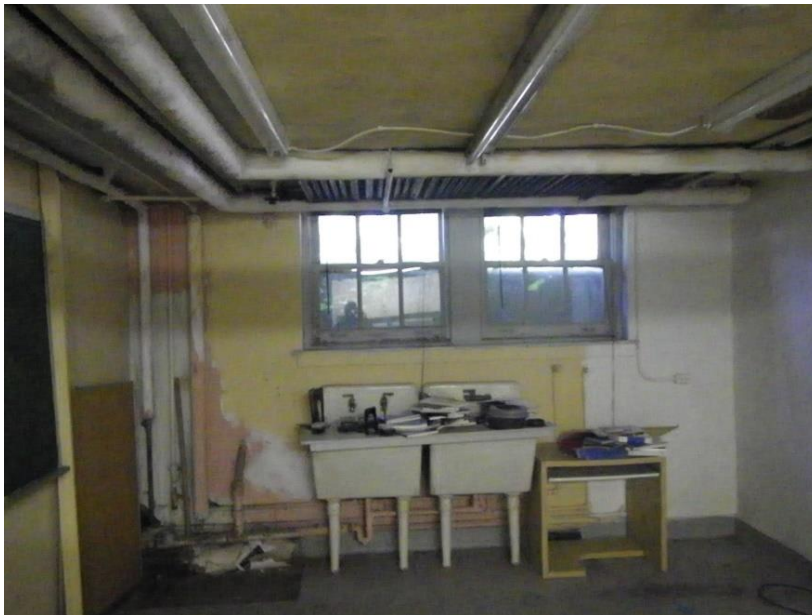
1. Limited areas of water-damaged plaster were noted at various locations but primarily identified in the basement (Figure 40).

Figure 40. Basement (2016)

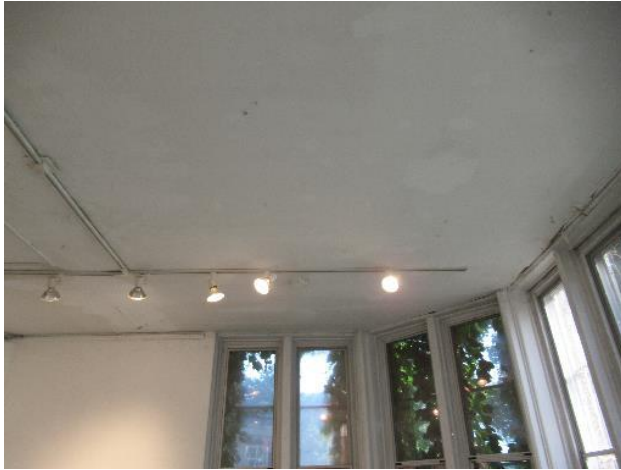
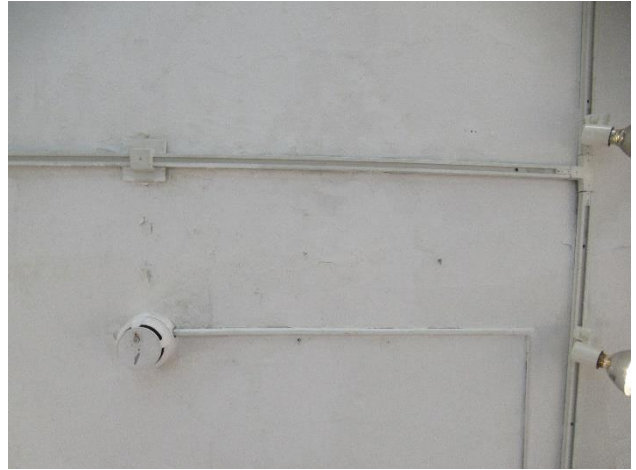
2. Limited areas of cracked plaster exist at various locations throughout the basement, first, second and third floor.
3. Water damage to the plaster ceiling of the sun room ceiling (Figure 41).

Figure 41. Sun room ceiling

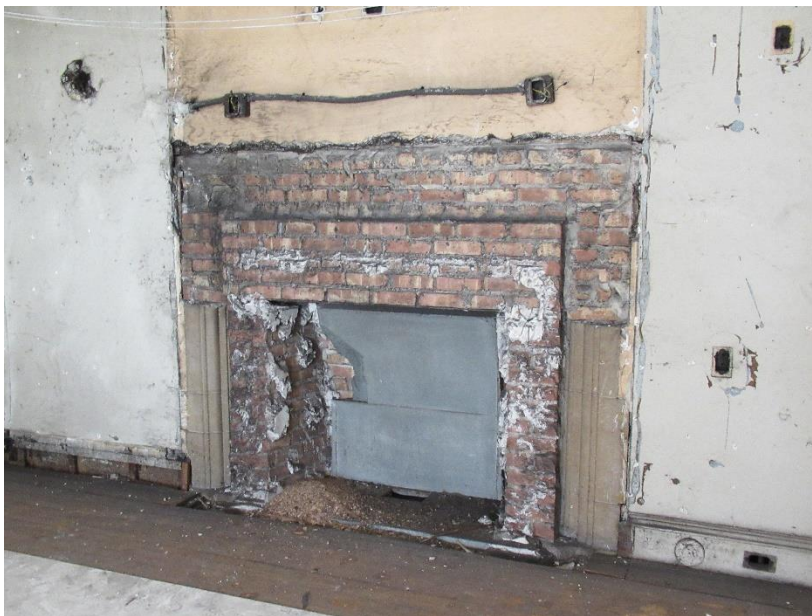
4. Historic fireplace mantel and wood trim was removed (Figure 42).
5. Non-original storm windows have been installed at many of the windows throughout the house (Figure 43 and Figure 44).

Figure 42. Fireplace with trim and tile missing

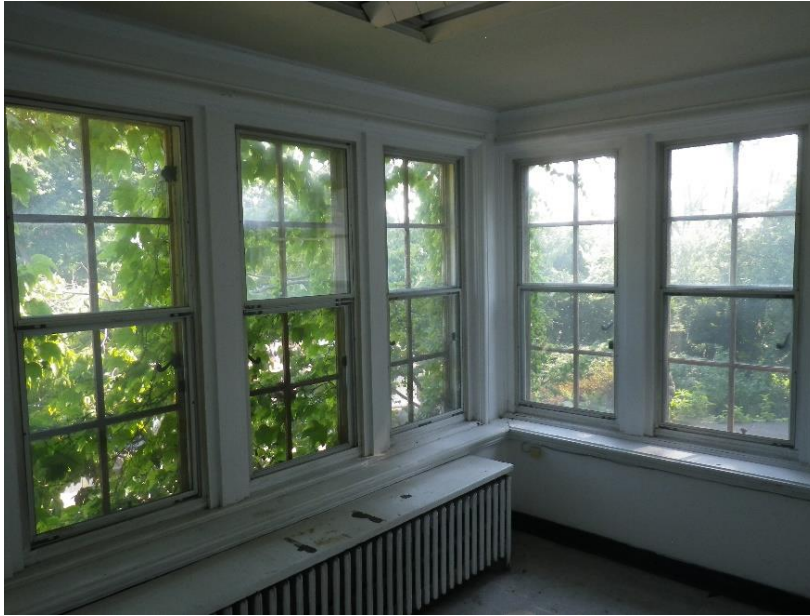
Figure 43. Steel windows with storm windows installed on interior (2016)

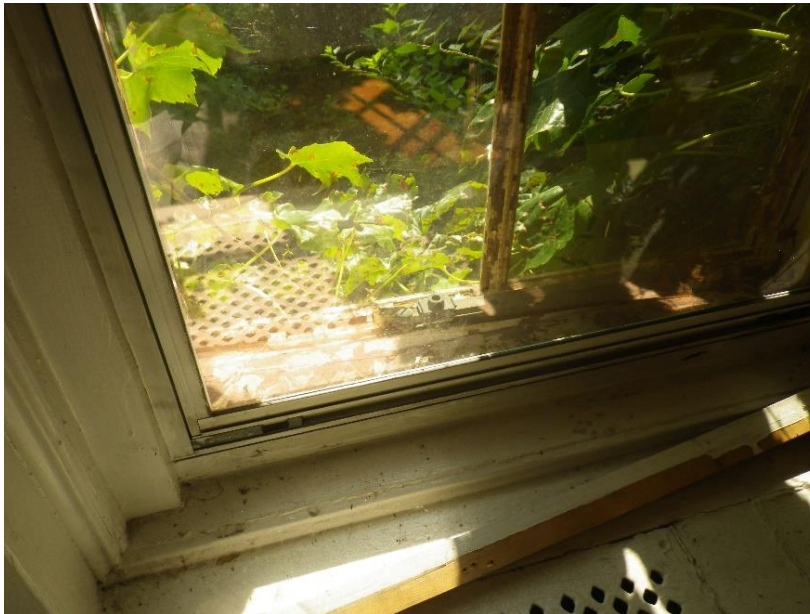
Figure 44. Non-historic interior storm window (2016)

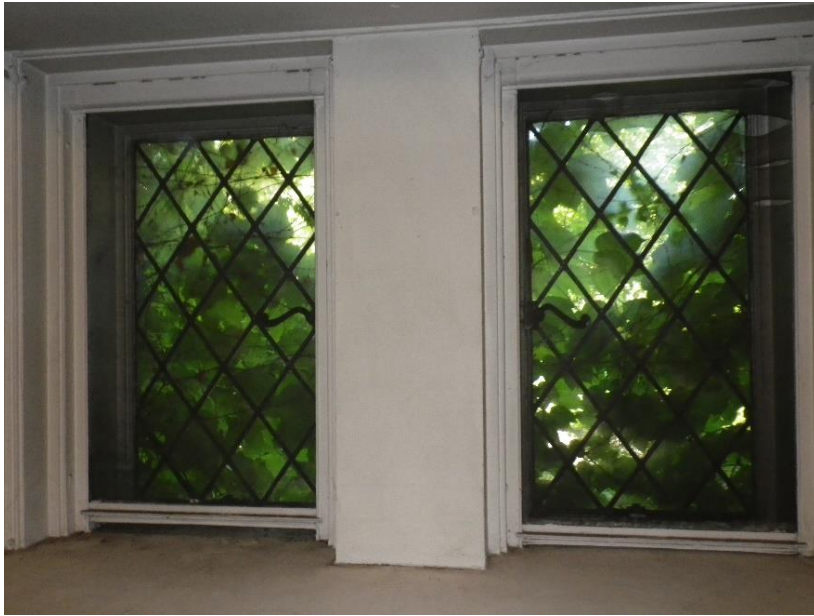
6. Non-historic interior aluminum-framed windows were installed at leaded windows (Figure 45).
7. Standing water found in basement mechanical room (Figure 46).

Figure 45. Leaded windows (2016)

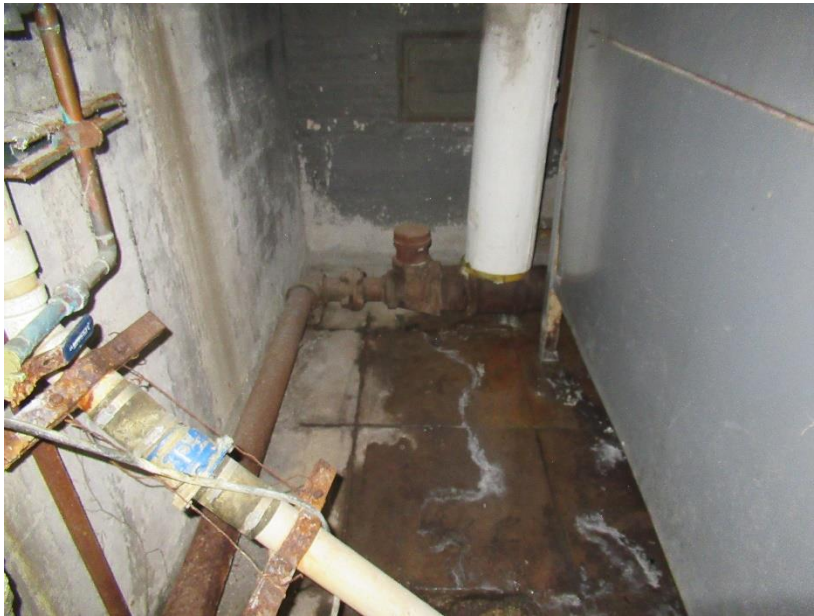
8. There was water dripping in the basement mechanical room. The source of the dripping water was not identified.
9. Indication of previous water leakage, at localized areas, was evident in the visible portions of the roof framing in the attic (Figure 47).

There are limited indications of previous water infiltration on the interior of the mansion and coach house, most notably in limited areas of the basement, as well as at various windows and at the roof framing. The first and second floors and the attic of the mansion generally appeared dry; however, there was standing water at two locations in the basement of the mansion. The sources of the water in the basement should be identified and corrected.

Figure 46. Basement mechanical room with standing water

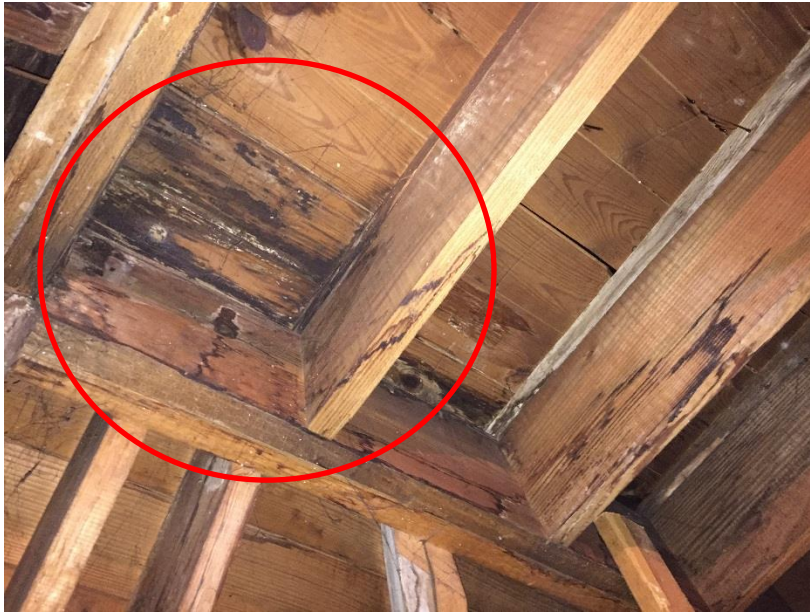
Figure 47. Water staining on wood framing members (2016)

9. Monitor the attic framing and interior plaster for signs of water infiltration and cracking. Perform additional evaluation if these conditions are observed.

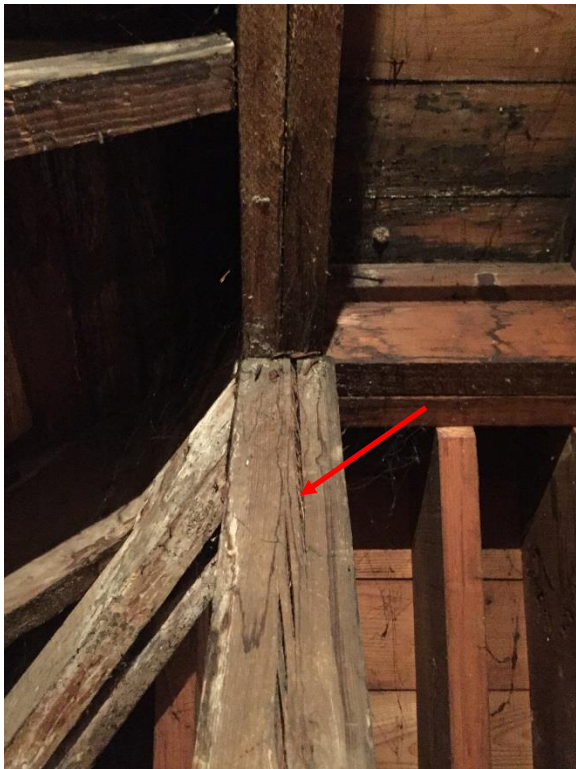
10. Surface checks in various structural wood frame members was present in the framing visible in the attic (Figure 48).
11. The observatory has exposed masonry on the interior, exposed steel roof framing and a concrete slab floor (Figure 49).

Figure 48. Checks in wood framing members (2016)

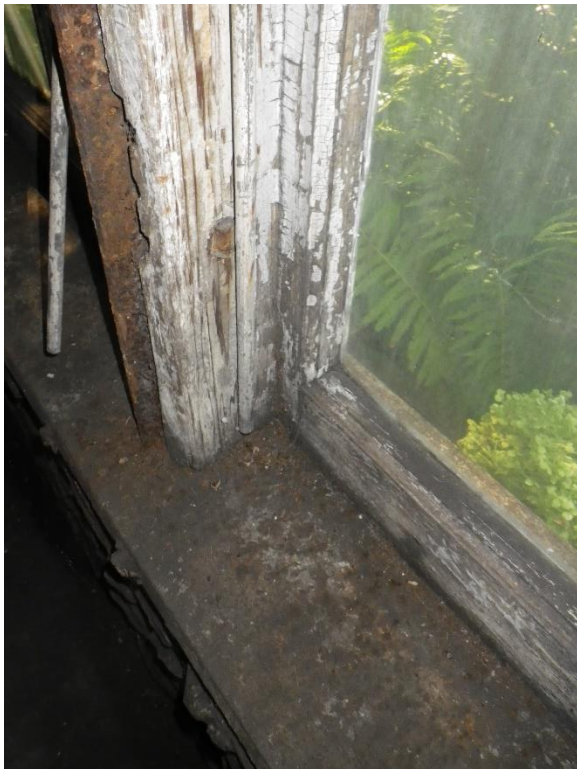
12. Peeling paint and areas of rot on the lower portion of the jambs and sills in the conservatory (Figure 50).
13. Limited areas of exfoliation of stone at the lower portions of the conservatory walls (Figure 51).

Figure 50. Deteriorated window sill and jamb in conservatory (2016)

- Estimated cost: \$100,000 allowance
4. Scrape and paint the existing wood window frames and sash in conservatory. Replace aged glazing putty as glass lites are replaced. Install wood Dutchman, as necessary, at sills and lower portions of jambs.

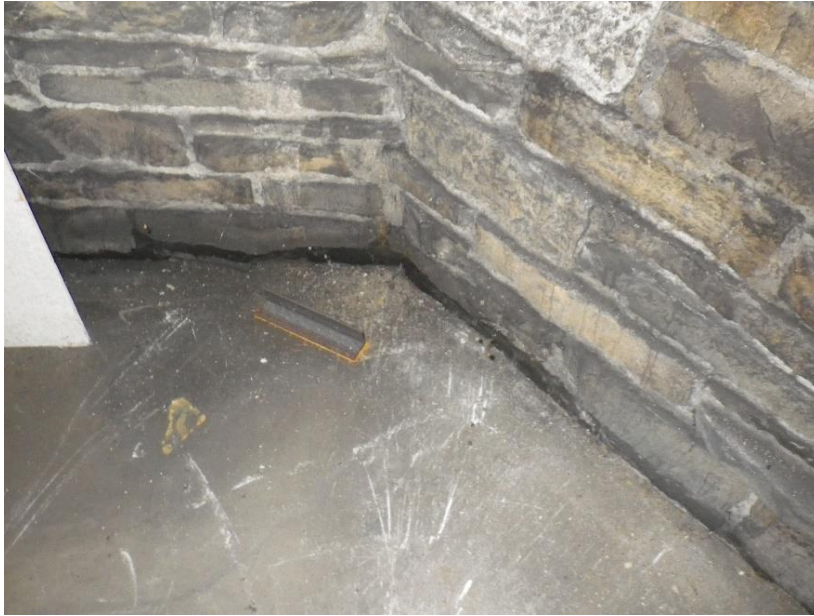
Figure 51. Deterioration of stone on interior of conservatory (2016)

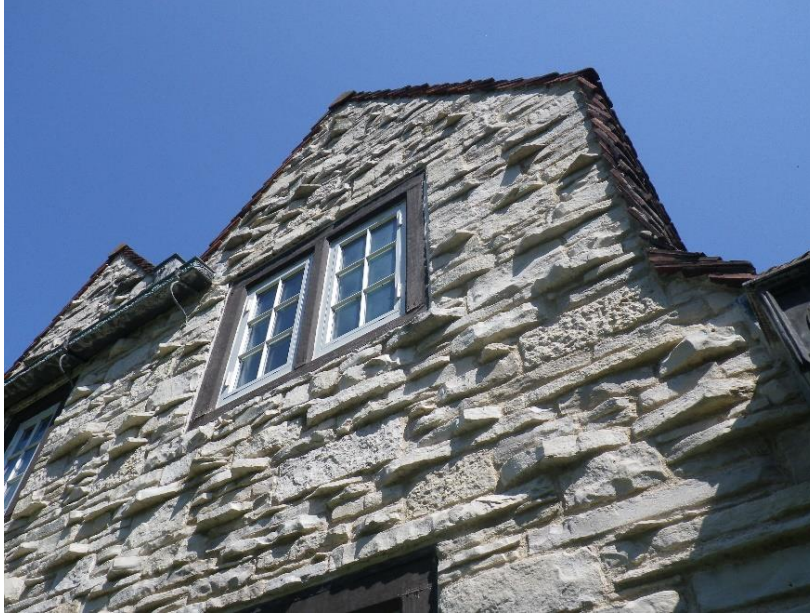
1. Vines are present on limited areas of the exterior masonry.
2. Isolated areas of cracked, debonded or missing mortar in joints between the limestone cladding.
3. Exfoliation of the limestone was evident at several locations, particularly at water shedding elements of the facade.
4. Efflorescence was present on the masonry.
5. Moss was present on the balcony roof, along with splits in the roof membrane.
6. Peeling paint on the exterior surface of the wood window surrounds, primarily on the lower portions of the jambs and sills (Figure 52).
7. Decorative copper gutters, conductors and downspouts are generally intact with some areas of impact damage on the leading edge of the gutter (Figure 53 and Figure 54).
8. Windows appear to be replacement aluminum or aluminum clad casement units set in the original wood window surround (Figure 55).
9. A few displaced roof tiles were noted.

Figure 55. Second floor window on south facade of coach house. Windows appear to be replacement aluminum or aluminum clad casement units set in the original wood window surround (2016)

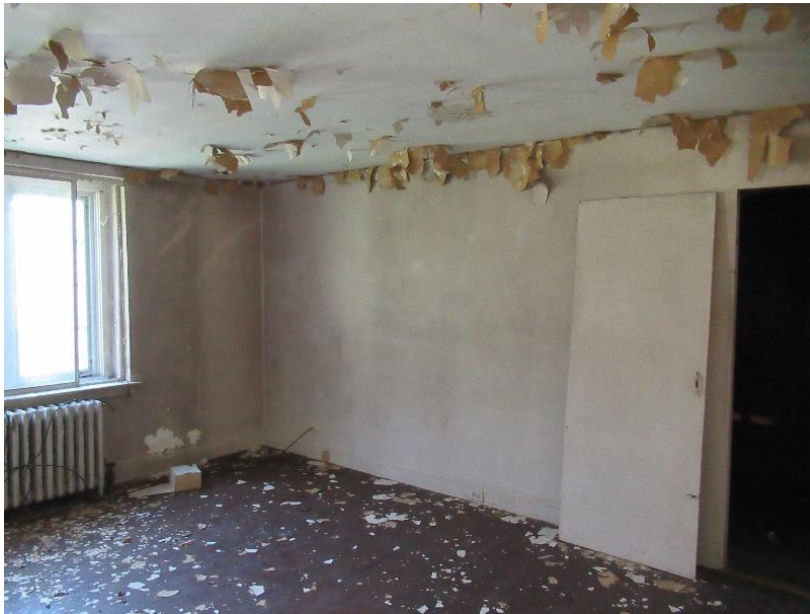
1. Overall peeling paint on the ceiling and interior walls of the coach house (Figure 56 and Figure 57).
2. Areas of water damage were noted at two window locations at north and south walls of the coach house (Figure 58 and Figure 59).
3. Open seams on second floor balcony floor (Figure 60 and Figure 61).

There was some damage to the plaster finishes observed in the coach house, which are likely a result of ongoing water infiltration. The peeling paint on the interior finishes may also be due to stresses in the coating system, which has occurred as a result of thermal changes from inconsistent heating and cooling.

Figure 56. Peeling paint throughout interior of coach house
