HARLEY CLARKE MANSION Condition Assessment

2603 Sheridan Road
Evanston, Illinois 60201

Final Report

September 11, 2019
WJE No. 2019.1266.4

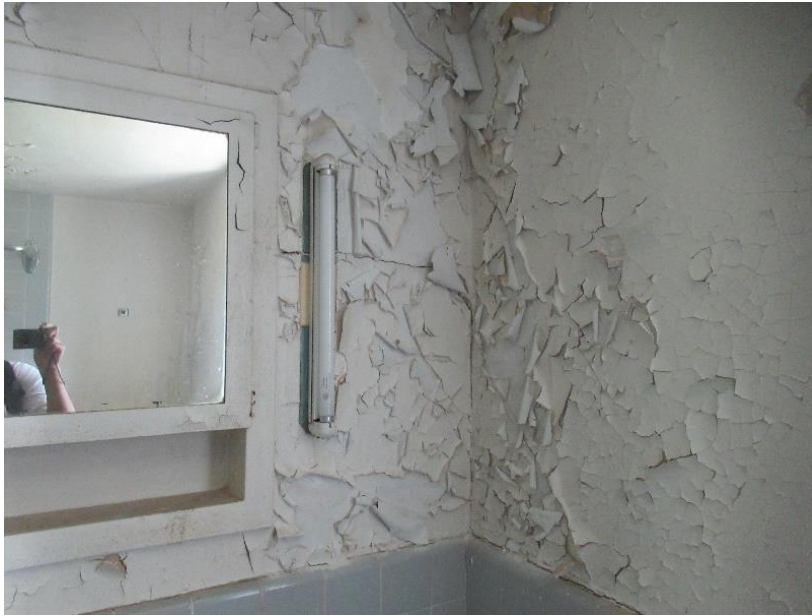
1. Overall peeling paint on the ceiling and interior walls of the coach house (Figure 56 and Figure 57).
2. Areas of water damage were noted at two window locations at north and south walls of the coach house (Figure 58 and Figure 59).
3. Open seams on second floor balcony floor (Figure 60 and Figure 61).

There was some damage to the plaster finishes observed in the coach house, which are likely a result of ongoing water infiltration. The peeling paint on the interior finishes may also be due to stresses in the coating system, which has occurred as a result of thermal changes from inconsistent heating and cooling.

Figure 57. Peeling paint throughout interior of coach house

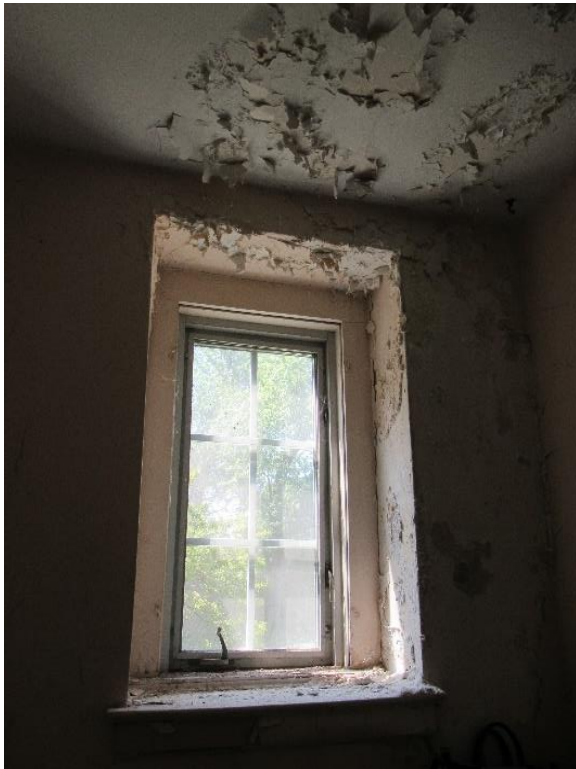
Figure 58. Water damage plaster adjacent to windows

- Estimated cost: \$2,500 allowance
8. Repair cracked plaster and water-damaged plaster on the interior of coach house.
 - Estimated cost: \$10,000 allowance

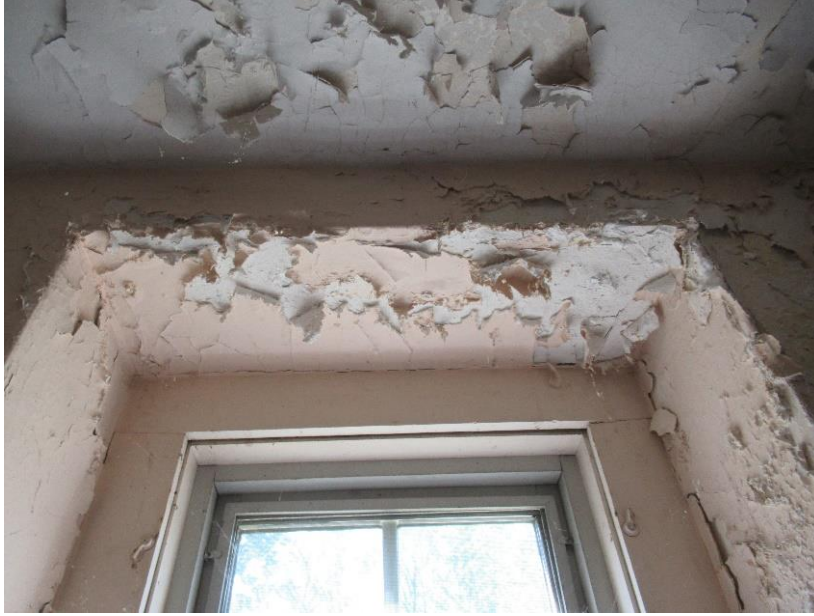
Figure 59. Water damage plaster adjacent to windows

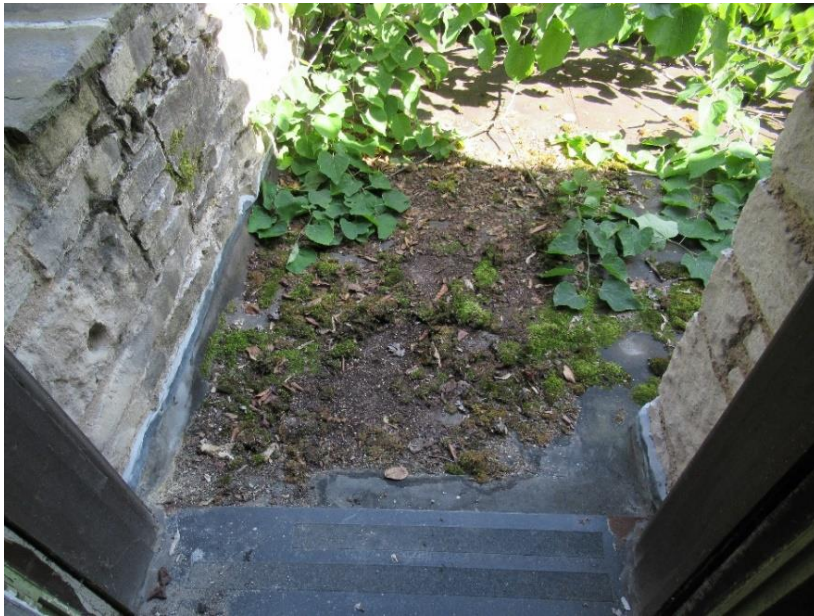
Figure 60. Coach house balcony

1. Remove and replace or salvage and rebuild balusters and railing above sun room.
 - Estimated cost: \$20,000
2. Replace balcony roof at coach house

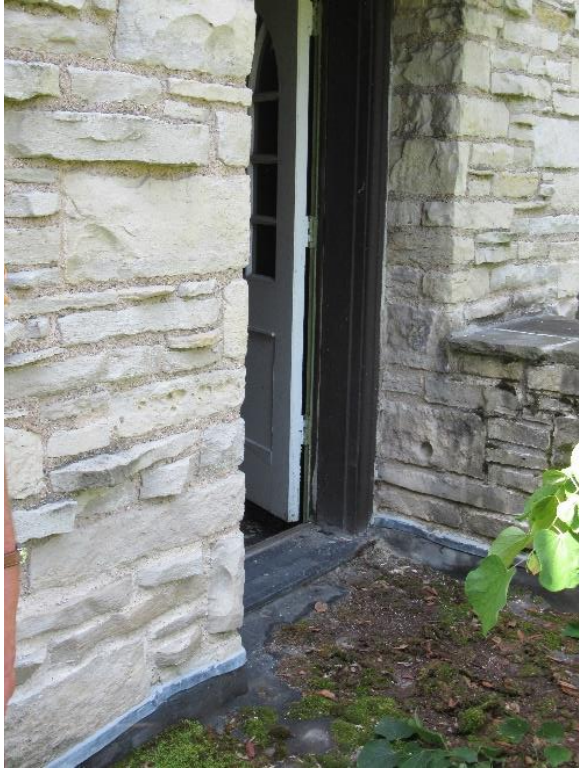
Figure 61. Coach house balcony
