ASBESTOS CONTAINING MATERIALS SURVEY

ARTISTS BOOK HOUSE

2603 SHERIDAN ROAD
EVANSTON, ILLINOIS 60201

ECS PROJECT NO. 53:3232

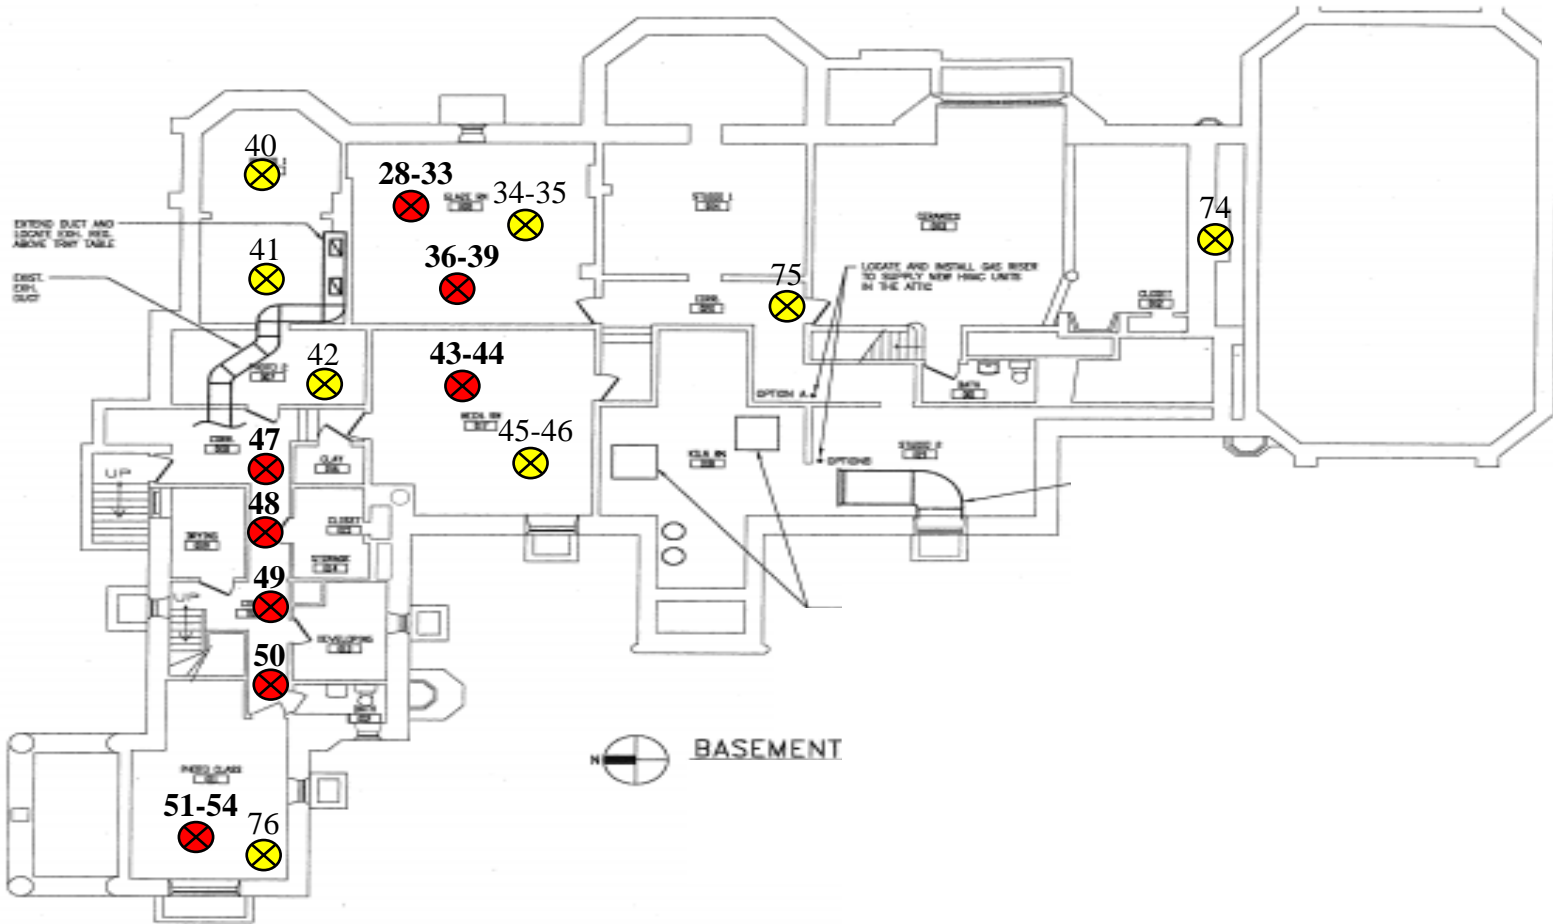
Basement Sample Location Diagram
ECS Project 53:3232
October 2021

| Sample ID | Material Description | Location* | Analytical Results | Estimated Quantity** |
|---|--|---|---|---|
| 28-29 | TSI Fitting Insulation on 6" Pipes | Basement | 65% Chrysotile | Unknown |
| 30-31 | TSI Elbow Insulation on 6" Pipes | Basement | 65% Chrysotile | Unknown |
| 32-33 | TSI Pipe Insulation on 6" Pipes | Basement | 65% Chrysotile | Unknown |
| 36-37 | TSI Fitting Insulation on 4" Pipes | Basement | 65% Chrysotile | Unknown |
| 38-39 | TSI Elbow Insulation on 4" Pipes | Basement | 65% Chrysotile | Unknown |
| 43-44 | TSI Pipe Insulation on 6" Pipes | Basement | 65% Chrysotile | Unknown |
| 47-48 | TSI Fitting Insulation on 6" Pipes | Basement | 65% Chrysotile | Unknown |
| 49-50 | TSI Elbow Insulation on 6" Pipes | Basement | 65% Chrysotile | Unknown |
| 51-52 | TSI Elbow Insulation on 6" Pipes | Basement | 65% Chrysotile | Unknown |
| 53-54 | TSI Pipe Insulation on 6" Pipes | Basement | 65% Chrysotile | Unknown |

If proposed construction activities will disturb the identified ACMs, then the materials will need to be removed by an Illinois licensed asbestos contractor using methods in accordance with current applicable state and federal regulations. The work will also need to be monitored and confirmed complete by an asbestos professional.

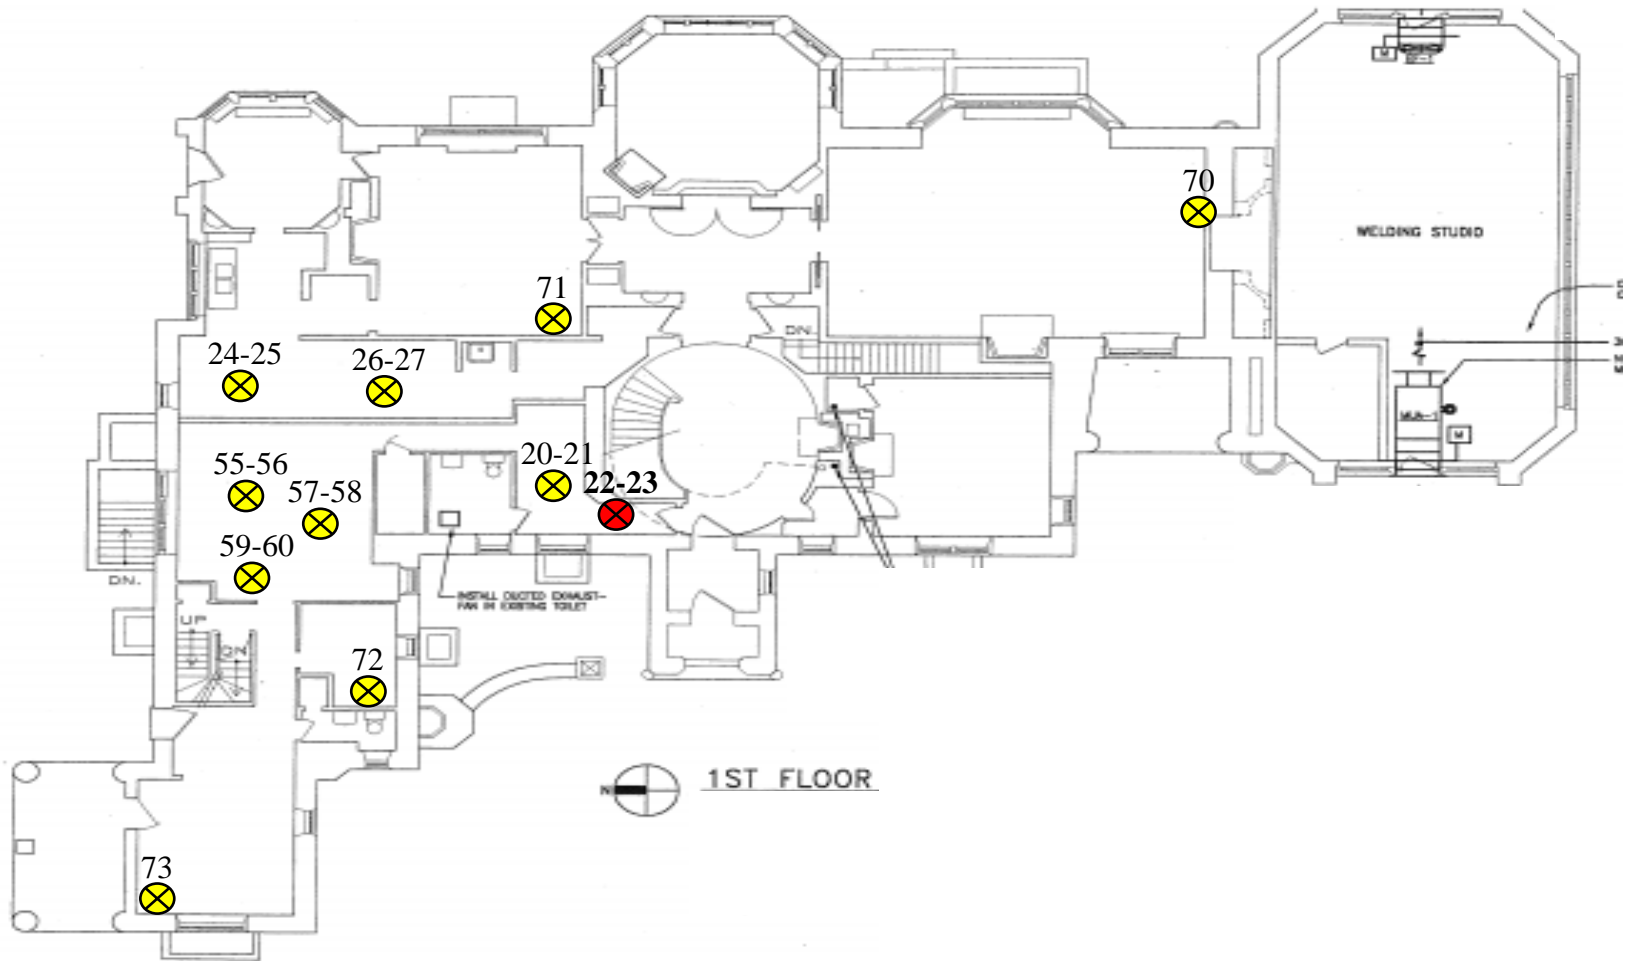
1st Floor Sample Location Diagram
ECS Project 53:3232
October 2021

| Sample ID | Material Description | Location* | Analytical Results | Estimated Quantity** |
|---|--|---|---|---|
| 22-23 | 9"x9" Green Floor Tile, Black Mastic, and Subfloor | 1st Floor | Floor Tile- 10% Chrysotile Mastic- 5% Chrysotile Subfloor- ND | ~ 250 SF |

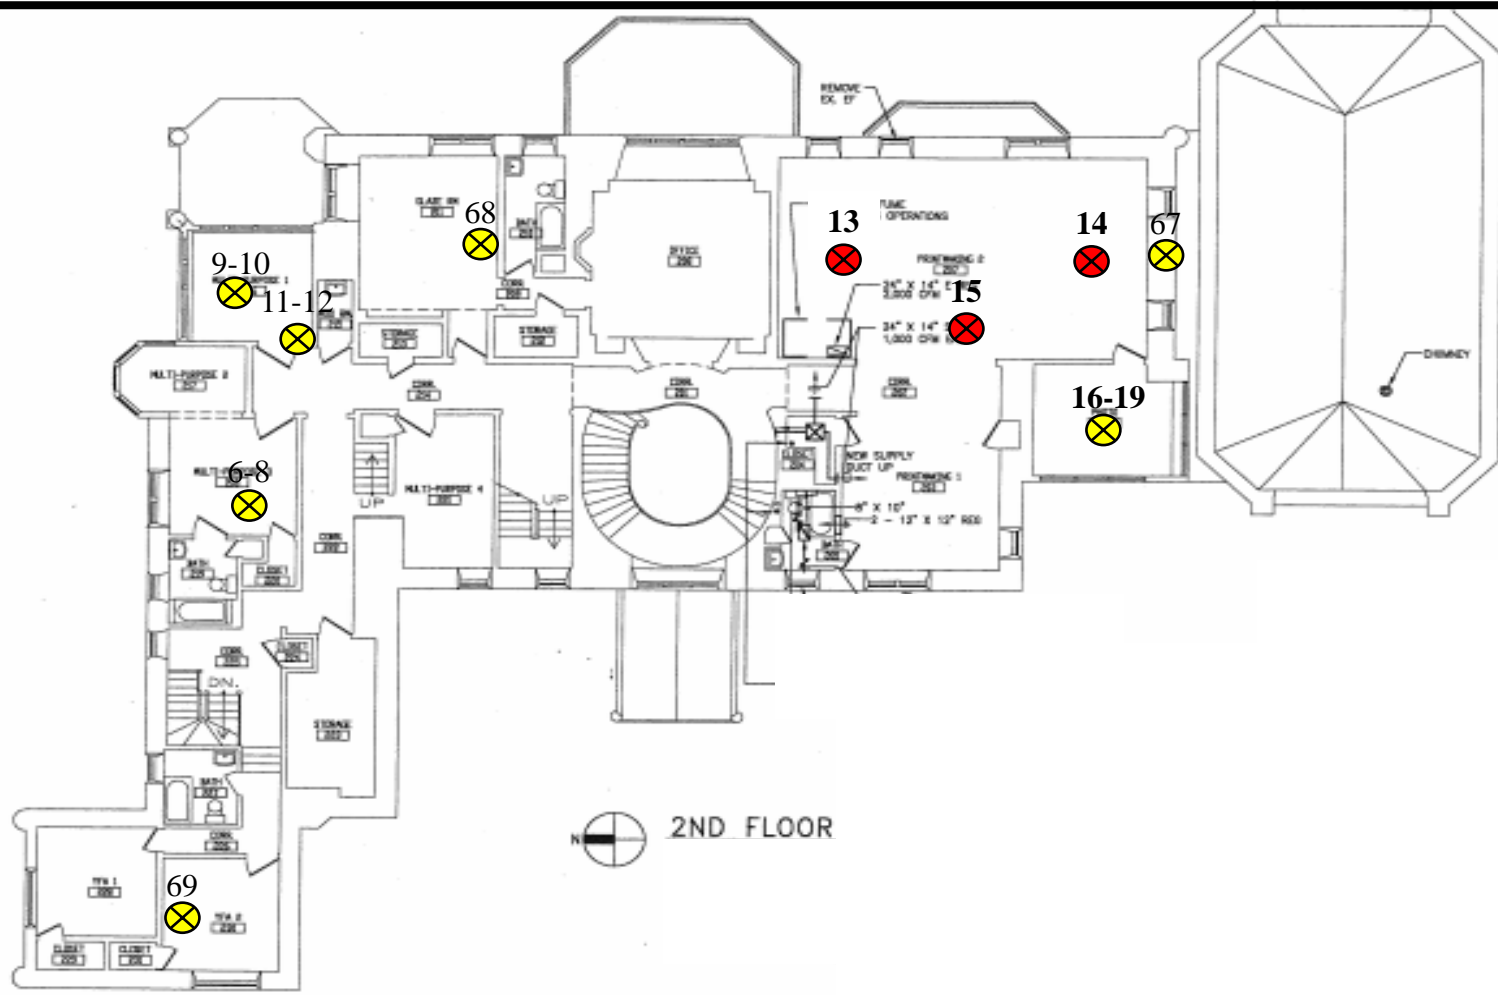
2nd Floor Sample Location Diagram
ECS Project 53:3232
October 2021

| Sample ID | Material Description | Location* | Analytical Results | Estimated Quantity** |
|---|---|---|---|---|
| 13-15 | 12"x12" White Floor Tile and Black Mastic | 2nd Floor | Floor Tile- ND Mastic- 3% Chrysotile | ~ 950 SF |

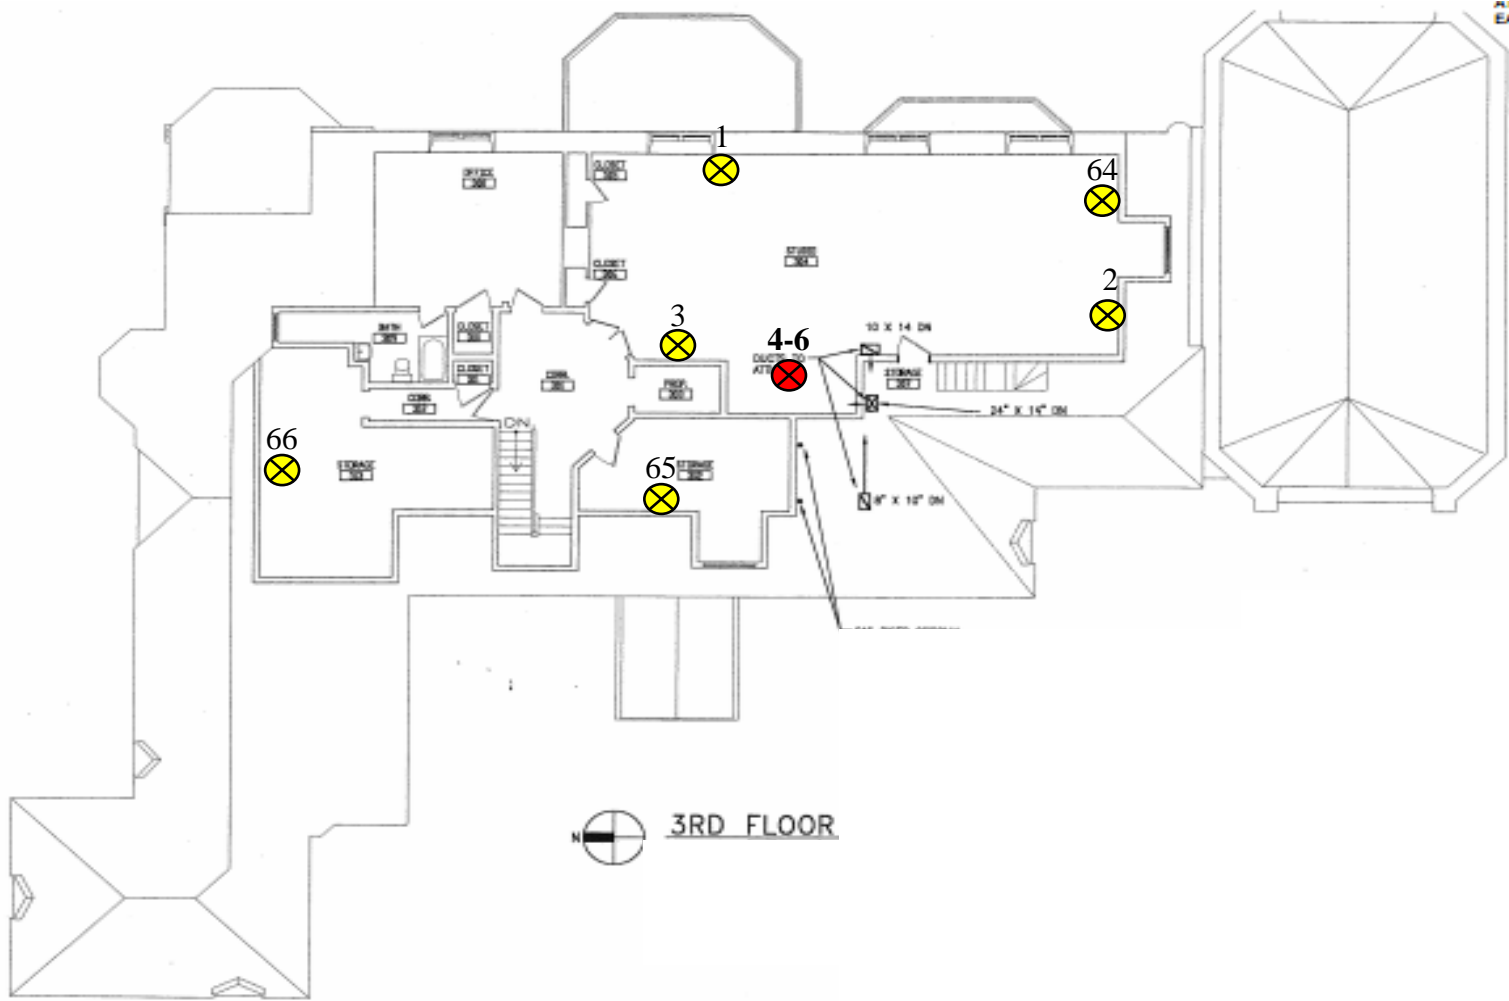
3rd Floor Sample Location Diagram
ECS Project 53:3232
October 2021

| Sample ID | Material Description | Location* | Analytical Results | Estimated Quantity** |
|---|---|---|---|---|
| 4-5 | 9"x9" Brown Floor Tile and Black Mastic | 3rd Floor - Ballroom | Floor Tile- 10% Chrysotile Mastic- 5% Chrysotile | ~ 200 SF |
