PAUL JANICKI
ARCHITECTS

Harley Clark Mansion
2603 Sheridan Road
Evanston, Illinois

Architectural Facility Assessment

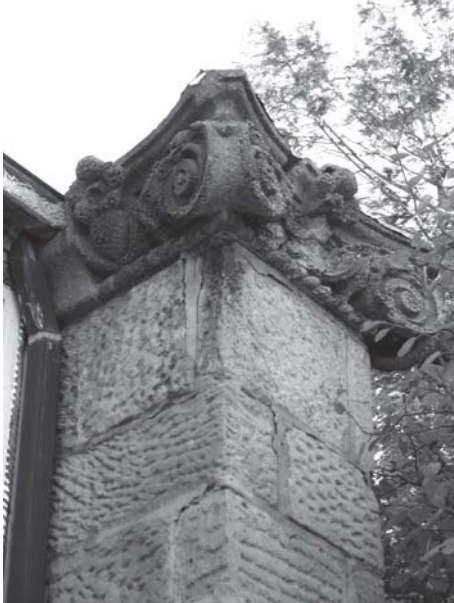
figure 1

There are some areas of grout decay on all elevations. There are decorative elements such as piers with limestone Corinthian capitals that are in immediate need of historically-correct tuckpointing. (figures 1 & 2)

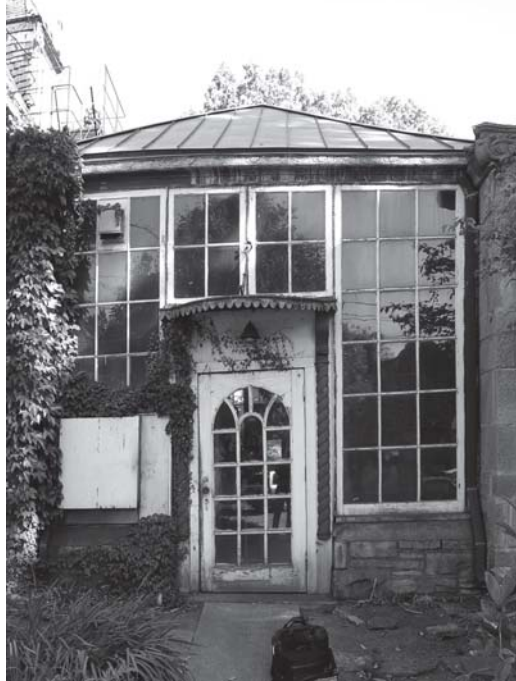
figure 3

The conservatory, presently being used as an iron shop, sits on the south end of the mansion. The roof has been replaced with new metal and appears sound. The west and east elevations were originally identical. The west elevation has the original wood and glass door that probably need to be remade to match the design as the door is in very poor condition. Also the decorative plinth blocks underneath the “baldacchino”

pilasters seem to be missing. The steel windows to the north of this door have been removed and boarded up. New windows to match will have to be installed there. (figures 3,4)

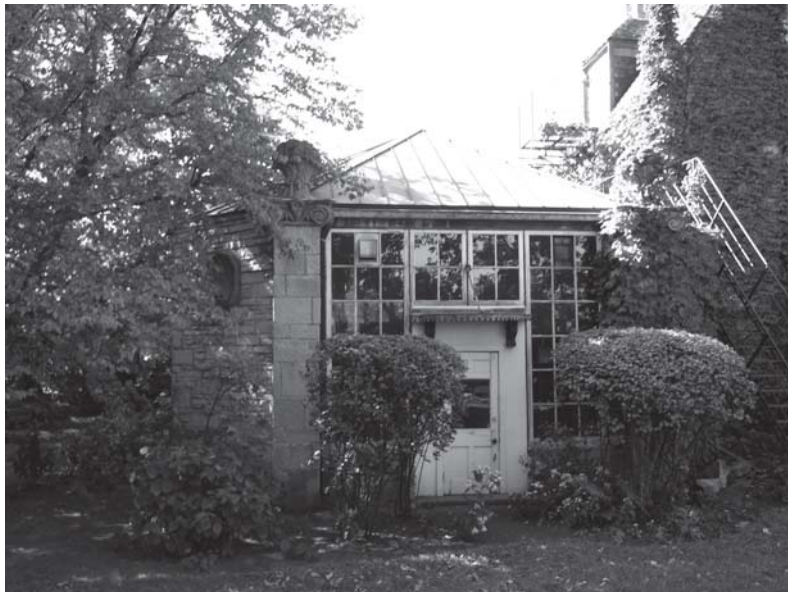
figure 4

On the east elevation the original door and decorative trim is missing altogether. These elements will have to be replicated and installed. There are also glass panels missing from some of the windows. The limestone and lannon stone are in good condition. (figure 4)

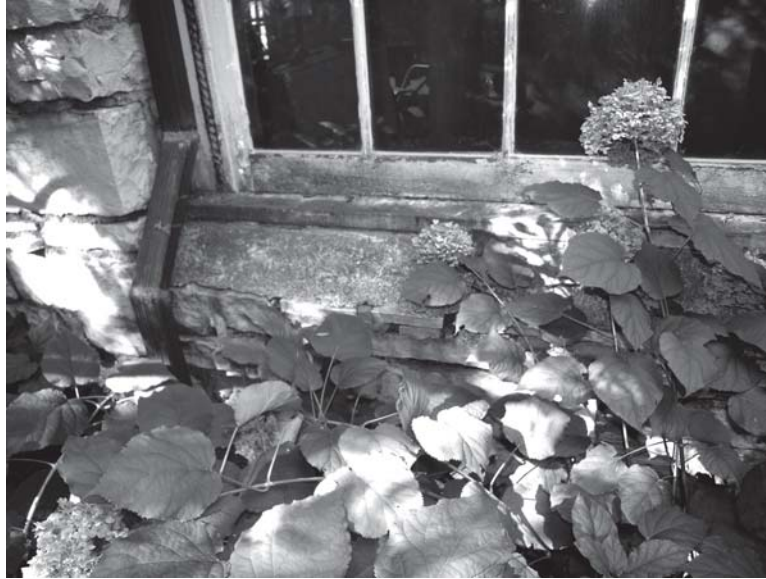
figure 5

On the conservatory there are windows on the south elevation where the sills are in poor condition and need replacement. (figure 5). Also the windows are in dire need of restoration and some of the original glass has been replaced with other materials.

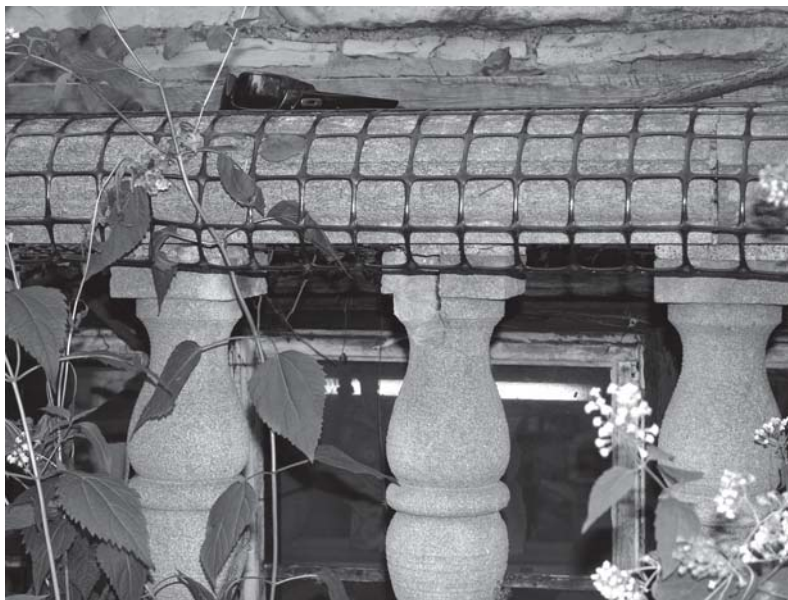
figure 6

There are decorative balusters (figure 6) on the east elevation that have spalled and need replacement. There is also a balcony on the east elevation with the same stone balusters. Some of the balusters are missing and will need to be replaced with new limestone replicas. There are other balusters (figure 7) that have been brushed with some sort of bitumen-based roofing tar. It is doubtful that those balusters can be reclaimed, so those would have to be fabricated for replacement as well.

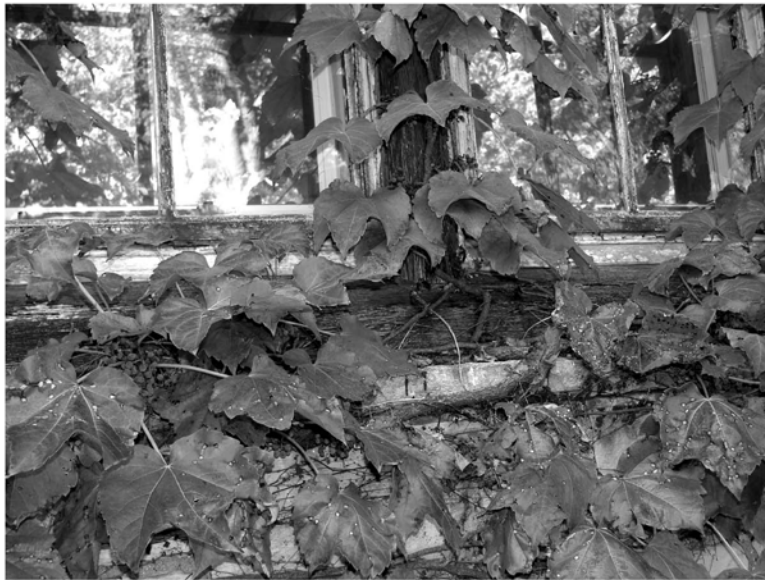
figure 8

Most, if not all of the wood brickmold exterior casings are in severely poor condition (figure 8). Most that are visible are partially to totally rotted. There are those that can be salvaged and restored and others that will have to be replaced. It appears that the original brickmold might have been stained but through the course of many seasons and with deferred maintenance, the wood is practically bare. New stain products are superior to paint and should be considered being used to replenish this wood.

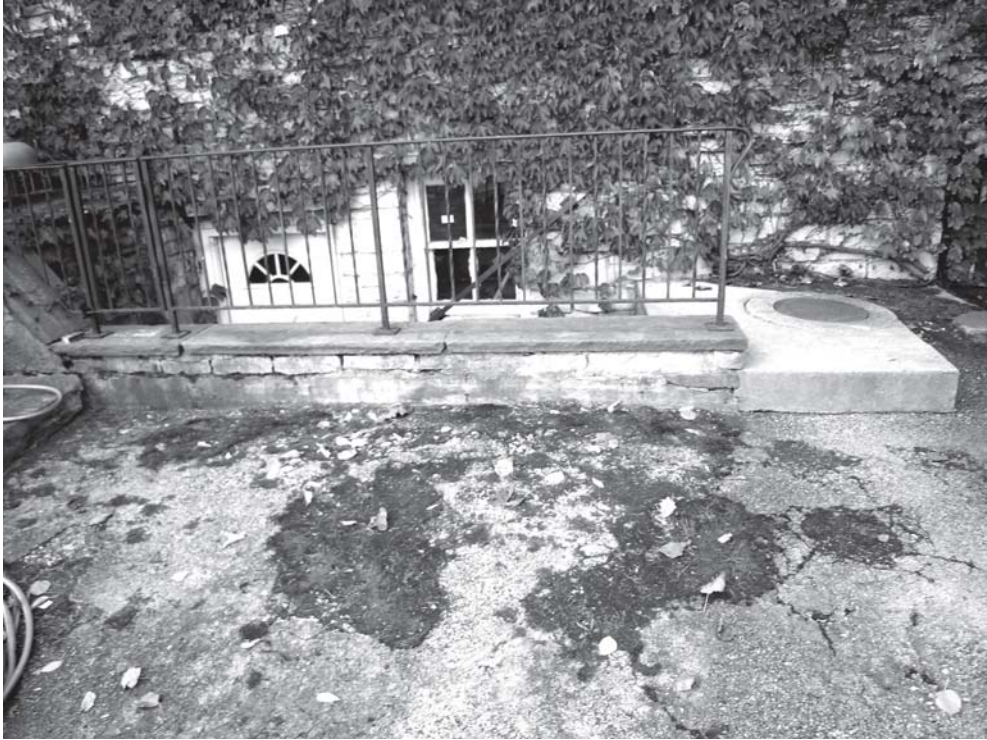
figure 9

The staircase leading to the basement on the north elevation is in need of repair. (figure 9). The stone base for the railing is in particularly bad shape and needs to be re-set and most likely some stone will have to be replaced. The iron railing is not original to the building and is also in poor condition and should be

replaced with an era-appropriate railing. The door that enters the basement is not original and an appropriate door replacement would be advised.

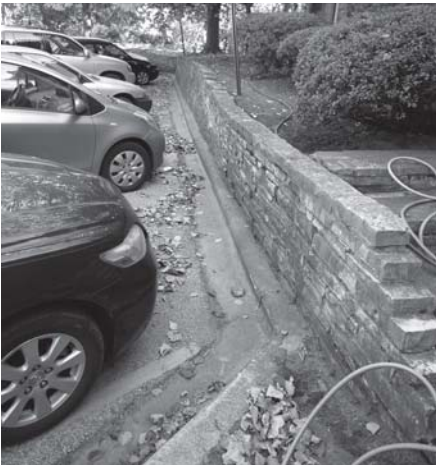
figure 10

The small retaining wall that runs around the north side of the building and circles the west side is in generally failing condition.(figures 10,11). The stone itself is in good condition but needs tuckpointing. The foundation is obviously failing and pitching forward. The remedy for this would be to remove the stone, clean all of the existing grout off the stone, pour a new foundation and reset the original stone onto this new structure.

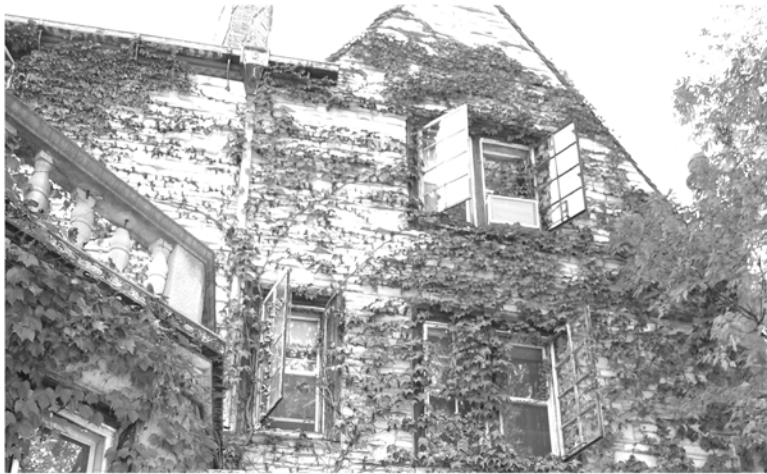
Figure 12

The original steel casement windows are still in place. The general note that can be applied to all of these windows is that they have not been maintained properly. The finish on all the steel parts of the windows has deteriorated. The closing mechanisms and locks are in very poor condition and will not open or close properly. Many, if not all of the original insect screens are missing. Some windows have been removed

and replaced with double-hung windows in order to install window air-conditioning units. In some cases, the windows are still in place but are propped open permanently and another window has been installed with an air-conditioning unit. (figure 12).

These windows can be restored although the restoration would be extensive and new hardware would most likely have to be custom-forged. The hardware could be restored as well, but is a difficult process. New steel windows that are double-insulated could be used as replacement windows if allowed by the local preservation board.

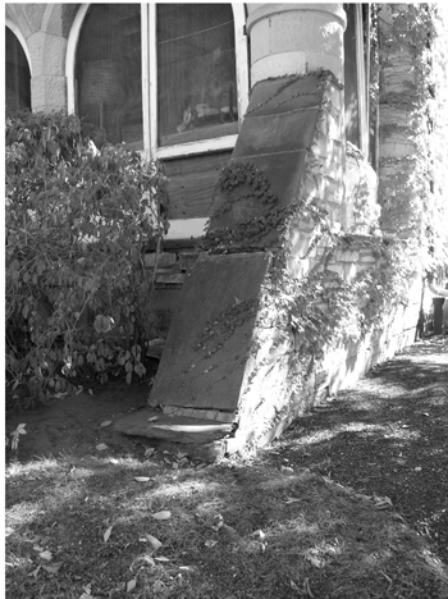
figure 13

There is a screened porch on the northwest corner of the first floor. The stone is in good shape although the stone clad buttress needs to be repaired and tuckpointed. There are what appears to be original wood insect screens on this porch that would need to be restored if elected to remain. (figure 13)

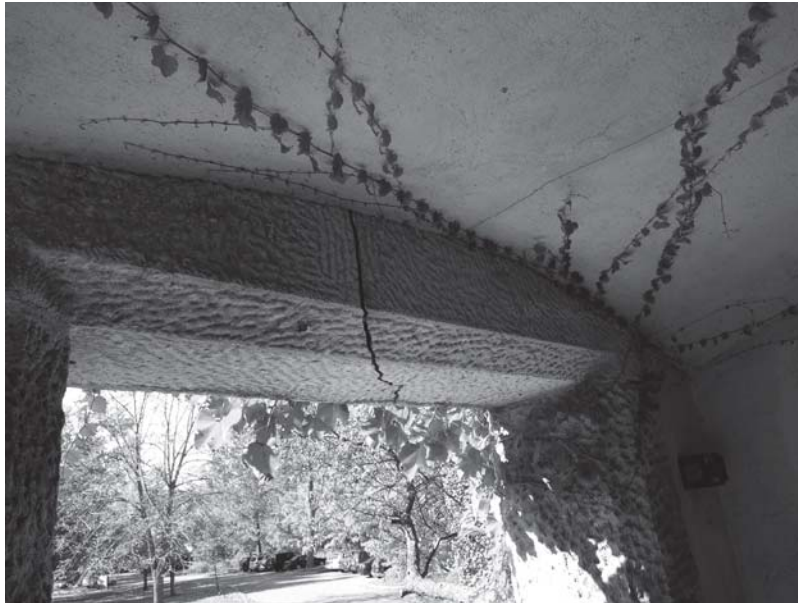
figure 14

The large limestone slab steps leading to the entrance to the building are in good condition. There is an iron railing that although in fair condition, is inconsistent stylistically with the house. There is an accessible ramp running from the south to the entry which is also in good condition. Whether it meets code needs to be determined. Also the termination of the ramp at the entry seems to be difficult for a wheelchair to navigate. The header stone over the entry has a large fissure running through it that is probably not safe. This stone should be replaced with a matching species and with the same hand dimpled chiseled finish. (figure 14)

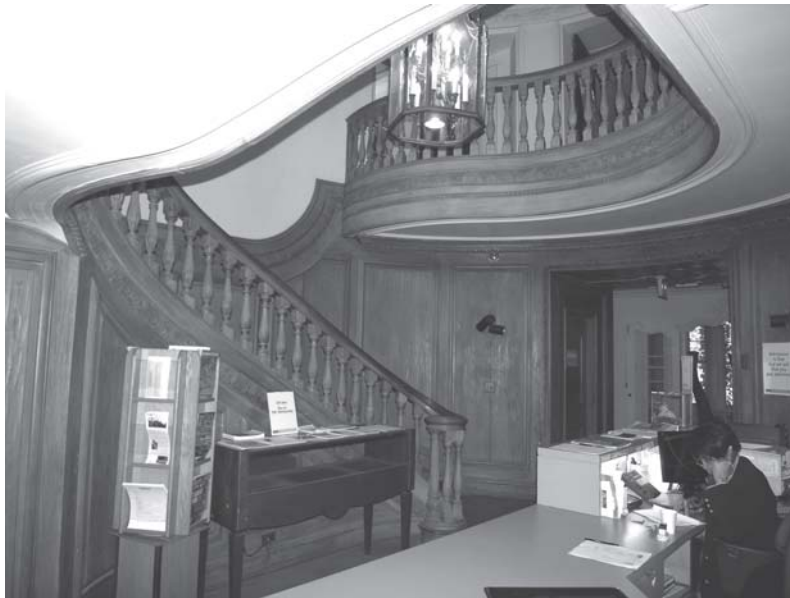
figure 15

The front entry hall is a wonderful example of a great house tudor staircase and paneling arrangement. The wood is hand-carved pickled oak with a clear varnish finish. It is in good shape although some patching will have to be done to cover holes where 1950 era light fixtures have been drilled through it. (figure 15). The entry vestibule, stairs, treads, railing and balusters are all in good condition and can definitely be salvaged. There is also an anteroom beyond the entry hall with the same wood and wood ceiling panel. Again, all of this is in good condition. The front vestibule has hand-troweled plaster decorations and moulding that has somehow survived and is salvageable.

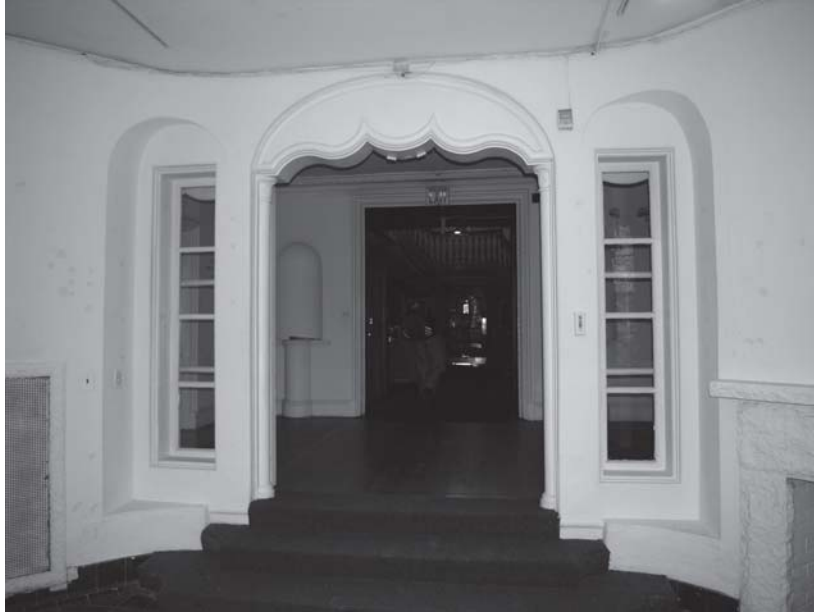
figure 16

The East Gallery is an octagonal room with original hand-made tile with an ivy leaf pattern. (figure 16). Although the tile is not in perfect condition, it could be preserved since it would be nearly impossible to find a tile of its artistic quality today. One option would be to make new tile with the same design and colors. (figure 17).

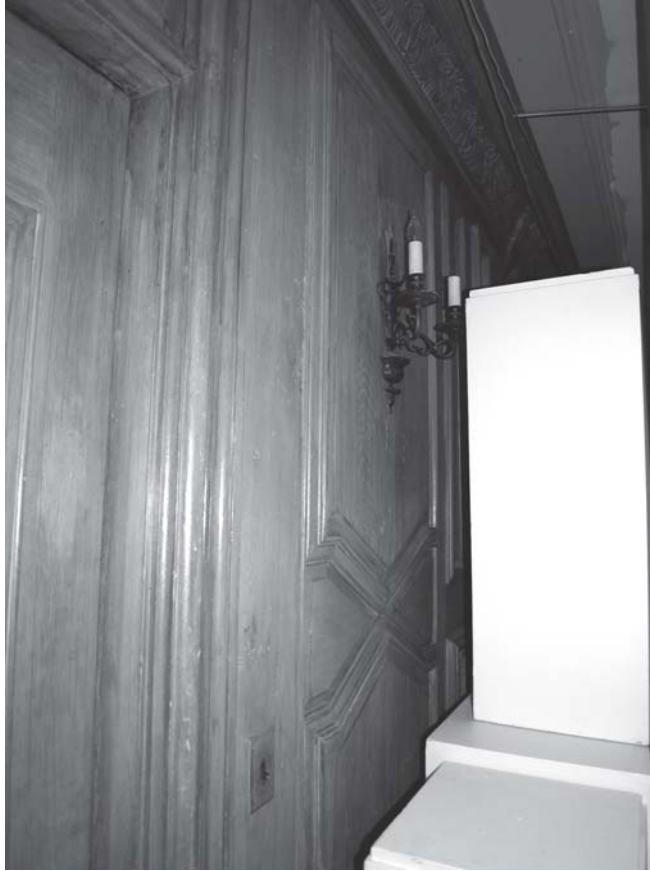
figure 18

The North Gallery, or the original Dining Room, has exquisite oak-paneled walls with the original light sconces which are presently obscured by white plaster walls installed for gallery use. These walls appear to be attached at the floor so the hope is that these walls can be removed and the paneling exposed. The original quartersawn white oak floors are in place and most of it should be salvageable. The photograph on the following page shows some of this paneling. (figure 18).

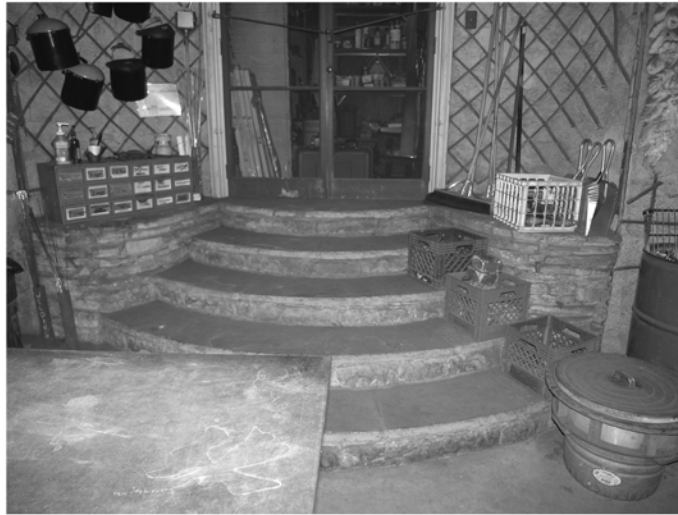
figure 19

There was originally a connection between the Living Room and the Conservatory that has been closed. This opening would then become the only interior access to the Conservatory if this was desired. The opening would require a great deal of careful historic restoration. On the Conservatory side of this opening there are still what appears to be the original doors and slate and limestone staircase. (figure 19,20).The stone is extremely dirty having been exposed to airborne contaminants from the use an iron shop. There is a beautiful plaster surround on the Conservatory side that appears to be salvageable. Wood trellises were originally installed in the apse-like opening and are beyond repair and must be replaced if desired.

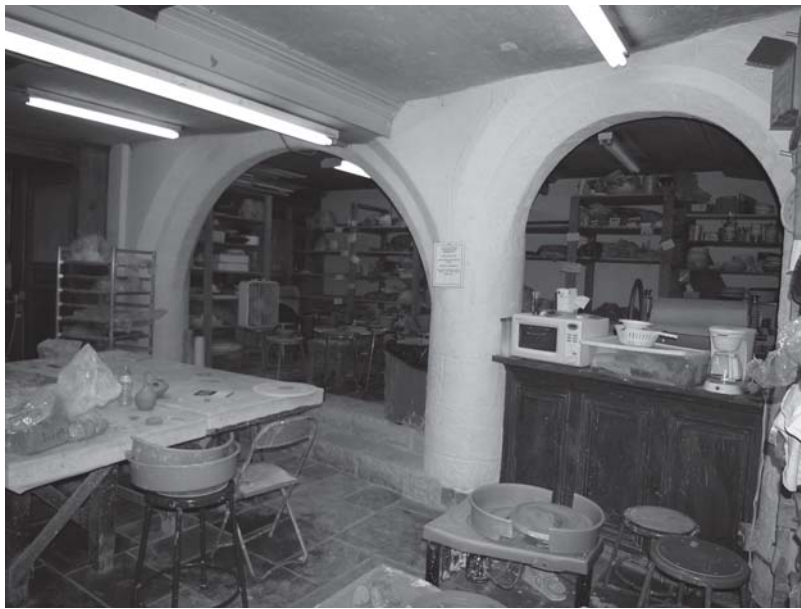
figure 21

Although there is quite a bit of square footage on this level, not much can be realized for habitable rooms. There lone room that could be reclaimed is currently being used as a pottery glazing studio and was once the Billiard Room. (figure 21). There are two stone arch openings that have been painted lime green and will probably be salvageable using an environmentally safe paint removal system. There is also a slate floor which is in very good shape considering the amount of abuse that has been inflicted. It most likely can be saved. There are ceiling beams with trim that may be able to be restored.

There is also some original stained millwork on the east end of the room including a door that used to lead to a lightwell that sits adjacent to the first floor Living Room. The millwork has been ravaged over time due to the spinning of pottery turntables and splattering clay. If careful restoration of this area were undertaken, it is likely that the wood could be saved. There are also original steel casement windows that are closed-up and obviously part of a lightwell that has since been abandoned.

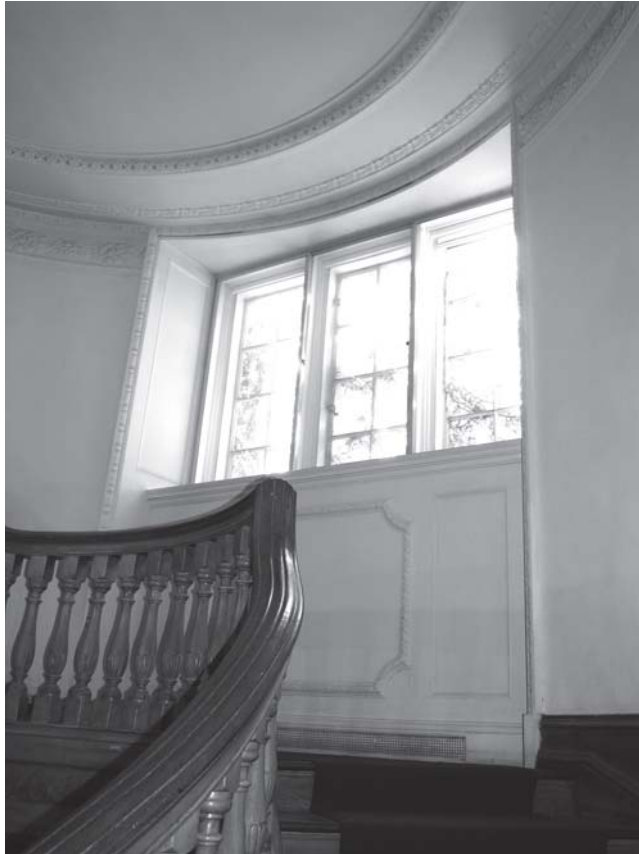
figure 22

One arrives at the second floor level via the oval entry stair that ascends from the first floor entry hall. The wood paneling from the first floor stairwell ends at the second floor and transforms into a highly detailed plaster interior. (figure 22). The railings, balusters and trim are in good condition. The ceiling plaster moulding is in very good shape and only needs some minor repair. The original quartersawn white oak floors are in good shape.

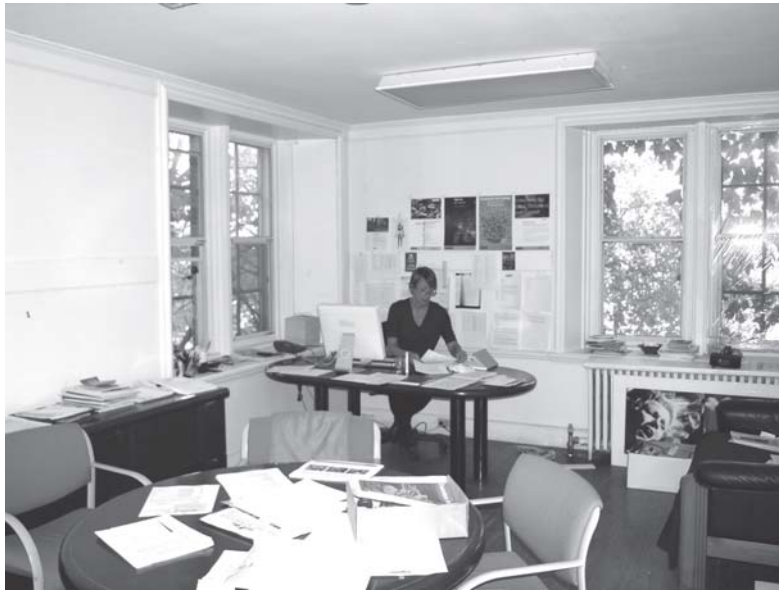
figure 23

Adjacent and to this space on the building's northeast corner is a small office which is mostly intact. Casings appear to be original and worth saving. (figure 23).The original quarter-sawn white oak floor remains and needs refinishing. All plaster surfaces need to be skimcoated and painted.

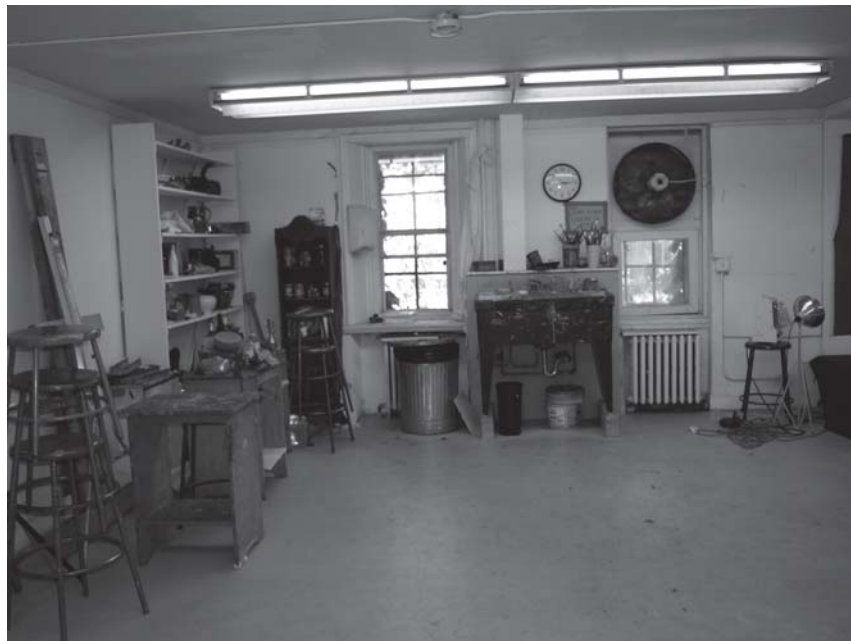
figure 24

The northeast corner of the house has been opened to a large studio from what was probably bedrooms. The floor is covered in vinyl tile and the original floor is most likely underneath. (figure 24). There is no way to know its condition at this point. All the exposed plaster surfaces need to be replaced with a skimcoat of new plaster. Some of the original window casings and sills are intact and need refinishing. Other casings have been removed and would need matching replacements. There is one window that has been removed and replaced with a wood double-hung to accommodate a window air conditioner. Another window has been removed to install a door leading to a newer fire escape. The original casings are now gone and a new steel casement window and new casings would have to be installed

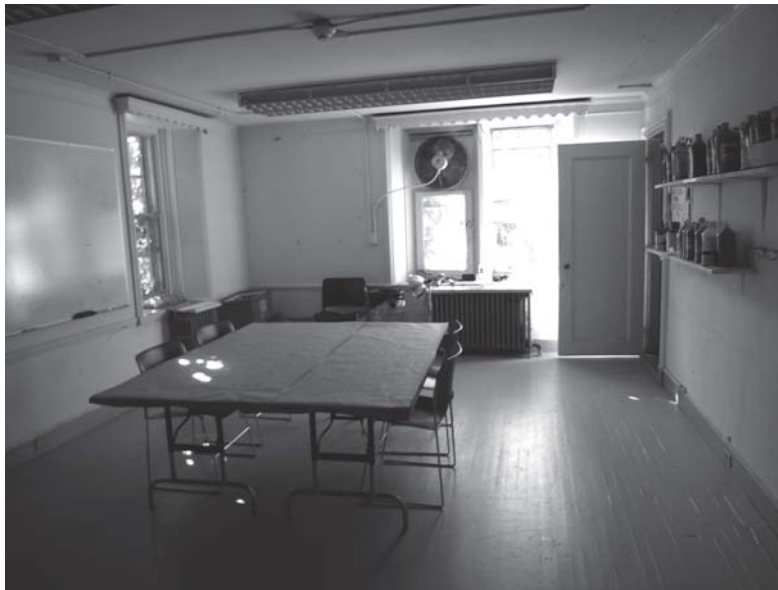
figure 25

The studio facing west and adjacent to the main staircase was probably a bedroom with an en suite bathroom. The room has most of the original trim and could be salvageable. (figure 25). There is a bathroom off the north end of this room which has the original tile floors and walls. This tile may be salvageable but this would take time and skill. Some tile pieces would have to be fabricated to take the place of missing or broken pieces. There is also some sort of paint that has been splattered over the tile walls and it is unclear at this point if it can be removed.

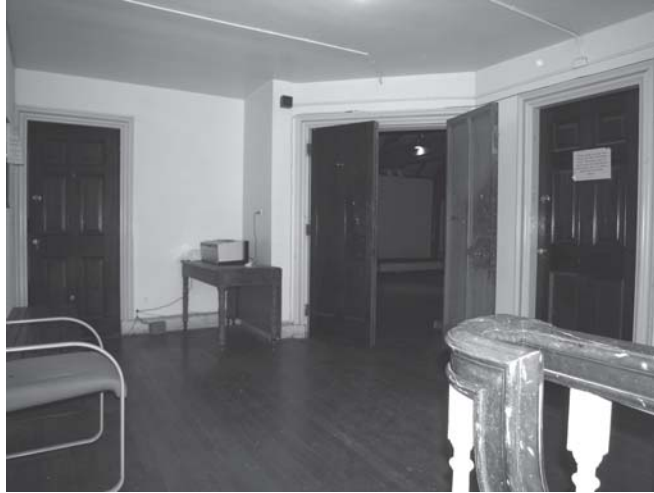
figure 26

The secondary stair leads from the second floor to a third floor vestibule. This vestibule looks to be mostly original. The original door and window casings are original and salvageable. There is no crown moulding. The original quartersawn white oak floors are still intact and could be reclaimed. The plaster walls and ceiling appear to be in good condition. (figure 26).

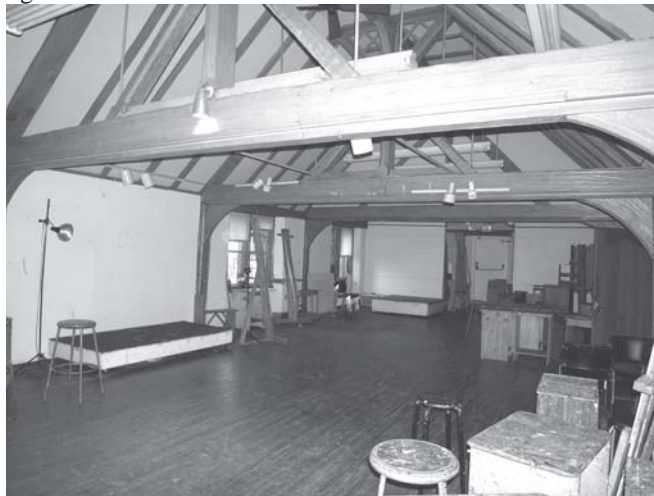
figure 27

There is a large Ballroom to the southeast of the stair vestibule. It has large exposed, decorative trusses fabricated with hand-carved oak. There are also oak battens, or half-timbering on the sloped roof/ceiling that are also of the same oak species and finish. All of this wood is in very good shape. Fluorescent lighting fixtures have been hung in this room and there are holes in the original ceiling plaster to accommodate their installation. There are also can lighting strips attached to the trusses and the hole from their removal would have to be repaired. (figure 27).

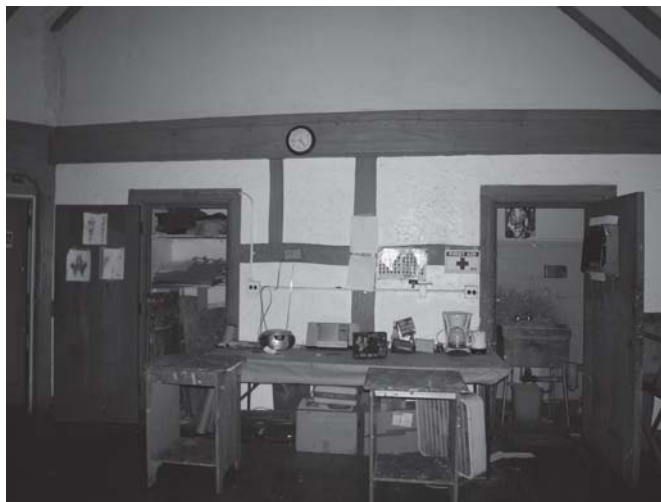
figure 28

The plaster walls have been covered with a contemporary drywall construction. Some of the original plaster and half-timbering walls remain on the north end of the room. The original oak floors are there and could

easily be salvaged. There is no remaining base trim and the original window casings are not salvageable. (figure 28).

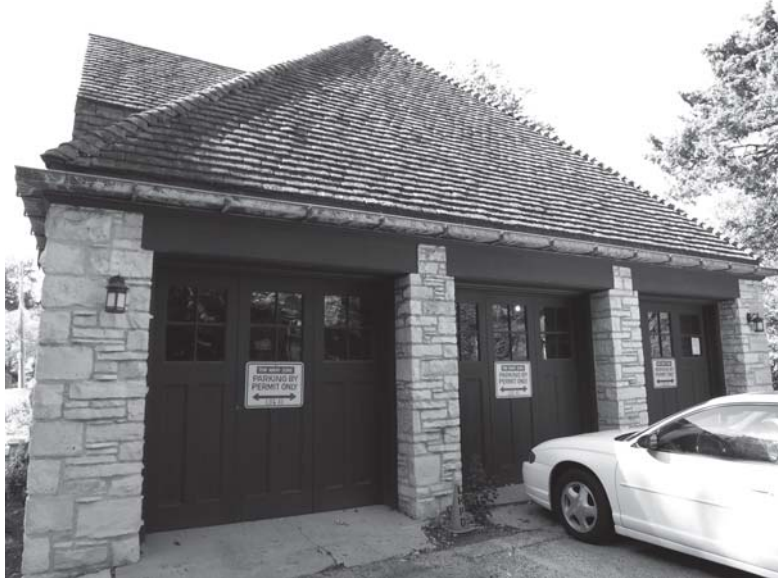
figure 29

The original wood doors are in fairly good shape and most likely can serve for some years to come. The coach house overhead garage doors have been restored lately and are in good condition. (figure 29).

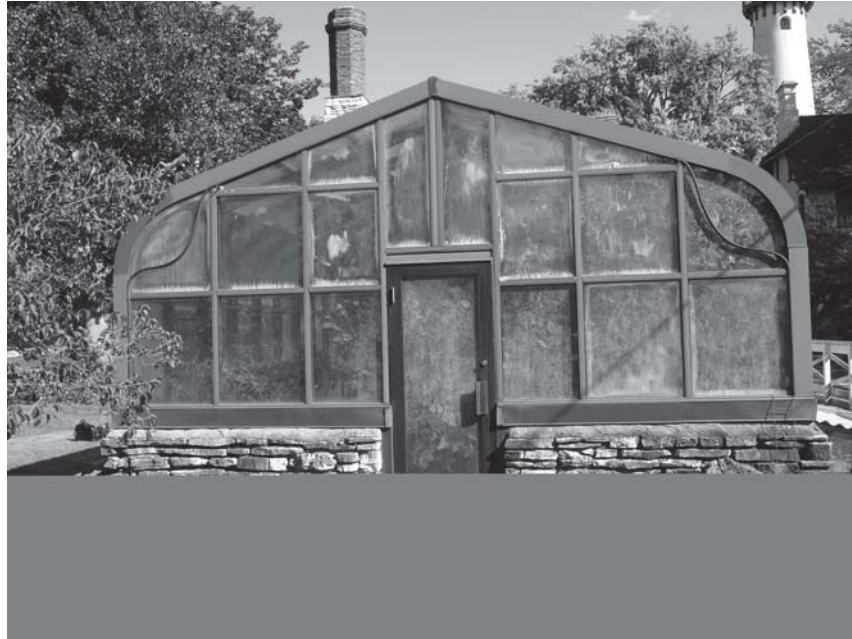
figure 30

There is a small greenhouse on the far west end of the coach house. The stone base around the bottom of this greenhouse is in need of tuckpointing. The stone also appears to be in need of an environmentally safe

washing. (figure 30). The glass of the greenhouse looks to be in average condition and will need to be restored at some point in the near future.
