Evanston, Illinois

Central Street: Streetscape Design Study

JULY 2007

Central Street Master Plan
prepared by:
The Lakota Group
Infrastructure Engineering Inc.
Gewalt Hamilton Associates

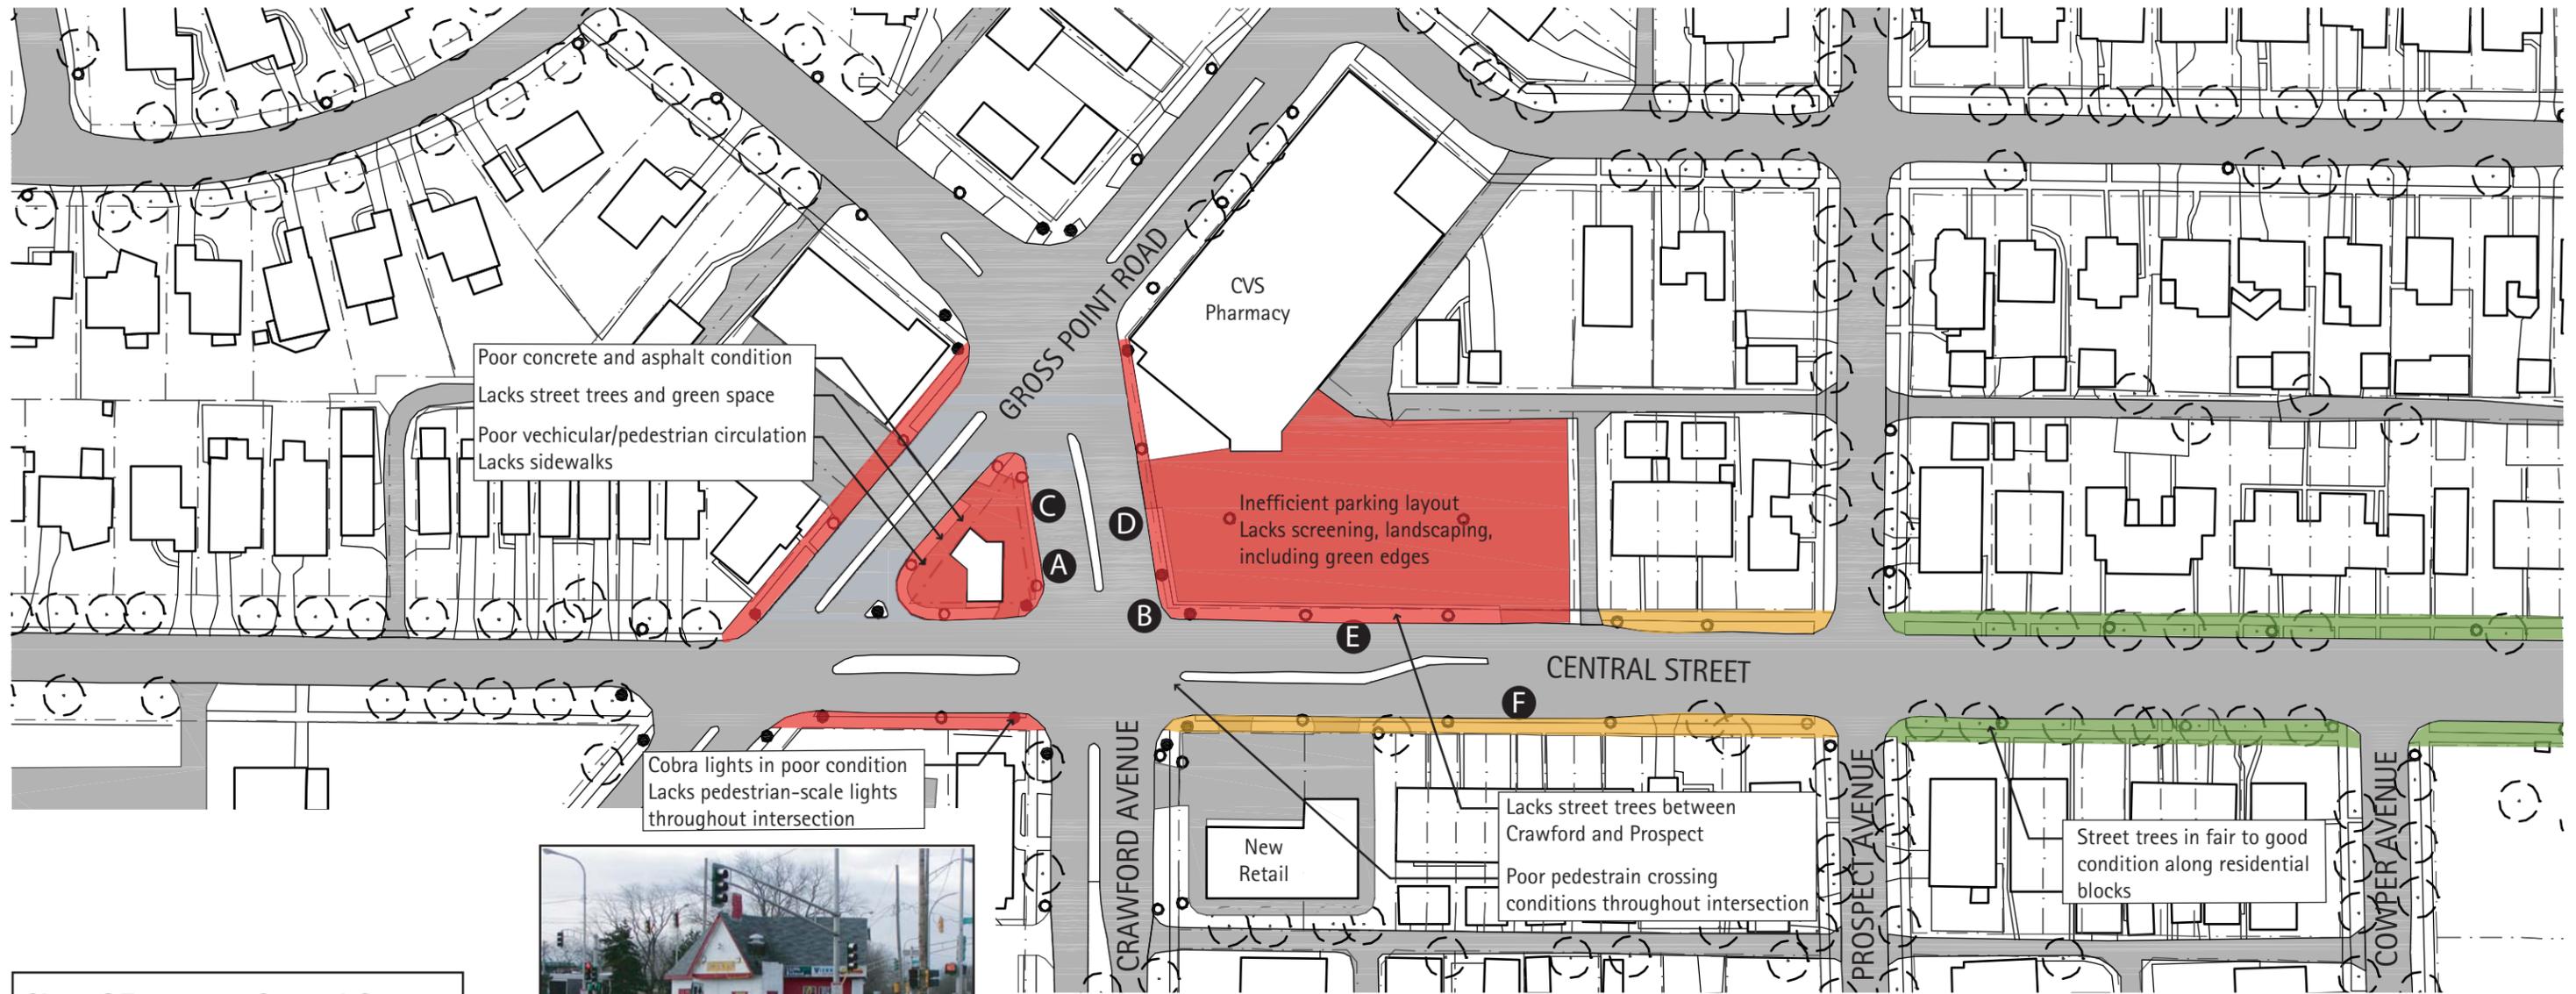
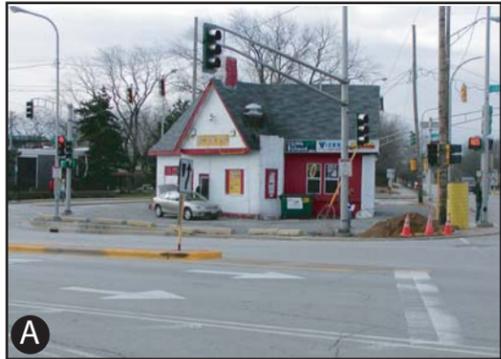
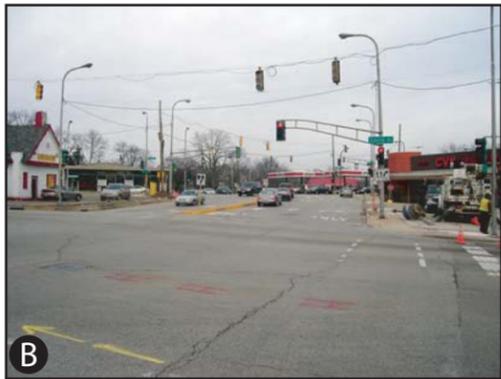
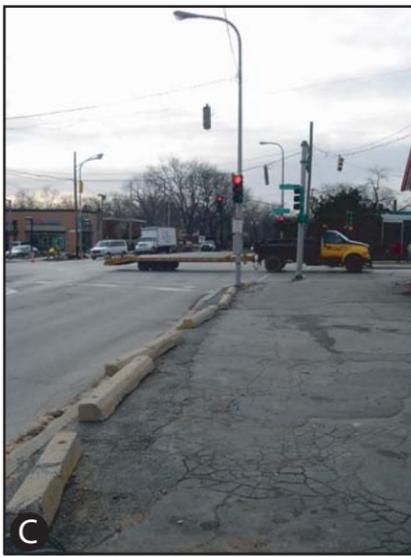
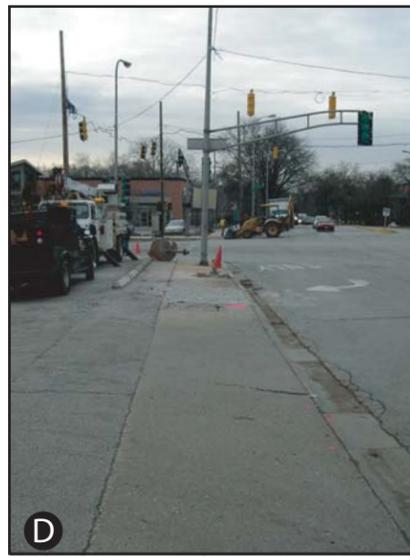
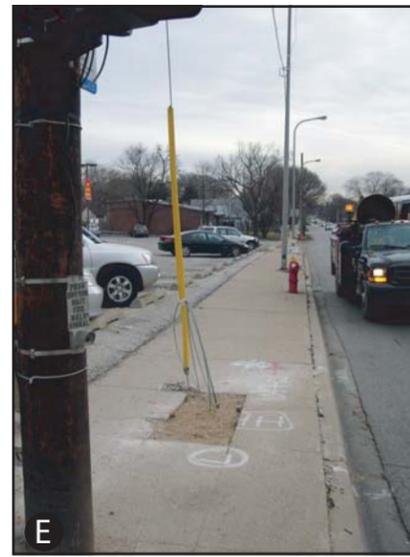
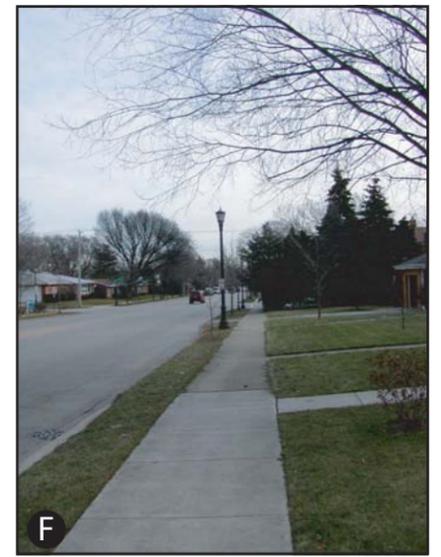
Figure 1.1: Streetscape Conditions - Intersection of Gross Point Road + Crawford Avenue

Gross Point/Crawford

- The "Hot Dog Island" site in the center of the intersection has deteriorated pavement and sidewalks and lacks landscaping.
- The CVS Pharmacy parking lot lacks screening and landscaping.
- Parkways along most stretches of Gross Point, Crawford, and Central lack street trees.
- The entire intersection lacks the City's pedestrian-scale lighting, marked pedestrian crossings, and landscaping.
- As a gateway location into Evanston, this intersection has excessive amounts of exposed asphalt and utilities, and buildings in need of rehabilitation or redevelopment.

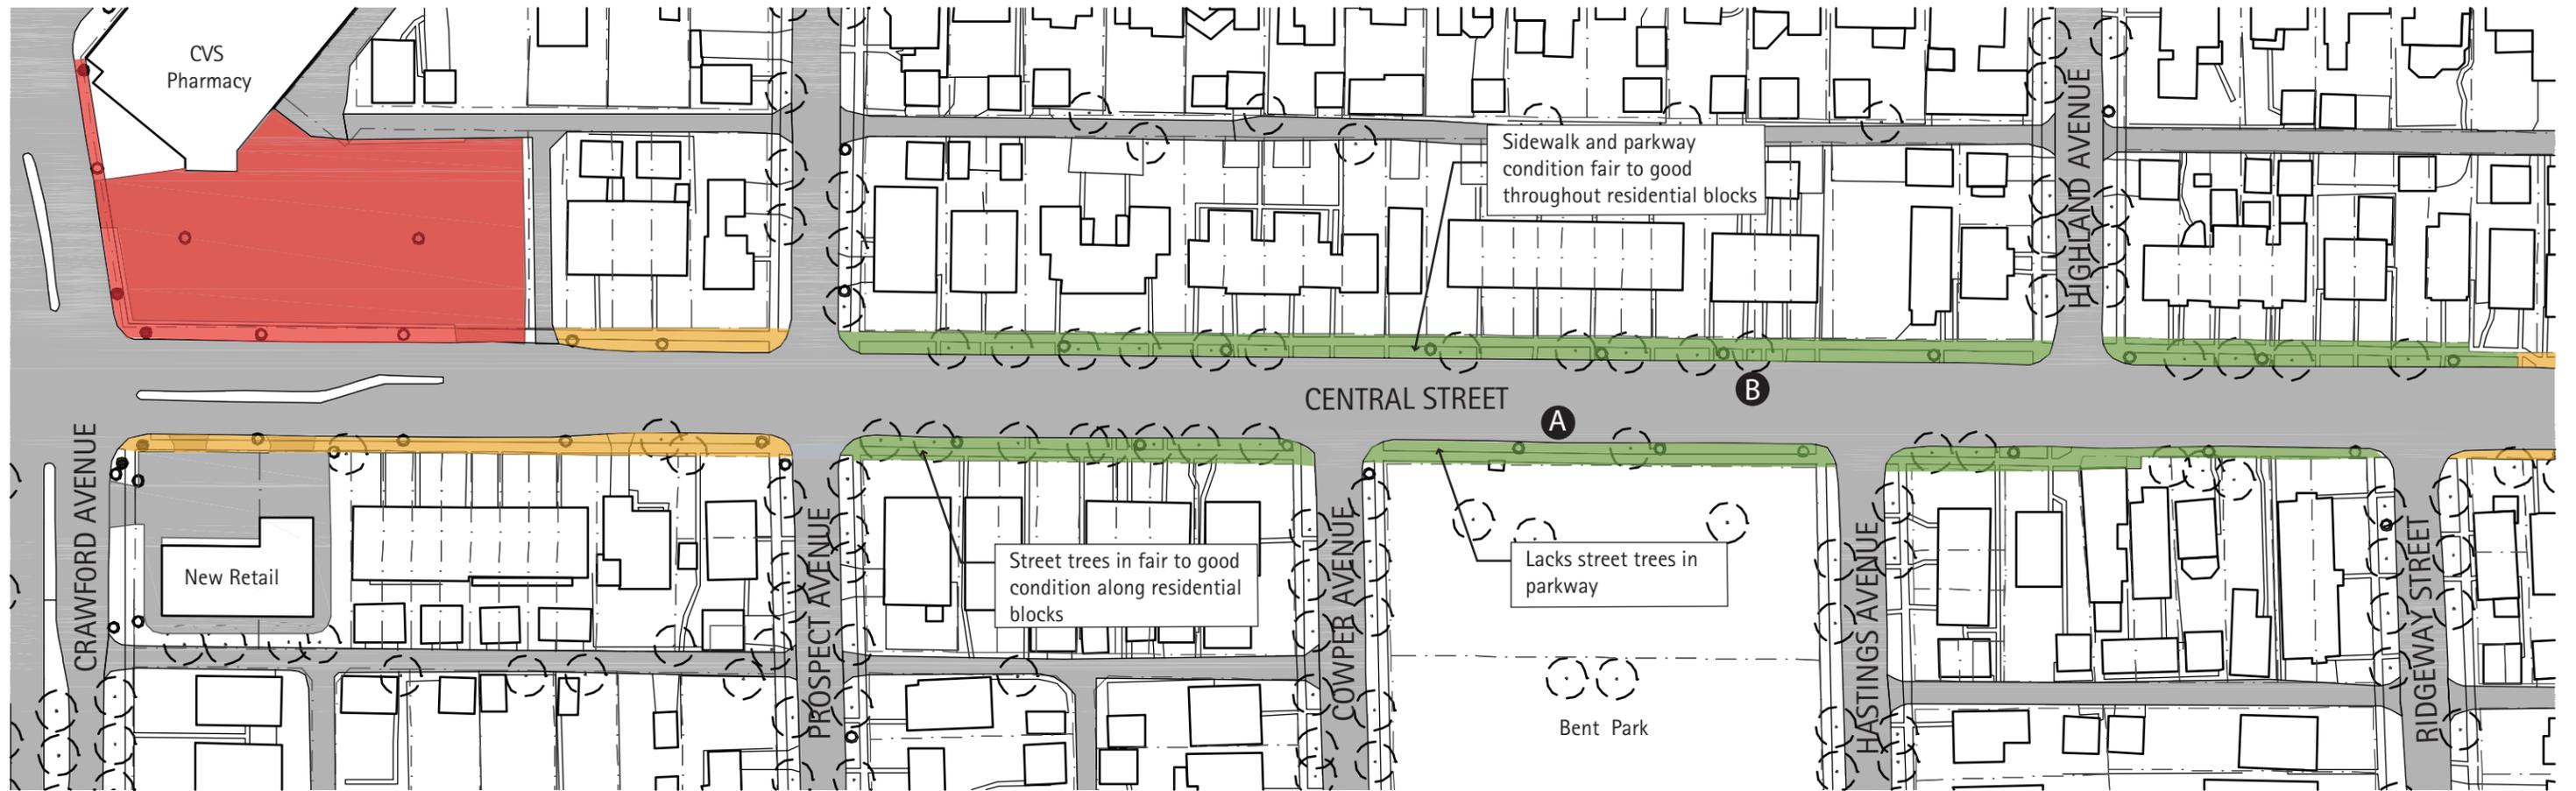
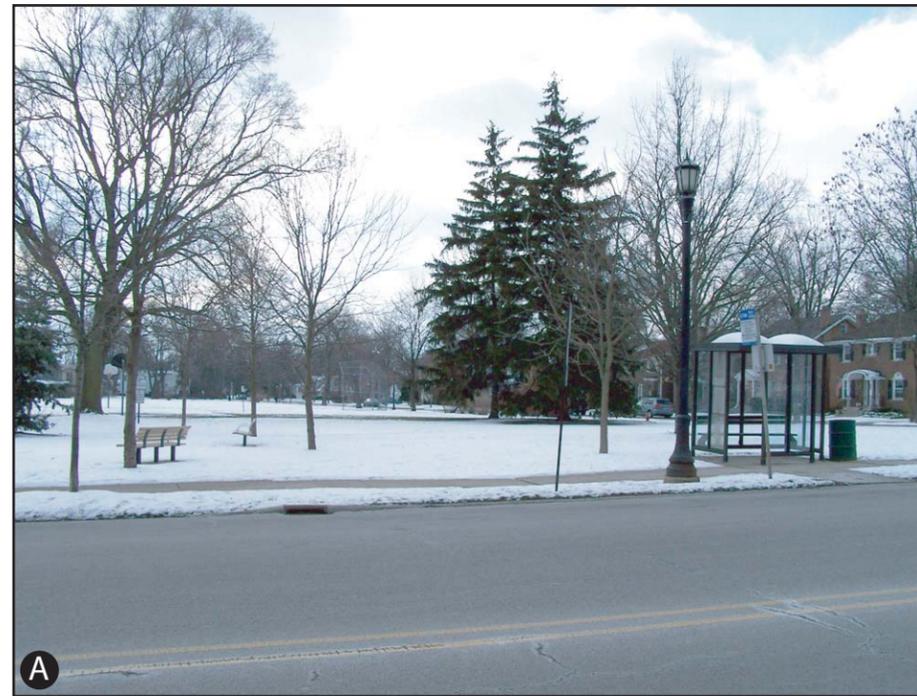
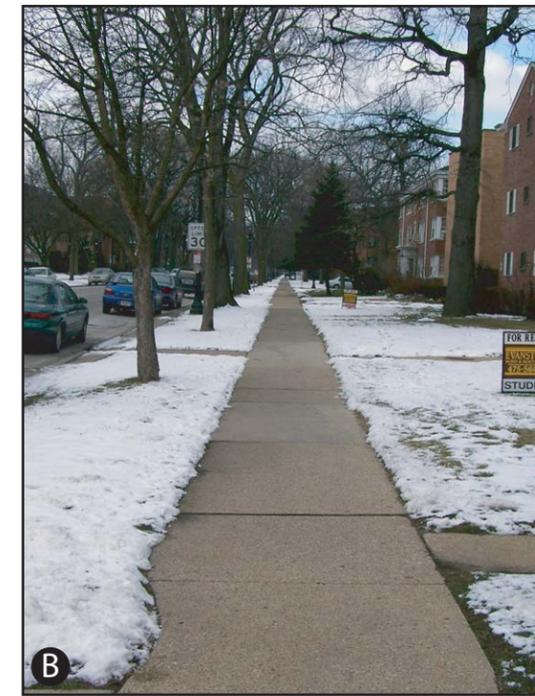
Figure 1.2: Streetscape Conditions - Crawford Avenue to Ridgeway Street

Crawford to Ridgeway

- Sidewalks, parkways, and street trees are in fair to good condition along residential blocks.
- The parkways along Bent Park lack street trees.

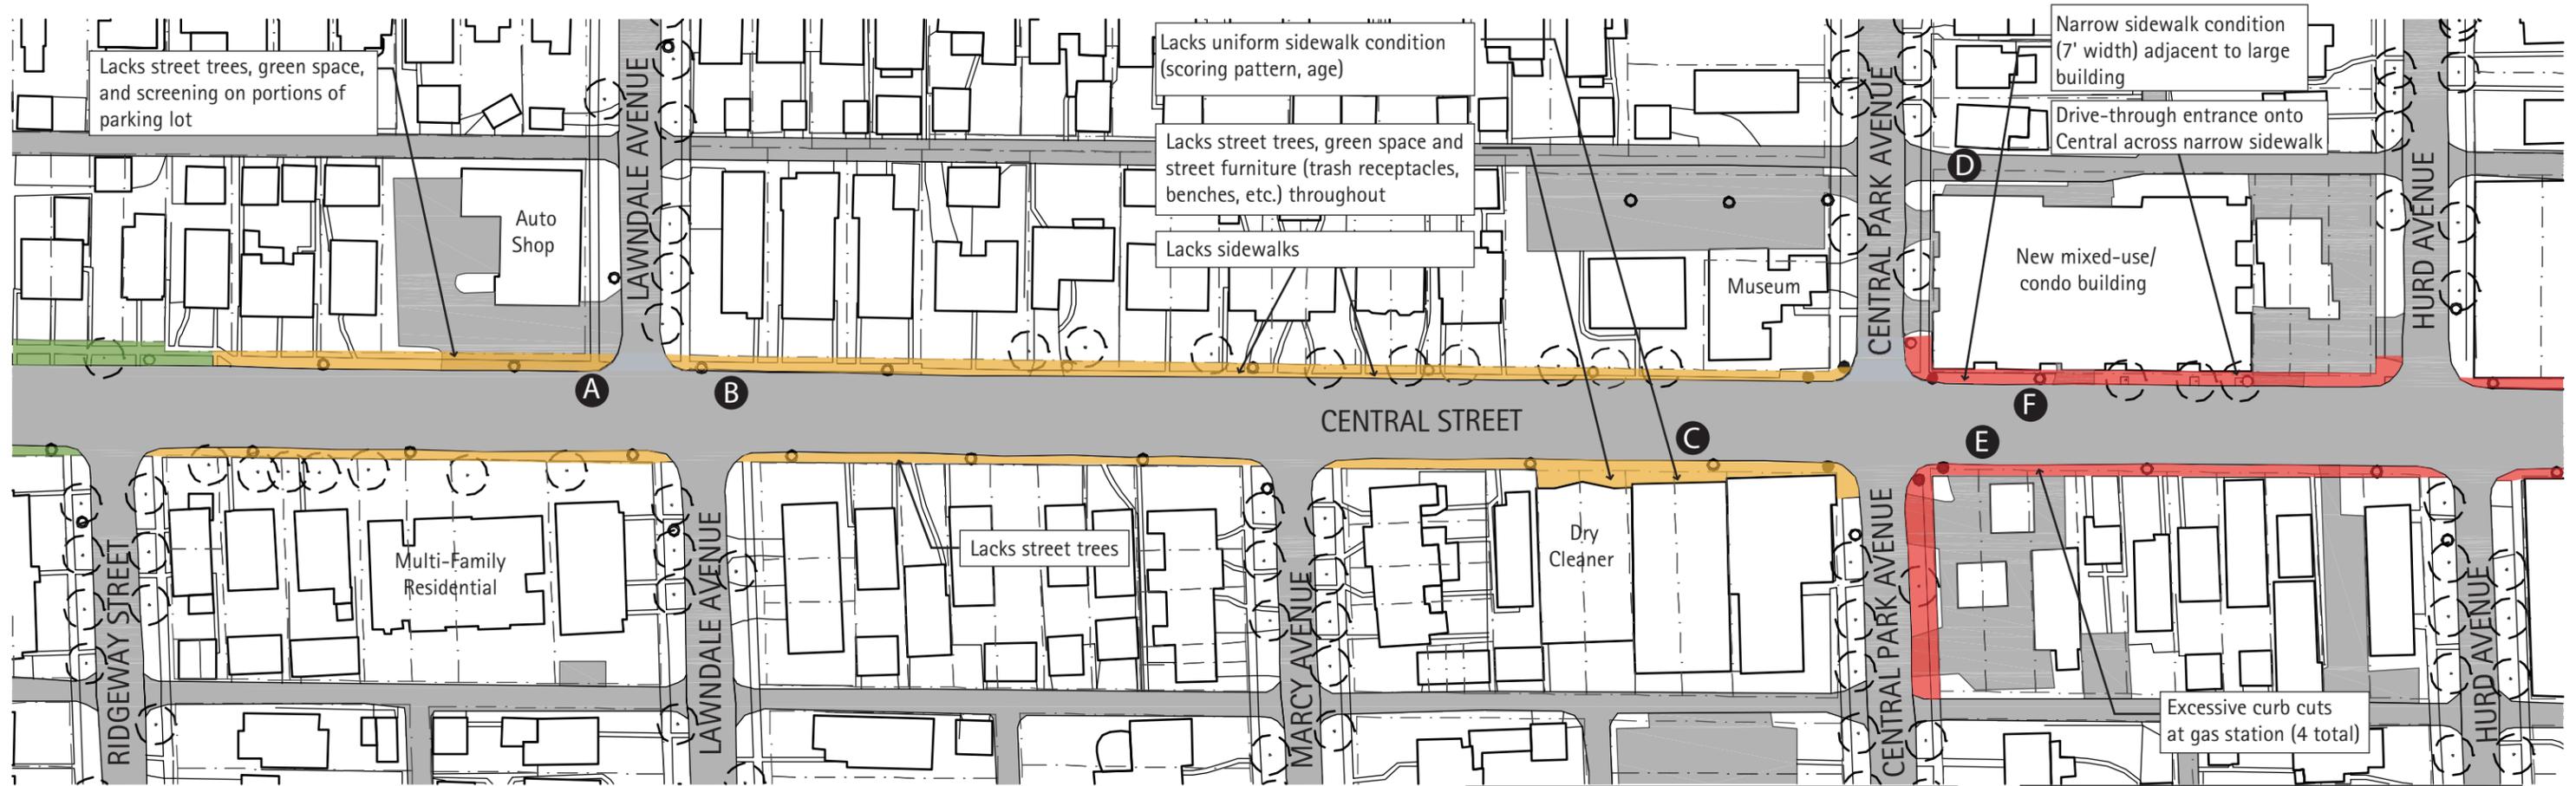
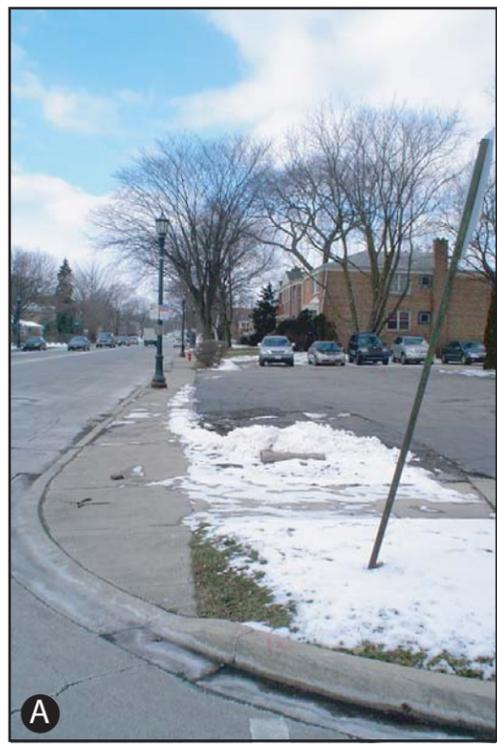
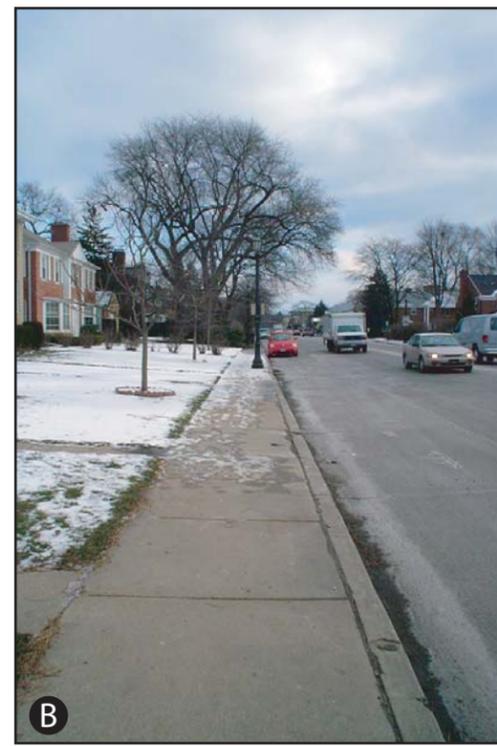
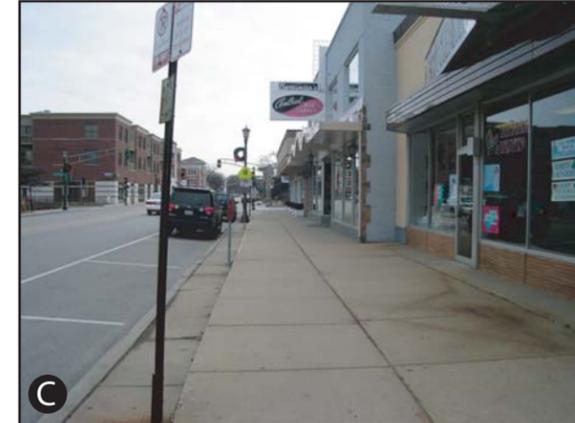
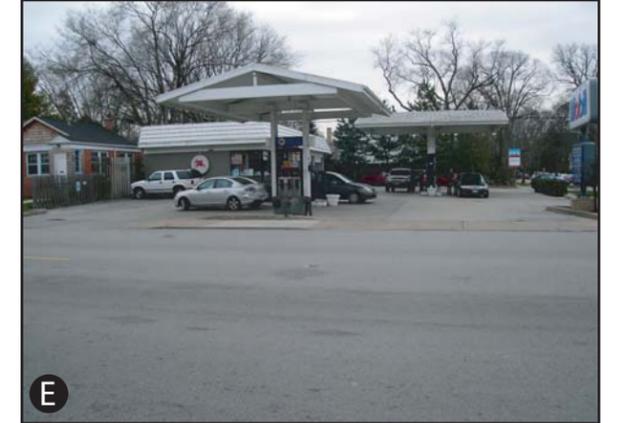
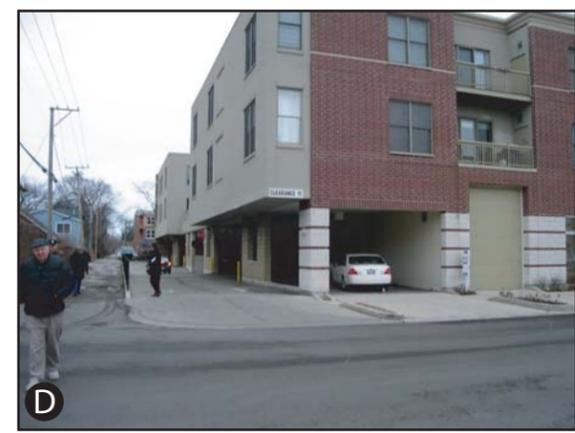
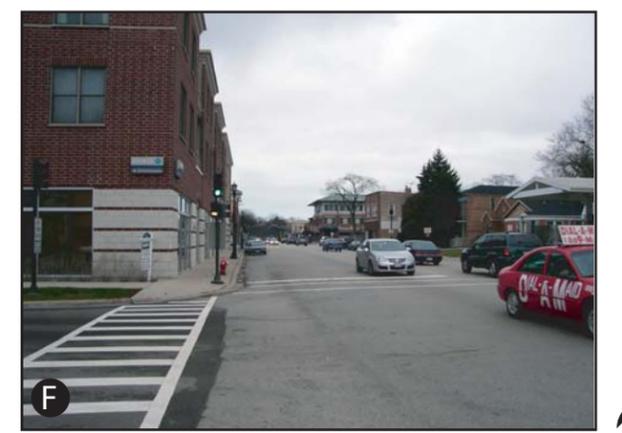
Central Street: Streetscape Study City of Evanston, Illinois
Figure 1.3: Streetscape Conditions - Ridgeway Street to Hurd Avenue

Ridgeway to Hurd

- The auto body shop at Central and Lawndale lacks street trees and screening (fence and/or landscaping) along its parking lot.
- Residential blocks between Ridgeway and Central Park lack street trees.
- Residential blocks throughout this stretch lack lawn parkways.
- Commercial blocks between Marcy and Hurd lack uniform sidewalks, street trees, and street furniture.

- The sidewalks in front of the Mitchell Museum of the American Indian are only 2 feet wide.
- The gas station at southeast corner of Central Street and Central Park has four curb cuts and minimal landscaping.

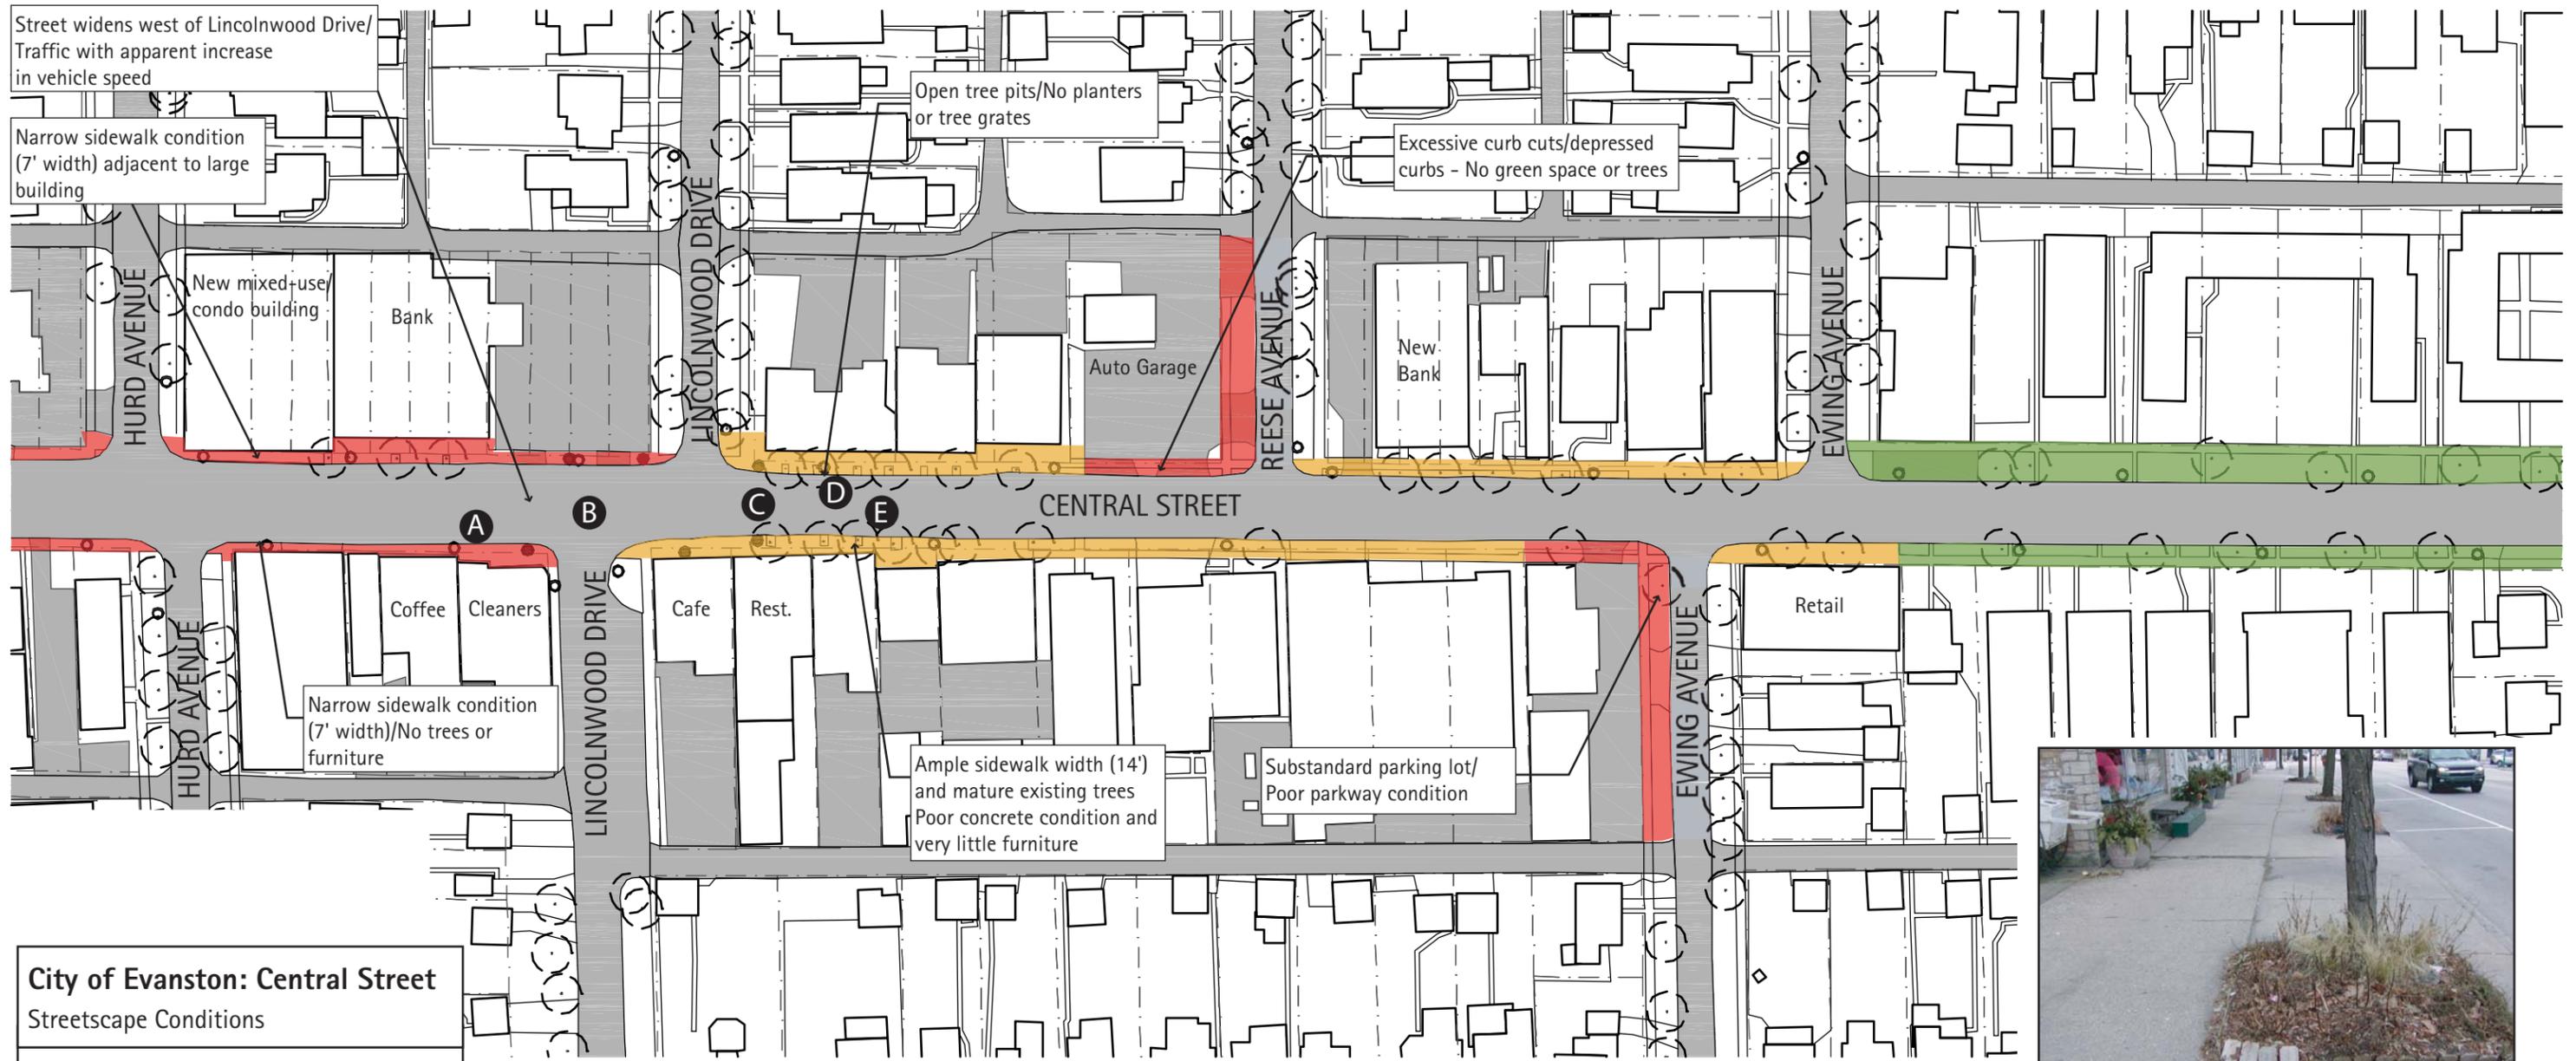
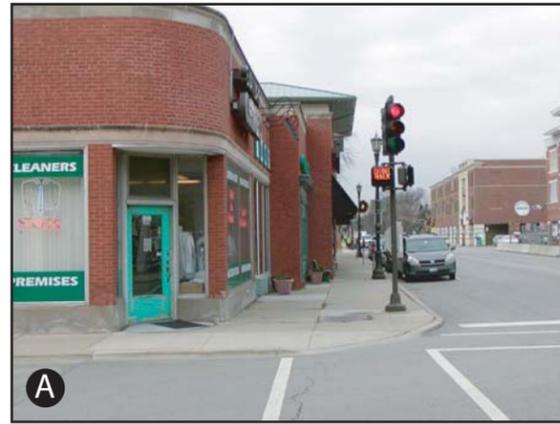
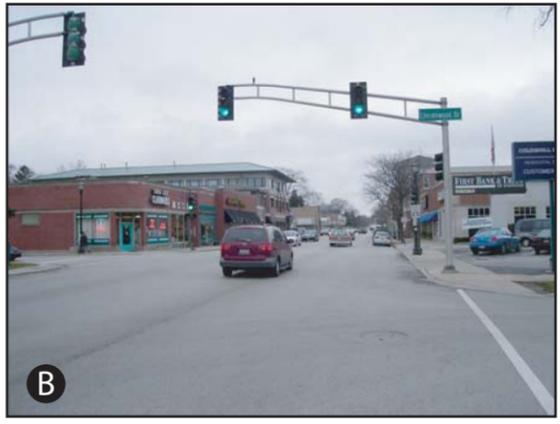
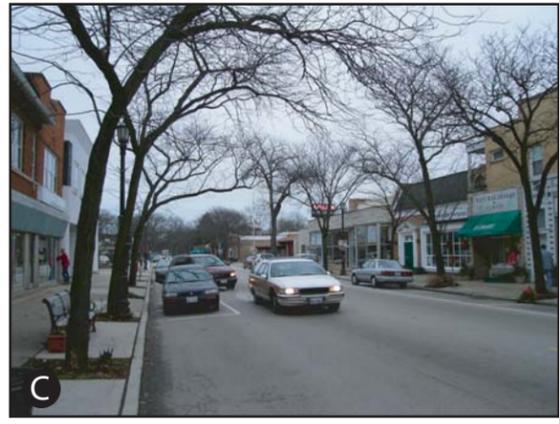
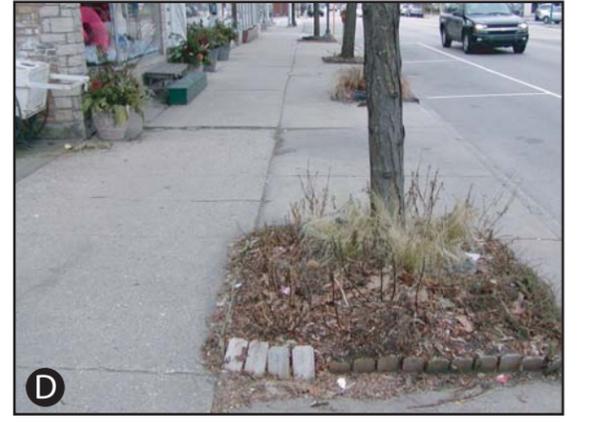
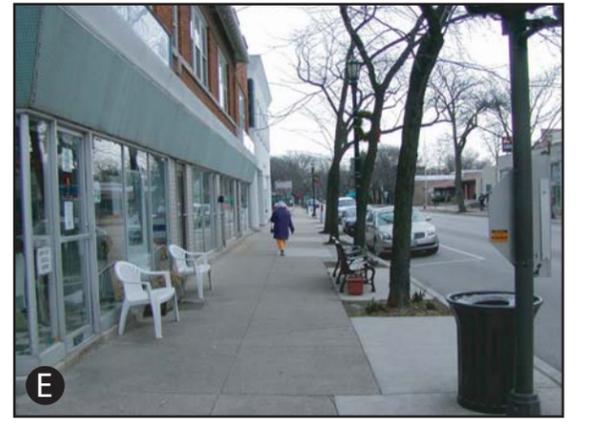
Figure 1.4: Streetscape Conditions - Hurd Avenue to Ewing Avenue

Hurd to Ewing

- Commercial blocks between Hurd and Lincolnwood lack uniform sidewalks, street trees, and street furniture.
- Commercial blocks between Hurd and Lincolnwood have narrow sidewalks and little opportunity for street trees or planters.

- The commercial block between Lincolnwood and Reese has a good pedestrian character. Large mature street trees and wide sidewalks result in a more pedestrian-friendly environment. However, the sidewalks, which are 14 feet wide, are mostly in poor condition.

- Trees are planted in open tree pits that lack root protection, such as grates, fencing, or raised planters.
- The auto shop’s parking lot at Central and Reese has excessive curb cuts, lacks street trees, landscaping, and screening.

- The parking lot at Central and Ewing adjacent to the video and convenience stores does not meet parking standards regarding access and circulation and the parkway is in poor condition and lacks street trees.

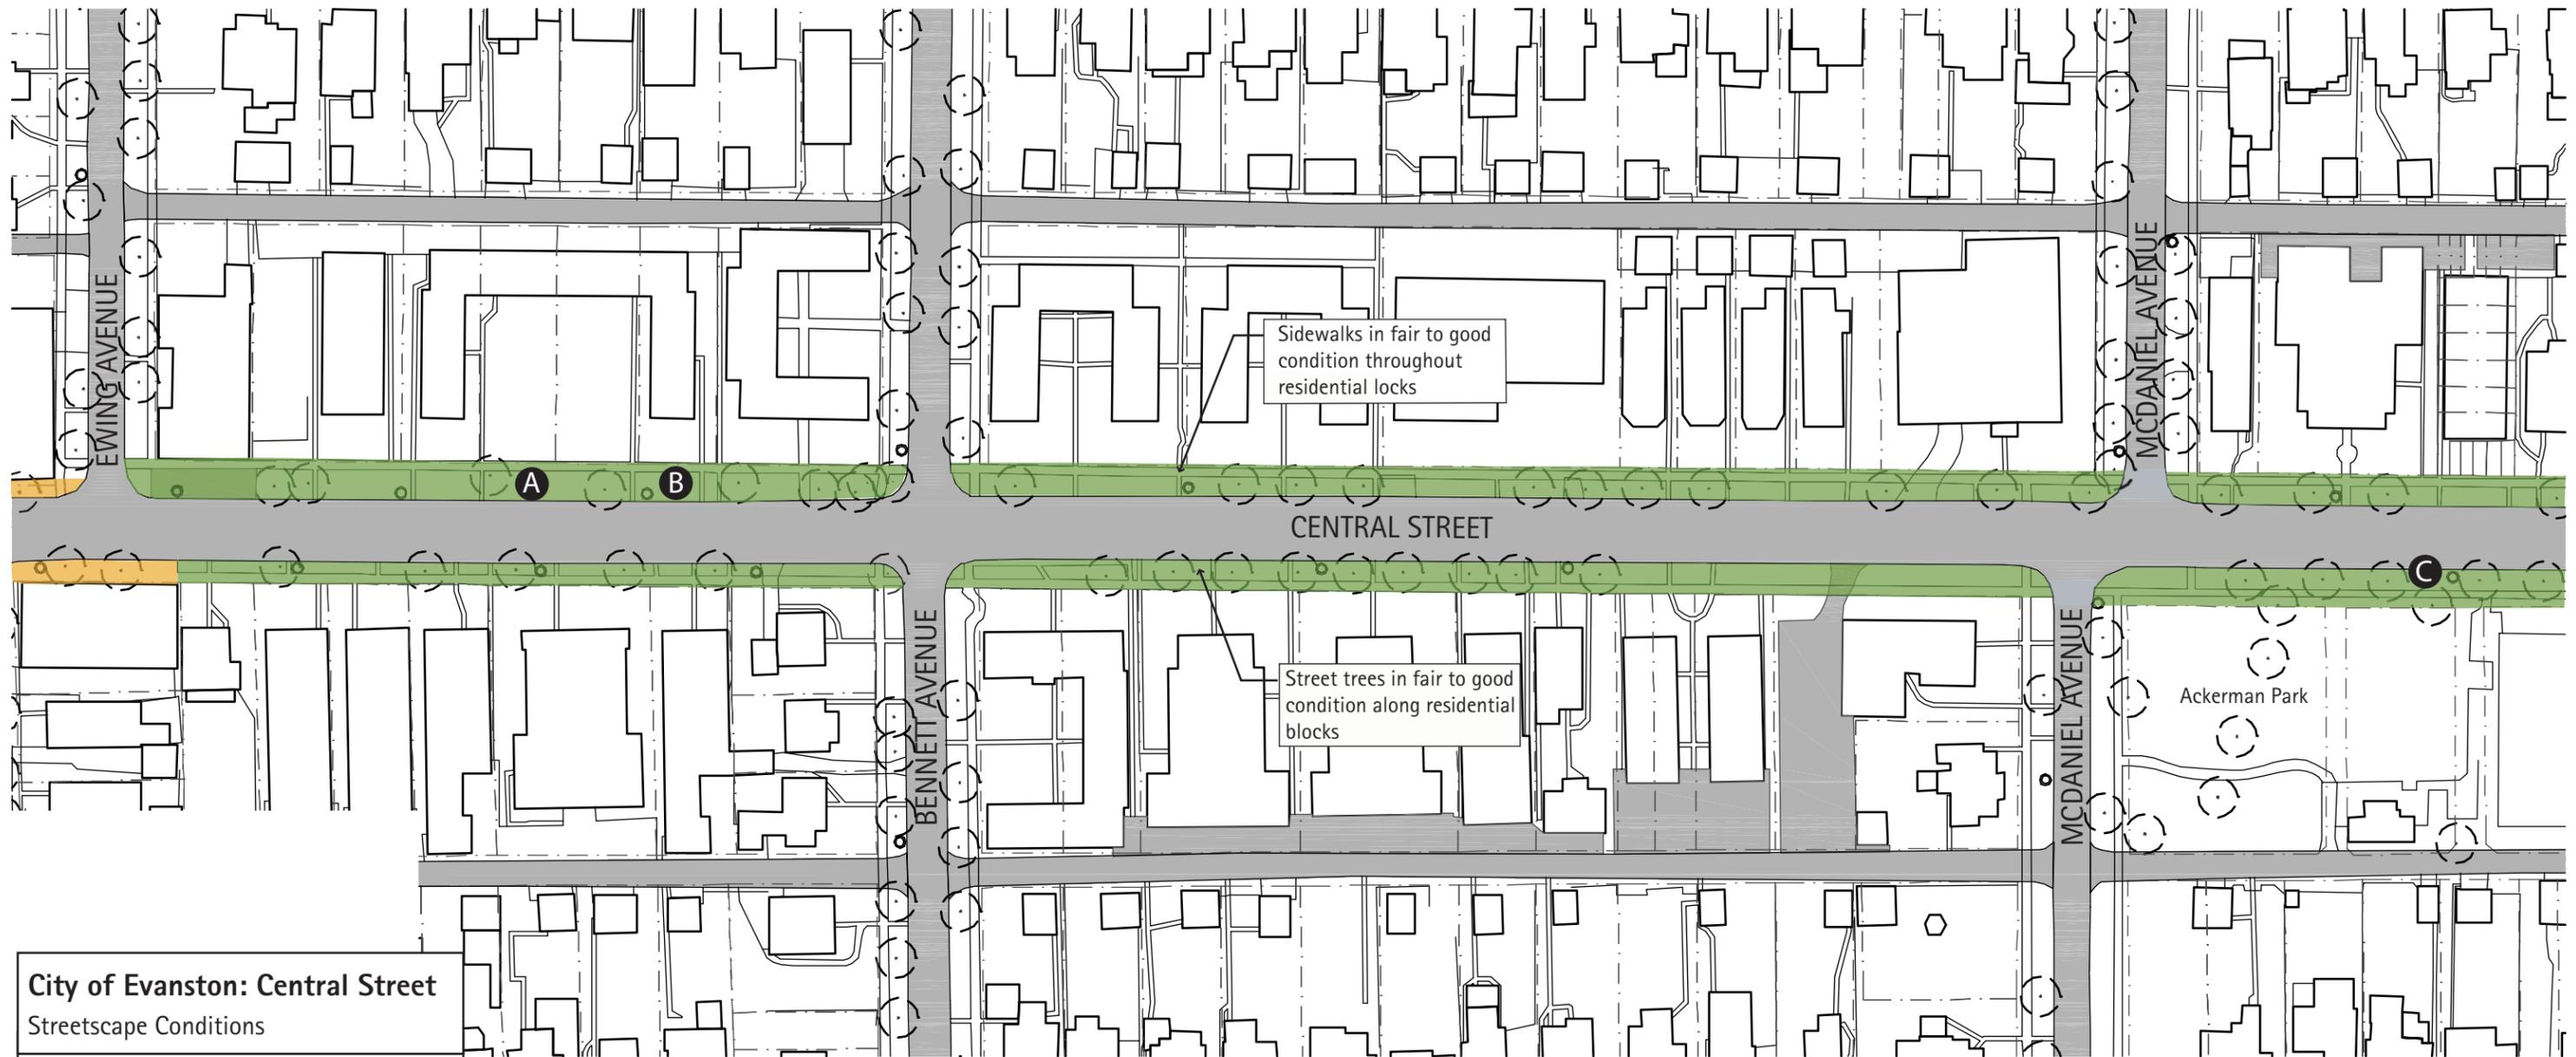
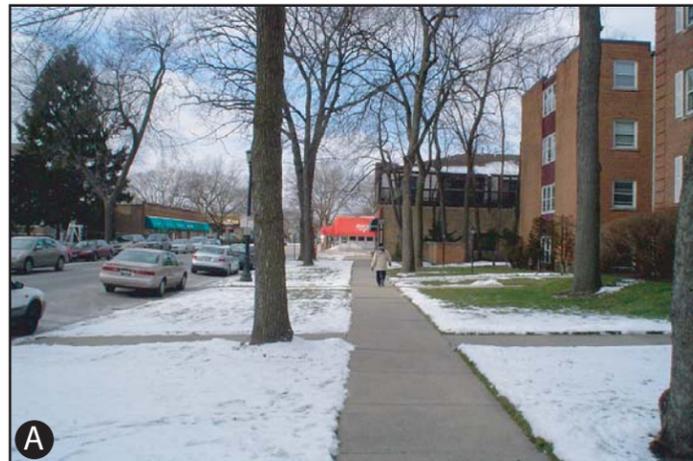
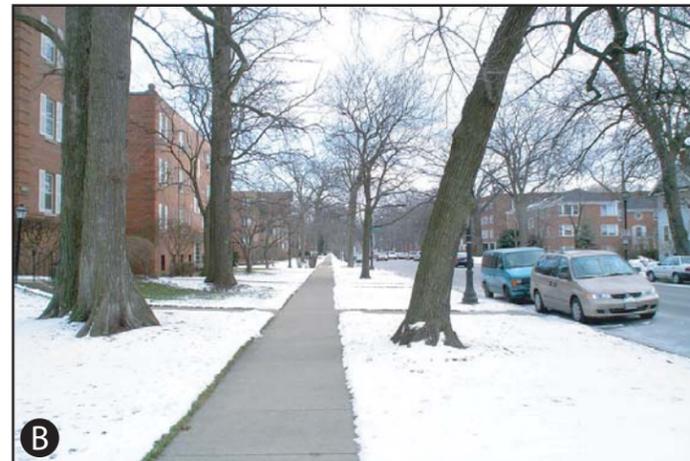
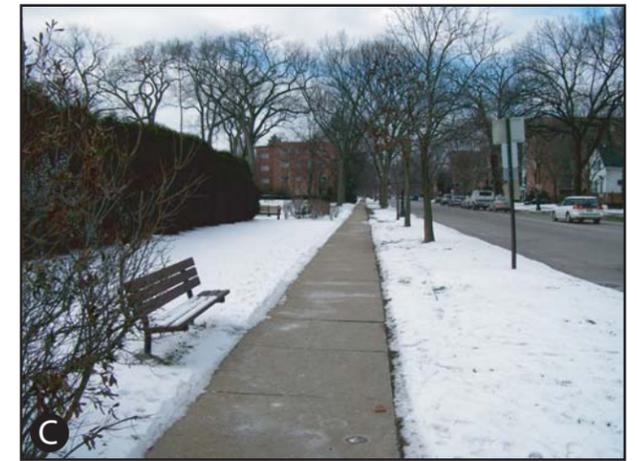
Figure 1.5: Streetscape Conditions - Ewing Avenue to McDaniel Avenue

Ewing to McDaniel

- Sidewalks, street trees, and parkways are in fair to good condition.

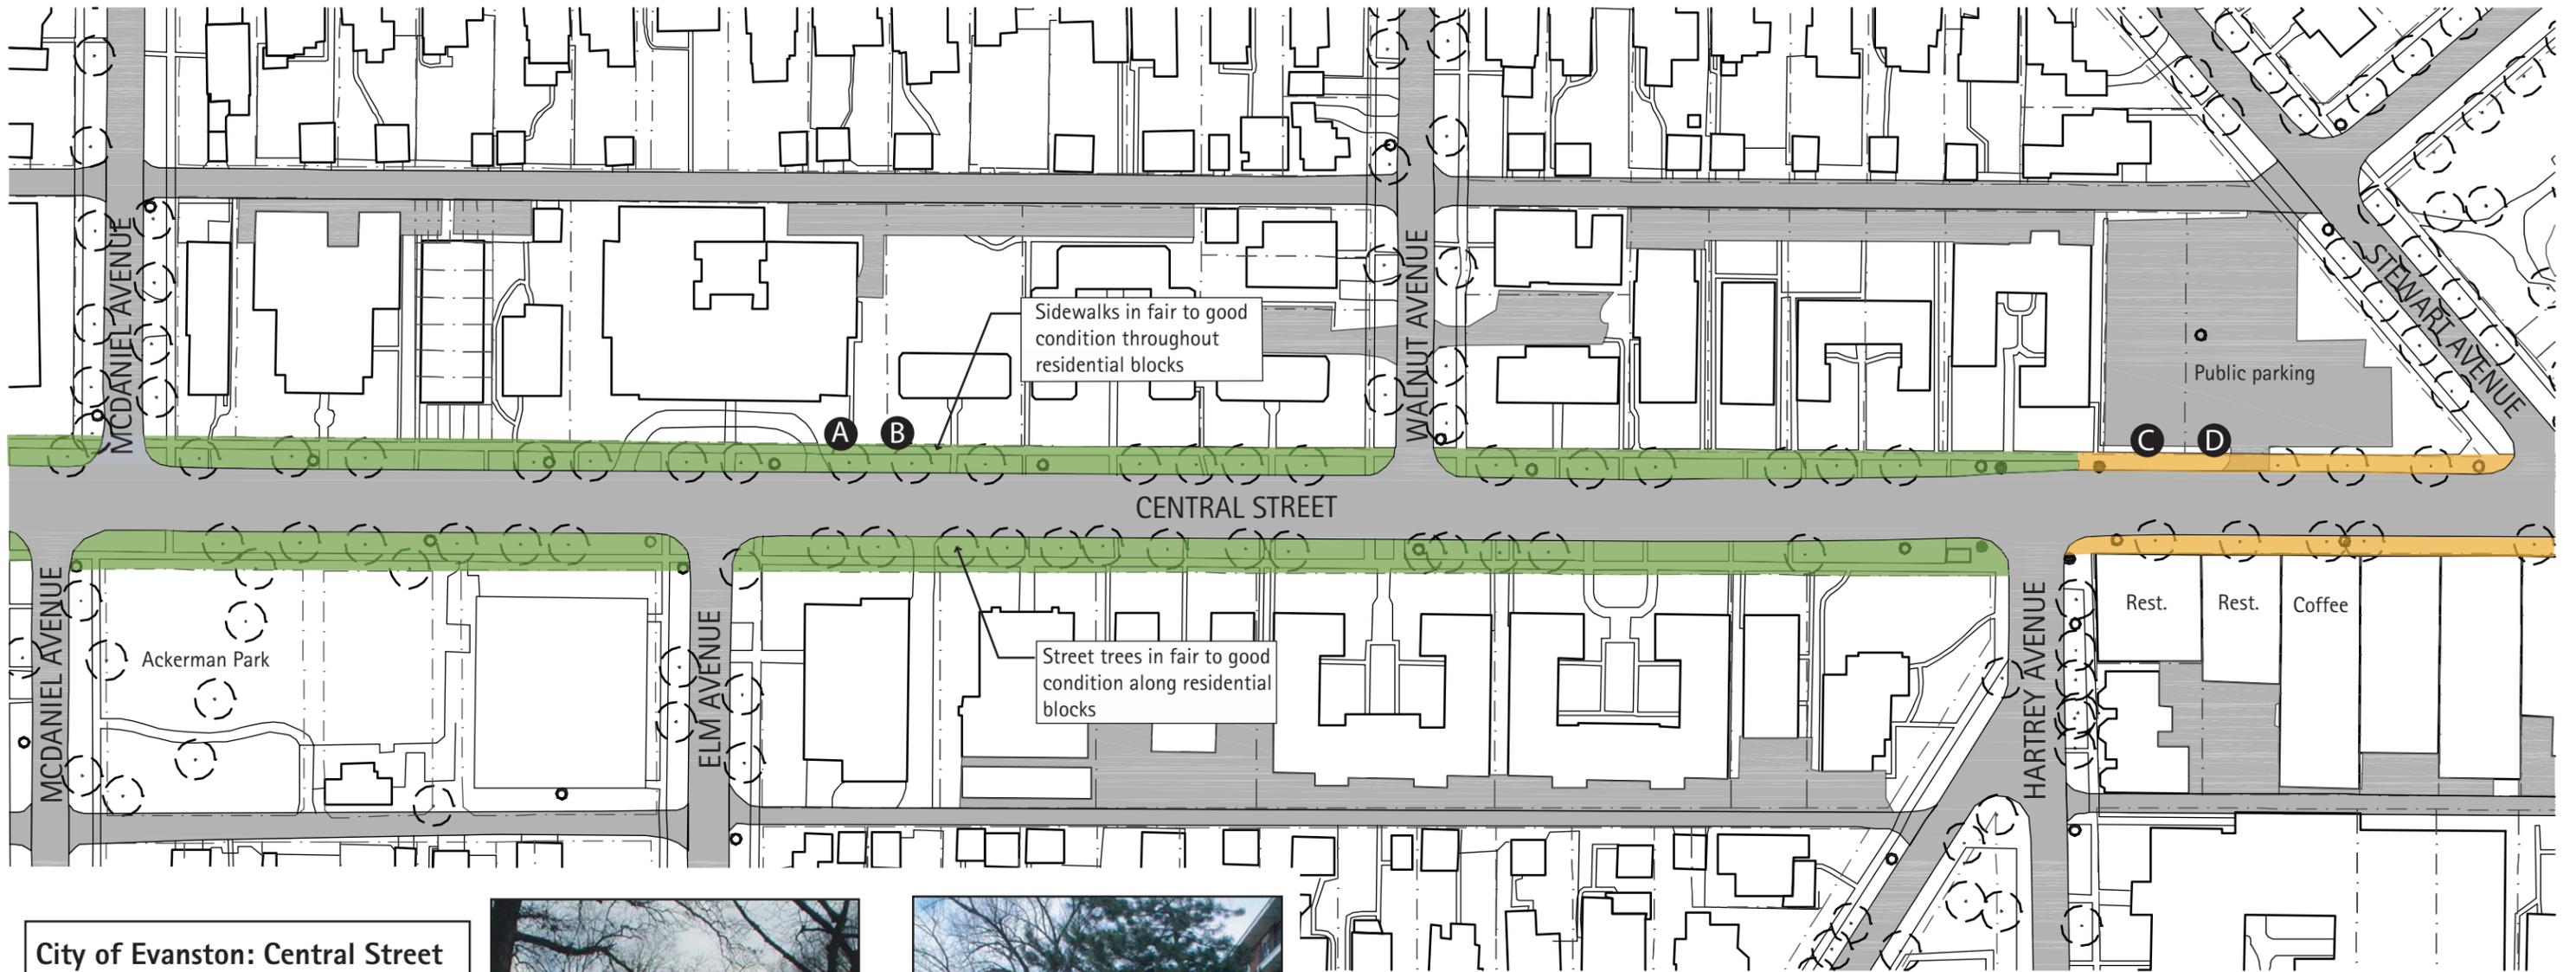
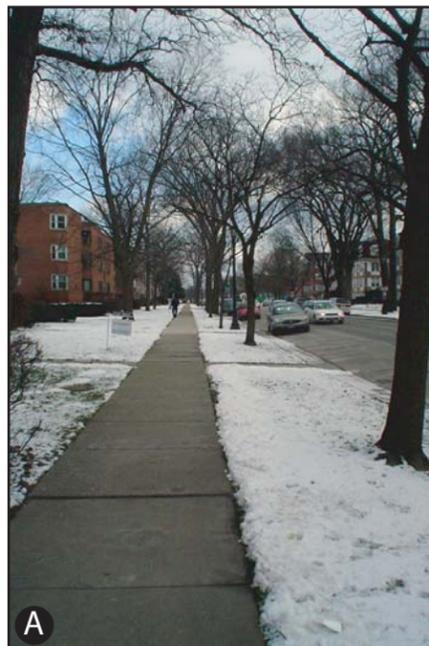
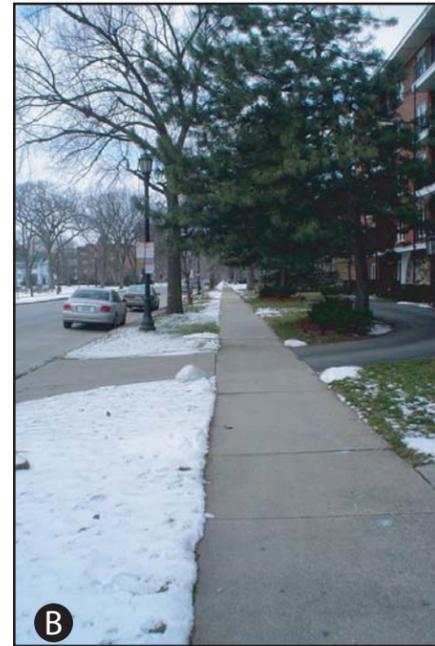
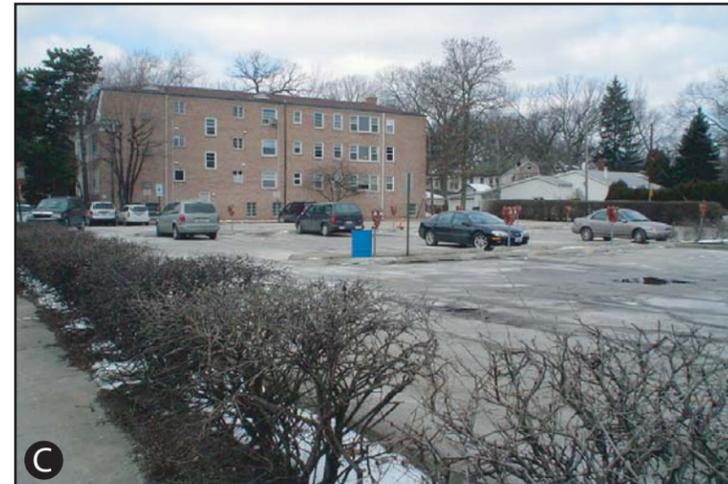
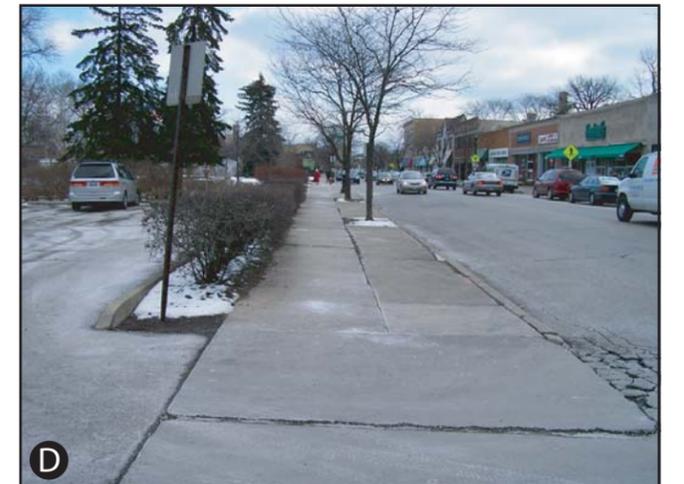
Figure 1.6: Streetscape Conditions - McDaniel Avenue to Hartrey Avenue

McDaniel to Hartrey

- Sidewalks, street trees, and parkways are in fair to good condition.
