Evanston, Illinois

Central Street: Streetscape Design Study

JULY 2007

Central Street Master Plan
prepared by:
The Lakota Group
Infrastructure Engineering Inc.
Gewalt Hamilton Associates

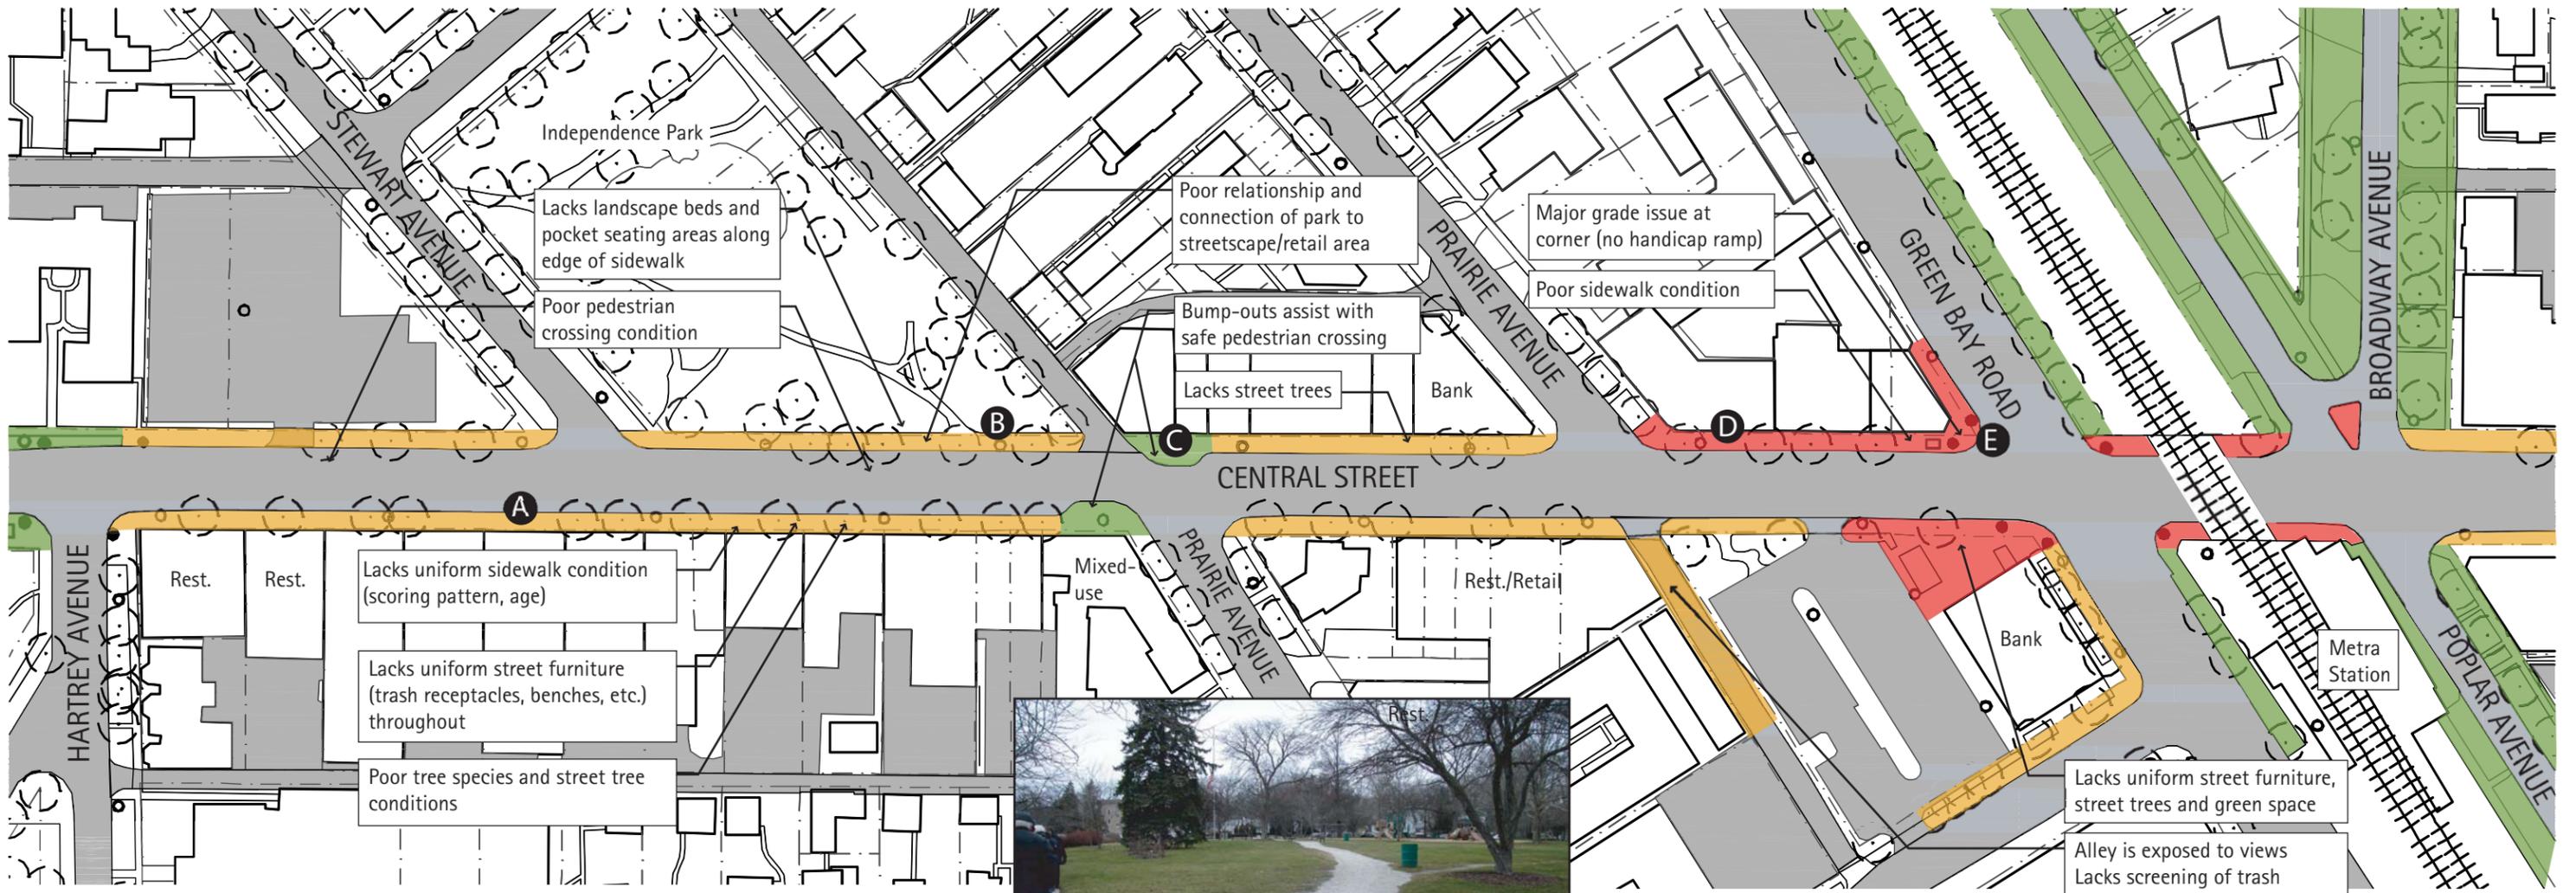
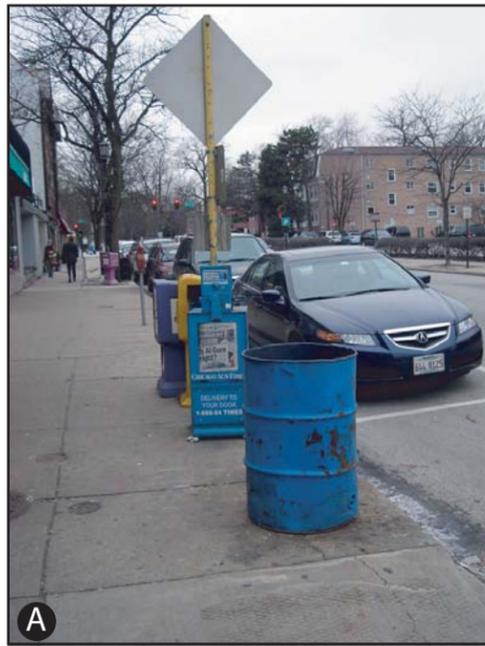
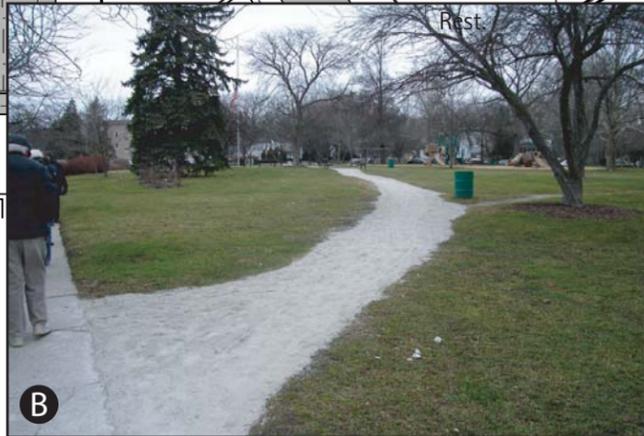
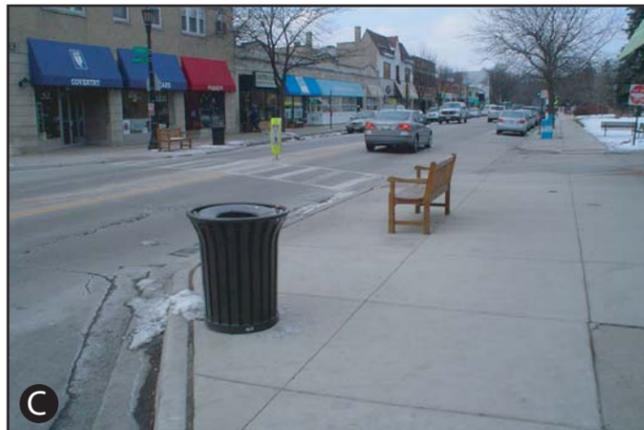
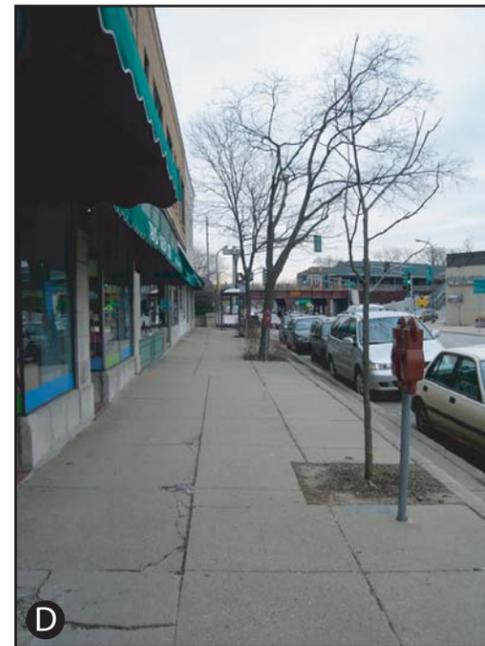
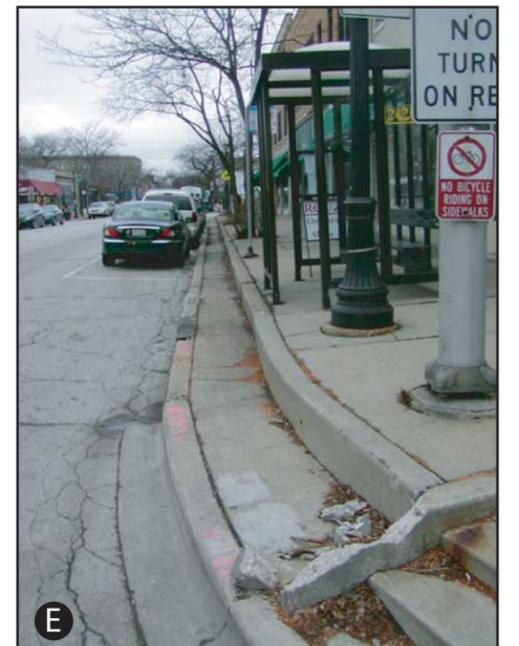
Figure 1.7: Streetscape Conditions - Hartrey Avenue to Green Bay Road

Hartrey to Green Bay

- Commercial blocks between Hartrey and Prairie lack uniform sidewalks, planting areas, and street furniture.
- Trees are planted in open tree pits that lack root protection, such as grates, fencing, or raised planters.
- Some street tree species along these blocks are not a resilient variety (e.g. Green Ash, a species susceptible to disease), are in poor condition, and/or have bad form.
- Sidewalks are in fair to poor condition.

- Independence Park lacks landscaping, seating areas, and street furniture along Central. The park has equipment for children, but it is not oriented to use by other age levels. Benches are outdated and the corner seating area is deteriorated.

- “Bump-outs” at Central and Prairie provide pedestrians a safer crossing environment and give vehicular traffic a visual cue to slow down.
- Commercial blocks between Prairie and Green Bay lack uniform sidewalks, landscaping, and street furniture.

- The commercial area on the north side of Central has poor sidewalk conditions, as well a significant change in grade at the northeast corner of Central and Green Bay.

- The plaza at the southwest corner of Central and Green Bay lacks uniform street furniture and landscaping.
- The intersection at Green Bay and the viaduct under the tracks have limited sidewalk space for pedestrians crossing to/from the Metra station.

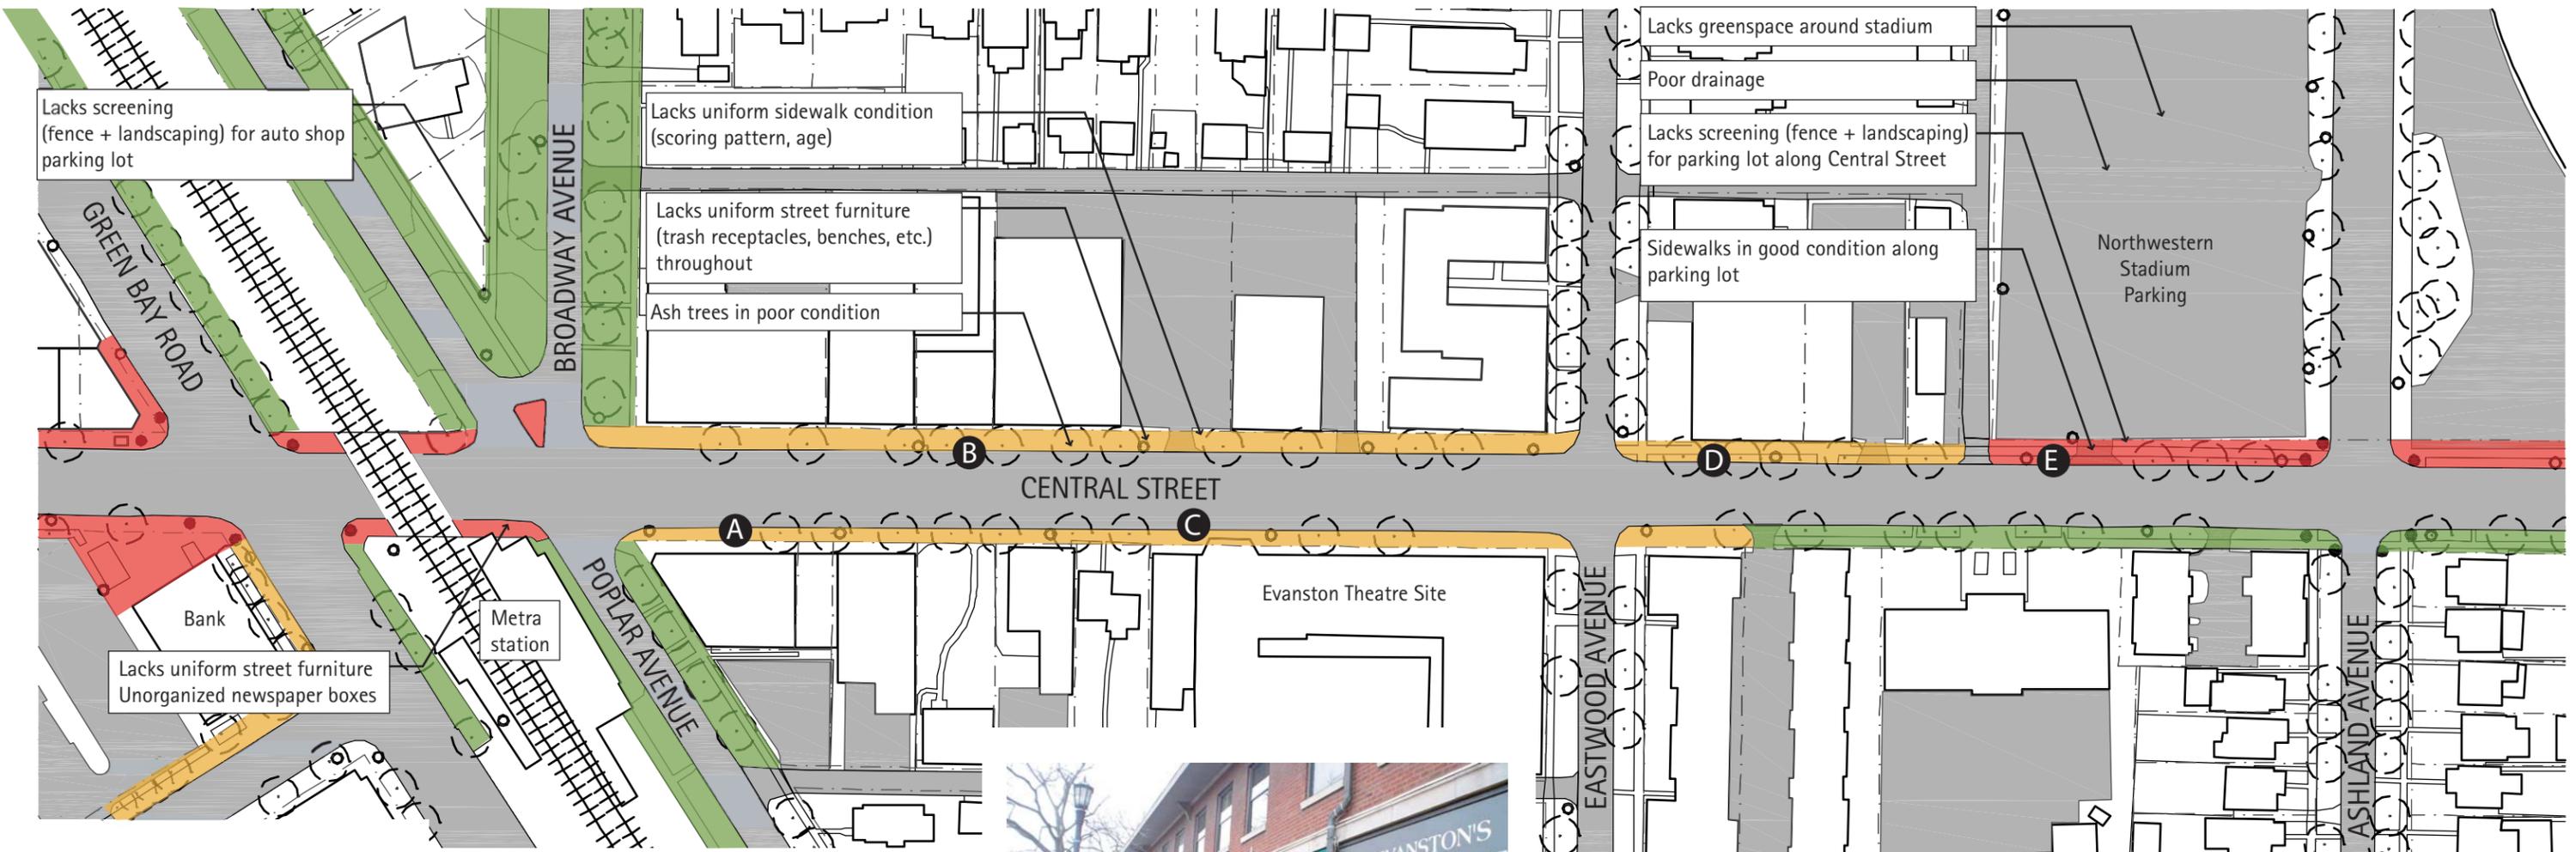
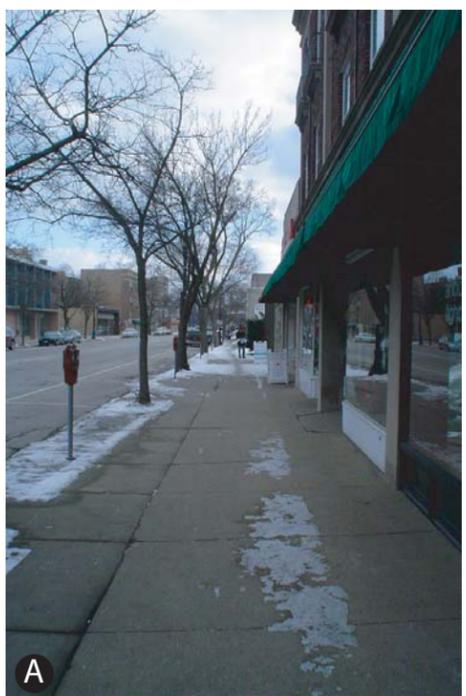
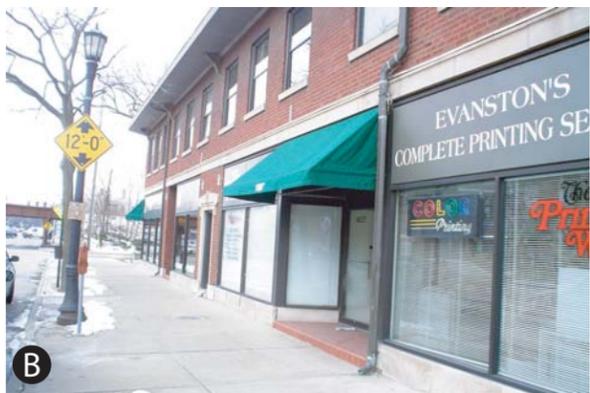
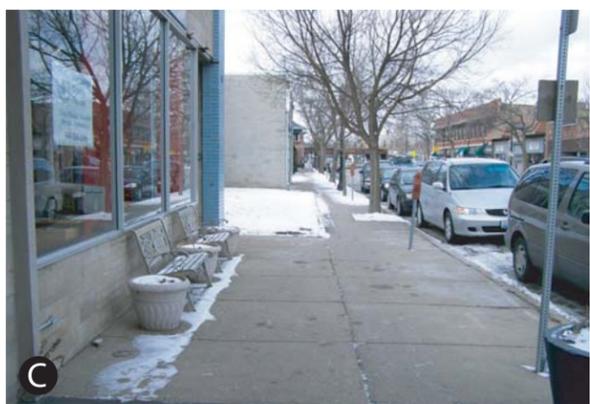
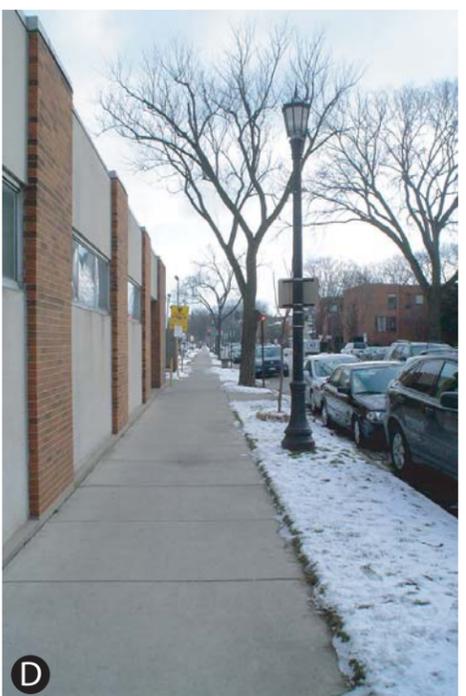
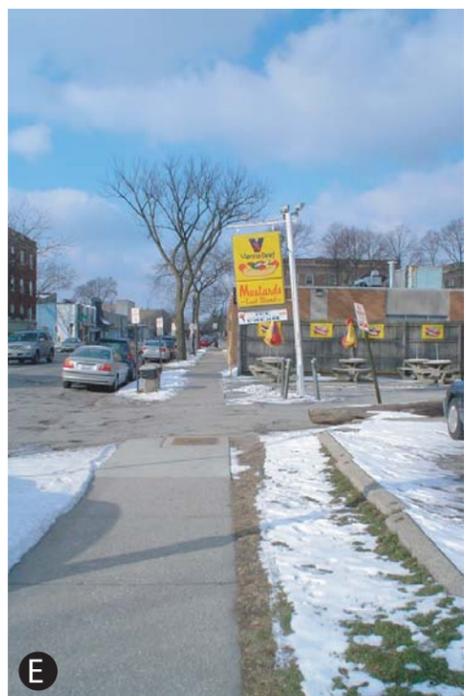
Figure 1.8: Streetscape Conditions - Green Bay Road to Ashland Avenue

Green Bay to Ashland

- The Metra station area lacks benches/seating and has numerous unorganized newspaper boxes. It also lacks designated drop-off areas.
- The auto body shop parking lot at Poplar and Broadway lacks screening and landscaping.
- Commercial blocks between Poplar and Eastwood lack uniform sidewalks, landscaping, and street furniture. Some of the Ash trees are in poor condition and/or form and are susceptible to disease.
- The Northwestern University stadium parking lot lacks landscaping and screening along Central. The lot also has drainage issues and lacks screening from adjacent single-family homes. Although the sidewalk along Central is in good condition, fencing, posts and landscaping around the lot are deteriorating.
- Sidewalks, parkways, and street trees are in good condition along residential blocks.

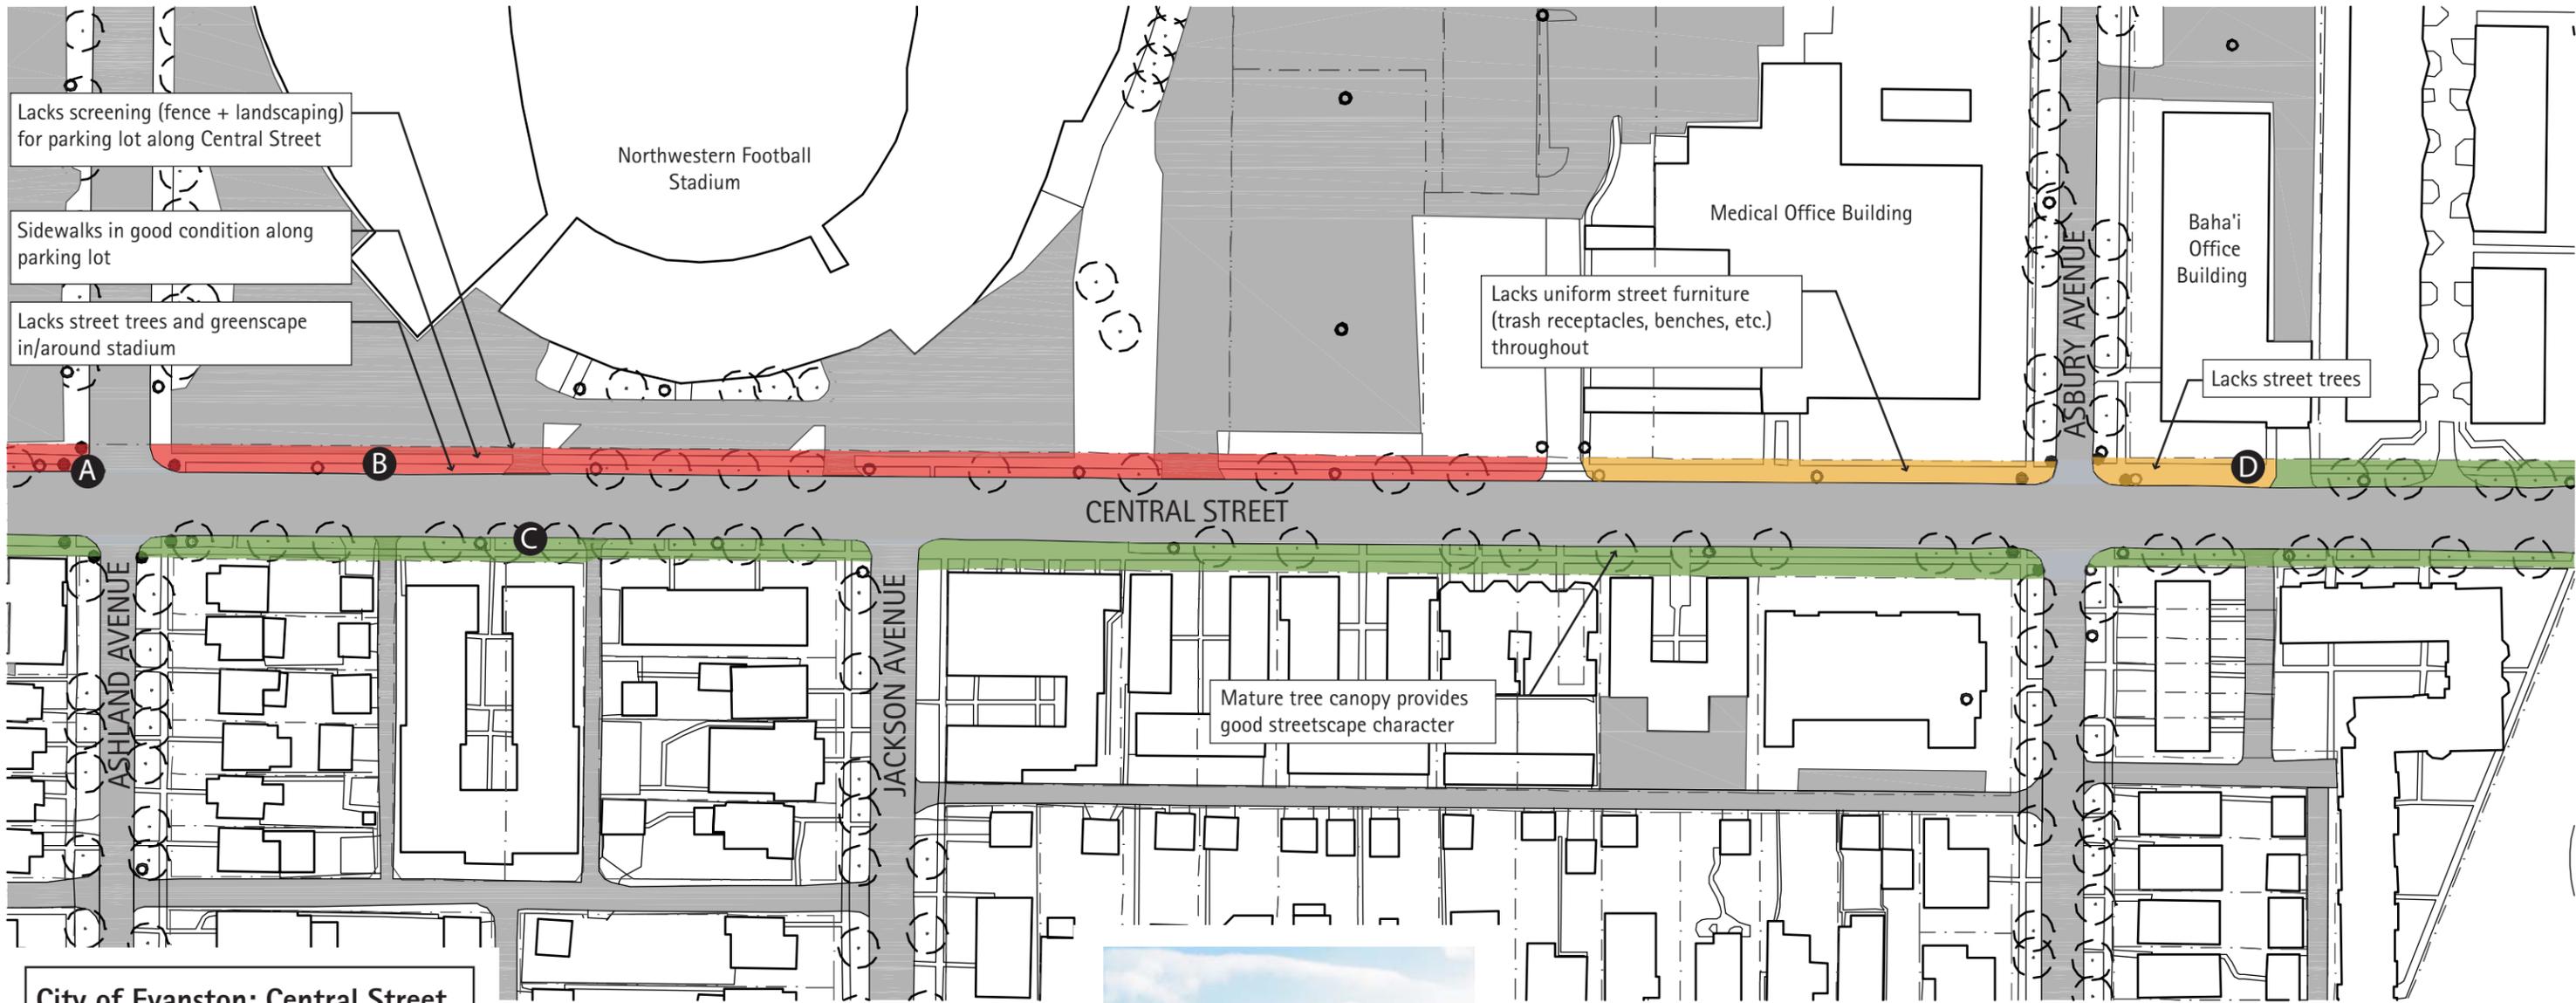
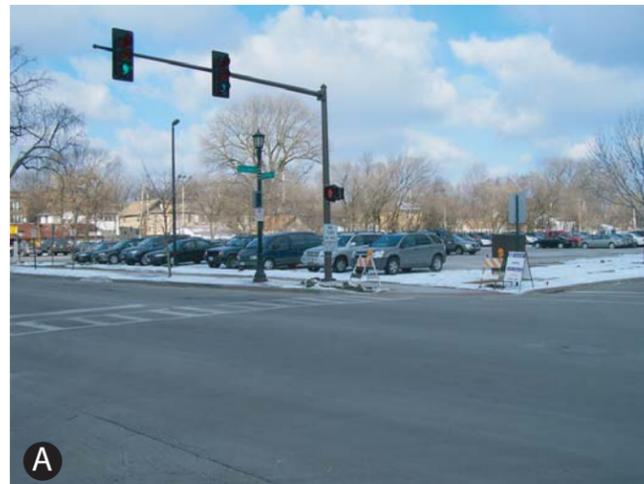
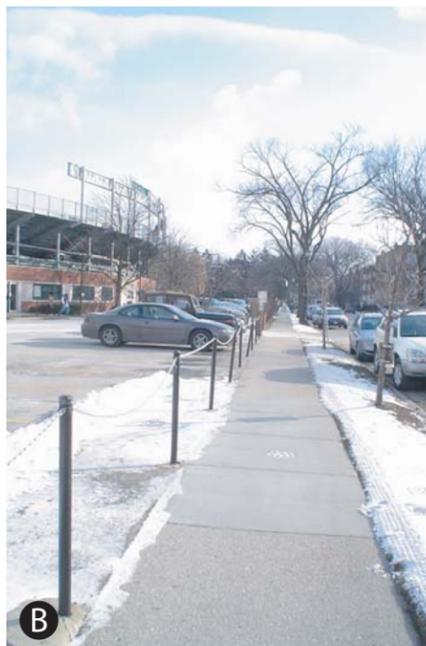
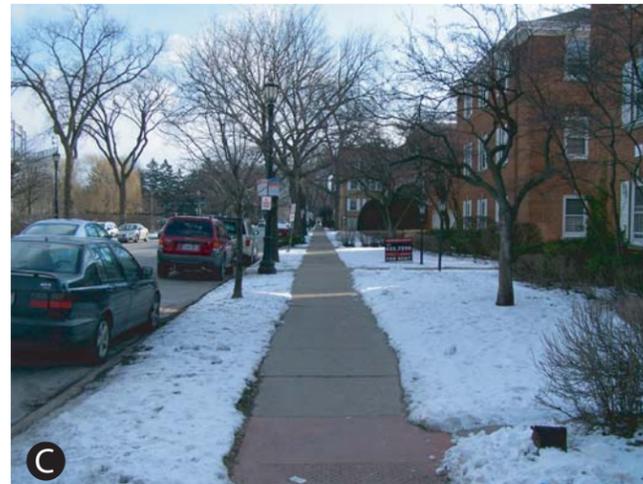
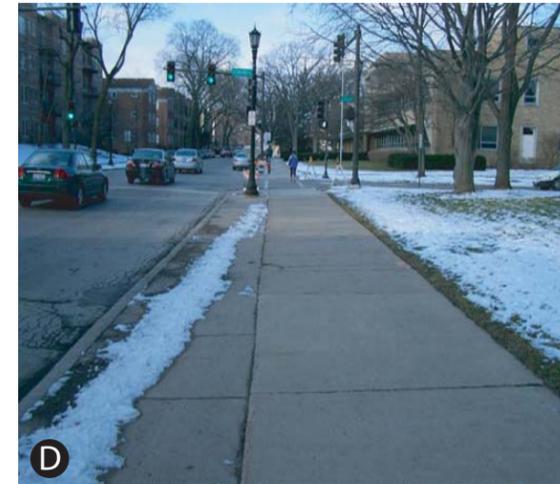
Figure 1.9: Streetscape Conditions - Ashland Avenue to Bryant Avenue

Ashland to Asbury

- The Northwestern University parking lot to the east of the stadium also lacks landscaping for the parking lot internally and along Central. The sidewalk along Central is in good condition.
- Street trees are in good to very good condition along residential blocks. The continuous mature tree canopy provides an attractive streetscape character throughout the residential blocks.

- Sidewalks and parkways are in good condition.

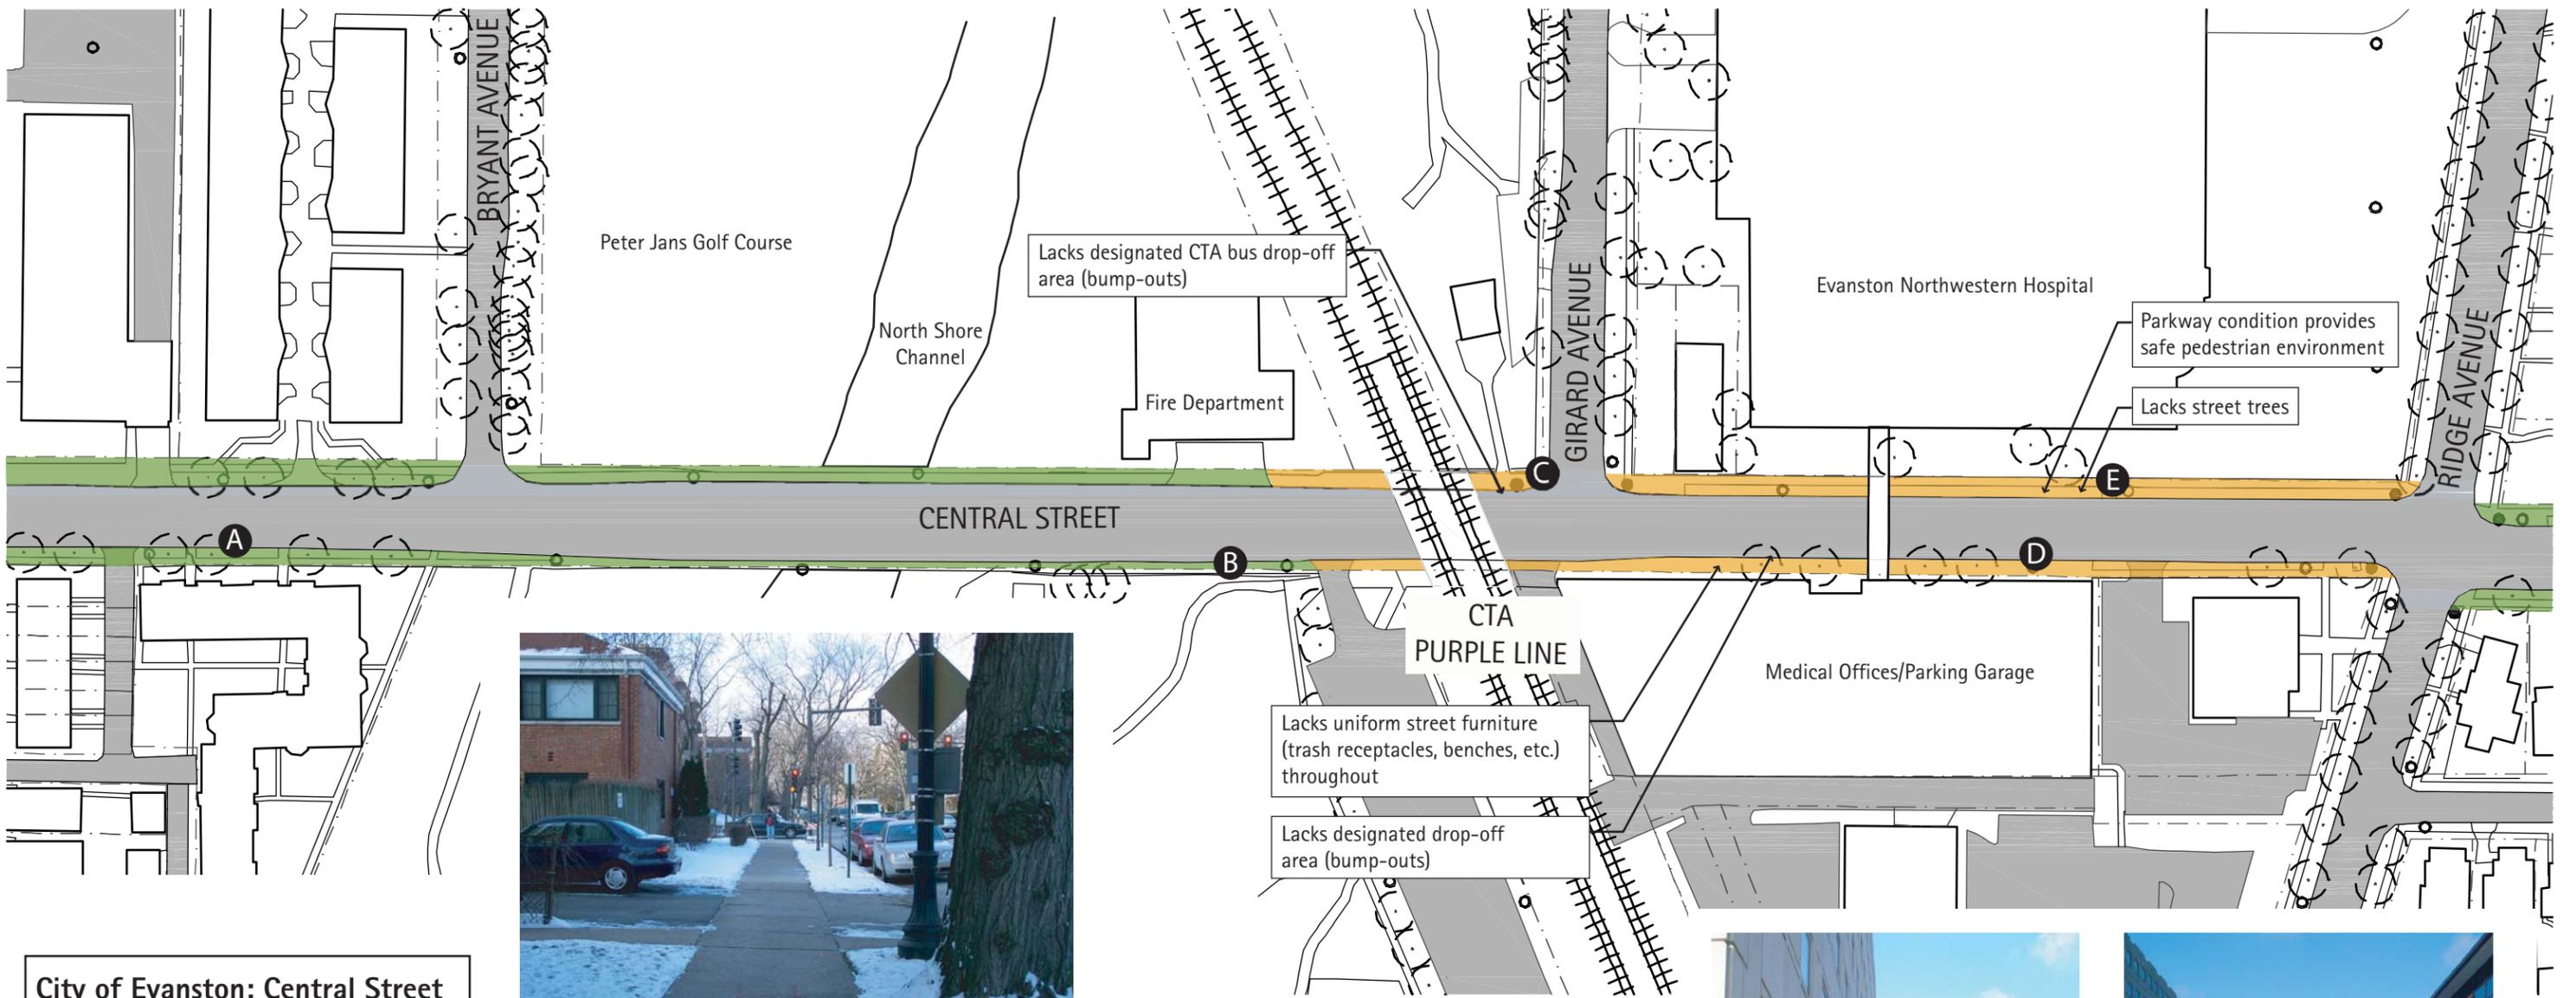
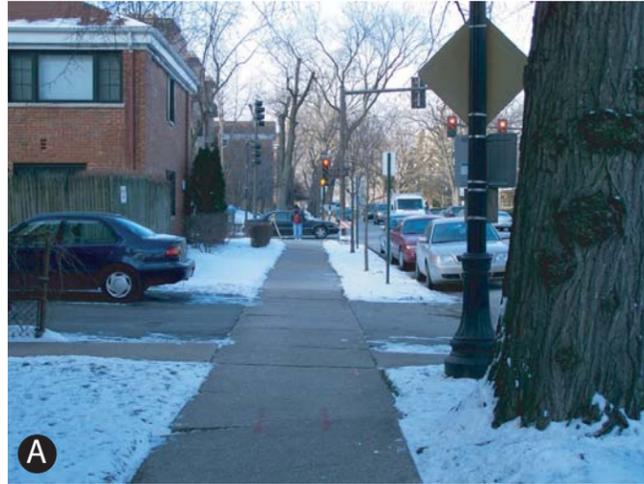
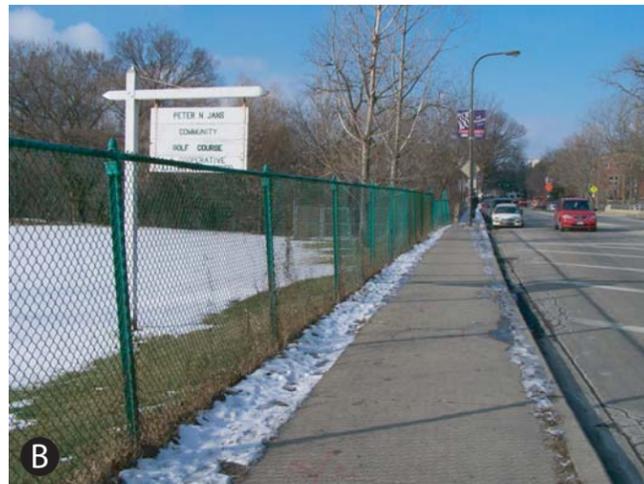
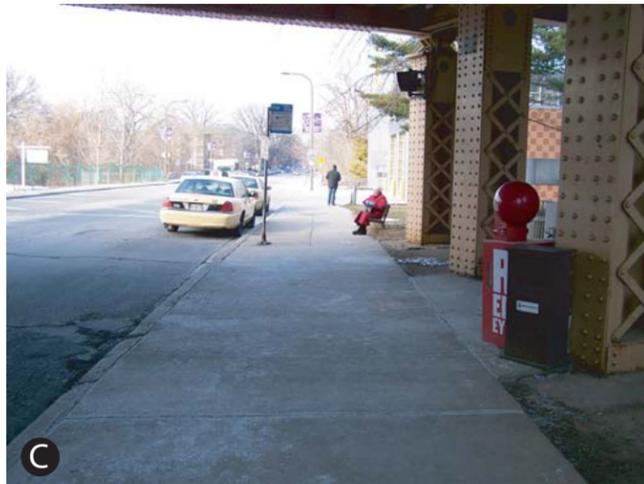
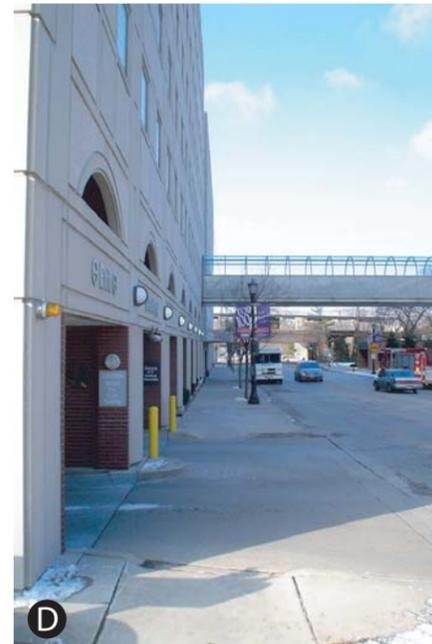
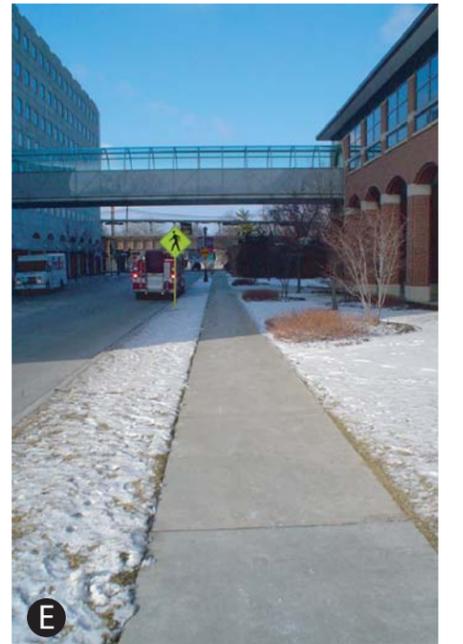
Figure 1.10: Streetscape Conditions - Bryant Avenue to Ridge Avenue

Bryant to Ridge

- The CTA station lacks designated bus and car drop-off zones.
- Streetscape in the block between Girard and Ridge lacks uniform sidewalks, street trees, and street furniture.
- The fence at the entrance to the Chandler-Newberger Community Center parking lot obstructs sight lines of exiting vehicles.
- The northwest corner of Girard next to the CTA station and golf course starter shack is unattractive and deteriorating. The sidewalk along Central is narrow.
