# PARKS STRATEGIC PLAN

## PARKS/FORESTRY and RECREATION DEPARTMENT

City of Evanston, Illinois

### RECOMMENDED PARK IMPROVEMENTS AND COSTS

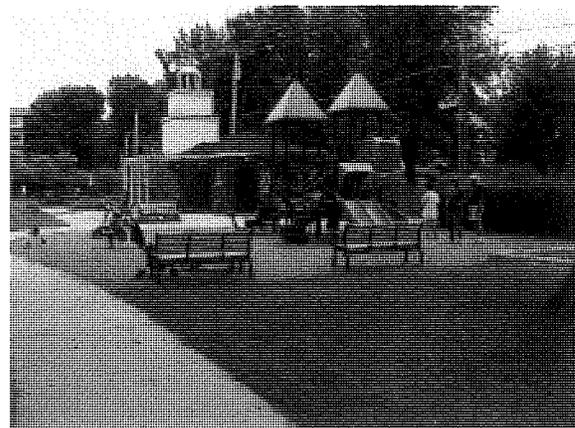
Ackerman Park – Building and Playground

- concrete surfacing in front of restroom building in poor and uneven condition
- turf areas around the building and open area are level and poorly drained creating poor turf conditions
- tennis court surfacing is cracked and in poor condition
- tennis court fencing is old and rusted
- tennis court posts and nets are old and worn
- the existing sign at the corner is old and outdated – too large for the area
- five benches are old and do not match newly installed benches
- trash receptacles are painted 55 gallon drums
- street trees along Central Avenue and McDaniel Street need to be added
- recently installed planting beds need to be increased in the number of shrubs

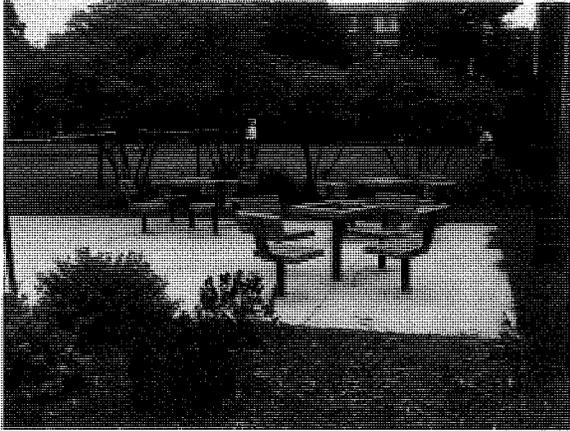
*Ackerman Park – Seating Area and Tennis Courts*

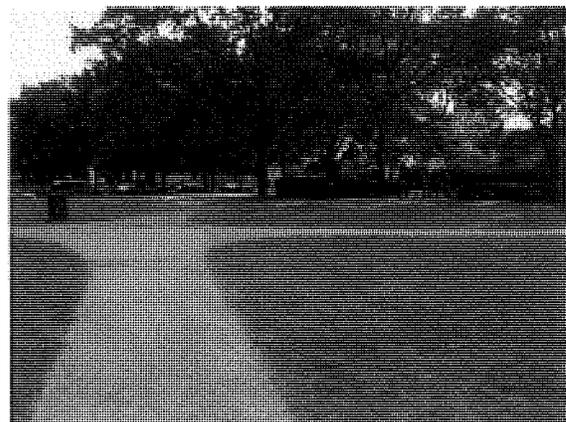
Alexander Park – Walkways

- pedestrian lighting is in poor condition and very ineffective/inefficient
- the concrete paving in the seating area is in poor condition, cracked, and uneven
- the asphalt path through the park is narrow and in poor condition
- the existing sign at the corner is old and outdated – too large for the area
- six benches are old and in poor condition
- trash receptacles are painted 55 gallon drums
- the drinking fountain is not ADA compliant
- the chain link fence along the north property boundary is old and rusted
- the existing playground structures are old, do not comply with safety guidelines, and are not ADA compliant

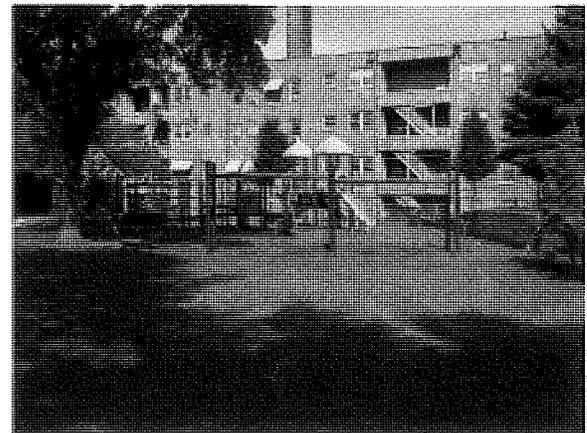
- turf areas around the building and open area are level and poorly drained creating poor turf conditions
- concrete surfacing in front of restroom building and the entrance from the alley is in poor and uneven condition
- the limestone path along the east boundary is narrow and in poor condition
- the softball field backstop is small and in poor condition
- basketball court asphalt surfacing is cracked and in poor condition
- the existing sign at the corner is old and outdated – too large for the area
- existing benches are old and in poor condition
- trash receptacles are painted 55 gallon drums
- the drinking fountain is not ADA compliant
- the chain link fence along the east property boundary is old and rusted
- the existing playground equipment is old, does not comply with safety guidelines, and are not ADA compliant

Baker Park - Playground

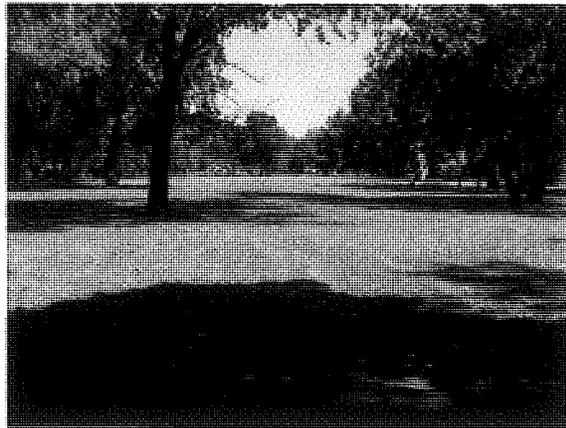
*Beck Park – View North*

- turf areas are level and poorly drained creating poor turf conditions
- concrete pavement at northeast corner is cracked, uneven and in poor condition
- the asphalt path through park is narrow and in poor condition
- the existing playground structures are old, do not comply with safety guidelines, and are not ADA compliant
- brick paving providing access to playground is in poor condition and uneven surfacing
- chain link fencing along west property boundary (canal) is rusted and in poor condition
- the existing sign at the corner is old and outdated – too large for the area
- existing benches are old and in poor condition
- trash receptacles are painted 55 gallon drums
- trees are old and several have been removed

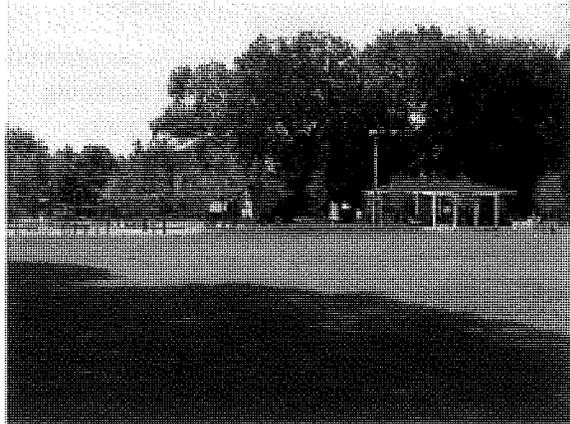
*Bent Park – Building and Playground*

- existing lighting around the building and playground is in poor condition and inefficient
- the asphalt service drive to the building is in poor condition
- tennis court color surfacing is worn
- tennis court fencing is old and in poor condition
- the basketball surfacing is in poor condition and cracked
- basketball and tennis courts do not have an accessible path
- soccer field needs to be regarded for better drainage
- the existing sign on Central Avenue is old and outdated – too large for the area
- existing benches are old and in poor condition
- trash receptacles are painted 55 gallon drums
- existing bus shelter on Central Avenue is in poor condition and poorly located in relationship to the park
- street trees are lacking along Central Avenue, Cowper Avenue, and Hastings Avenue
- trash receptacles are painted 55 gallon drums
- trees are old and several have been removed

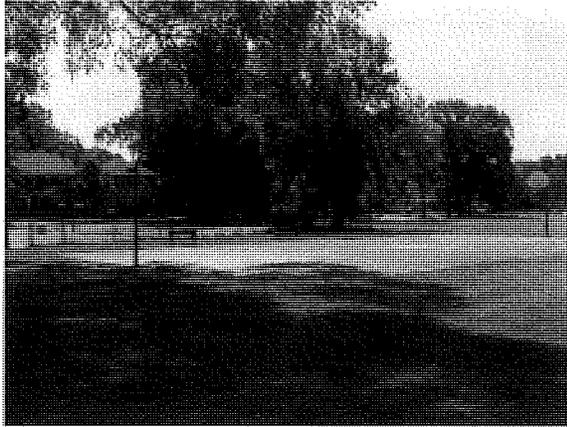
*Bent Park – Basketball and Tennis Courts*

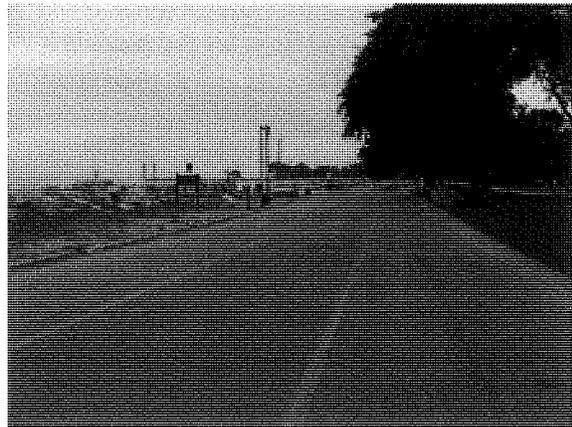
- dog beach is not ADA accessible
- the entrance drive needs to be resurfaced – paving is in poor condition
- parking lot for boat users is in poor condition – needs to be resurfaced and new curbing
- the concrete ramp for boat access is not long enough due to the low level of Lake Michigan
- the rip-rap breakwater needs to be modified
- signage for the breakwater needs to be modified and updated
- gates and fencing for the breakwater are in poor condition and need upgrading

*Boat Ramp – Access Drive and Boat Ramp*

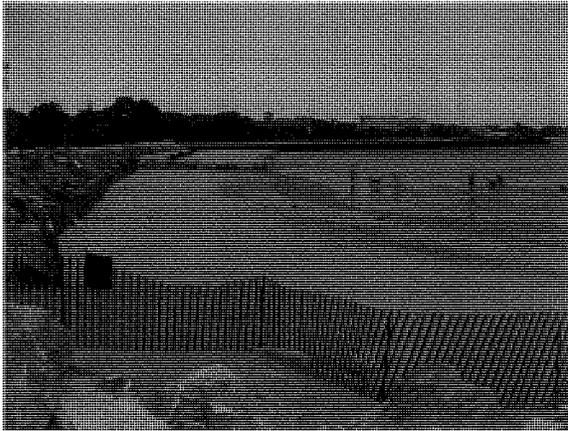
Boat Ramp – Dog Beach

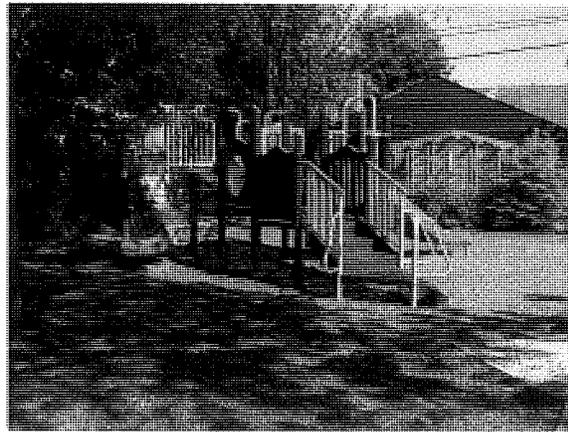
**Figure 9: Brummel-Richmond Totlot**

- portions of the exterior sidewalk are poor condition
- the existing chain link fencing along the north boundary is rusted and in poor condition
- existing benches are old and in poor condition
- trash receptacles are painted 55 gallon drums

*Brummel-Richmond Totlot*

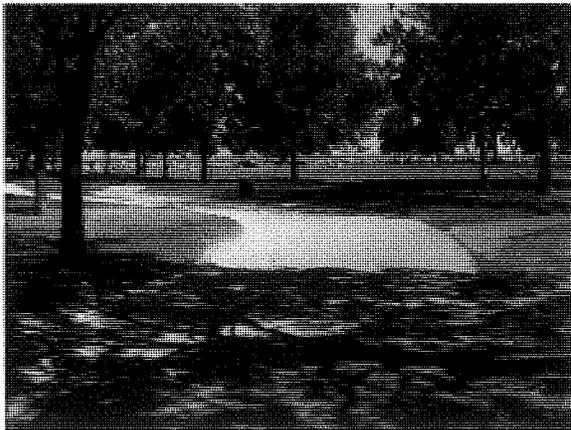
- turf areas are level and poorly drained creating poor turf conditions
- existing light fixtures are inadequate and inefficient
- existing limestone path and edging is in poor condition
- the existing cinder path and edging is in poor condition

*Burnham Shores Park – Path and Picnic Areas*

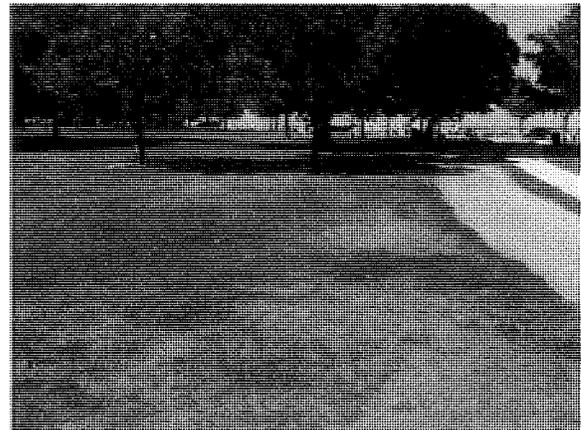
*Burnham Shores Park - Paths*

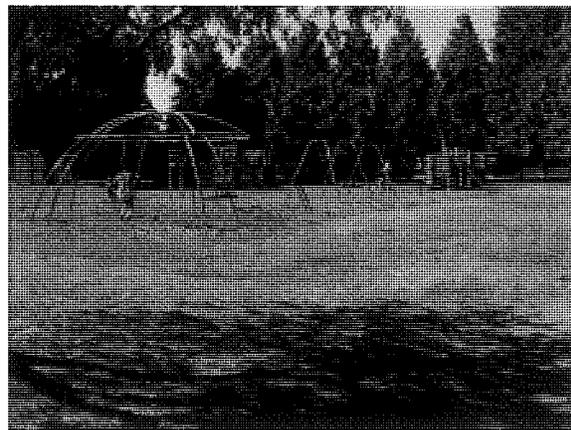
- play equipment, edging, and surfacing

*Burnham Shores Park - Playground*

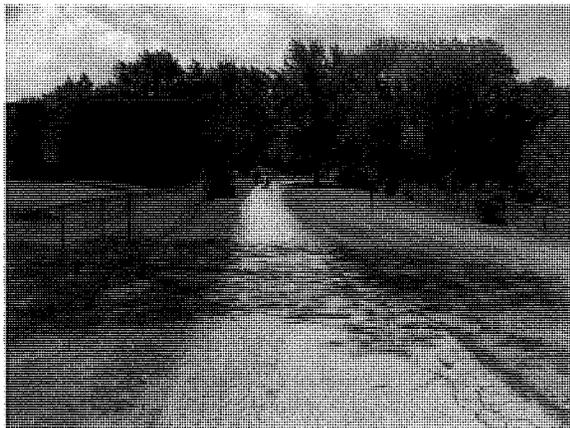
- turf areas are level and poorly drained creating poor turf conditions
- pathway through park is not lit
- asphalt path is in poor condition and poorly drained
- the existing playground structures are old, do not comply with safety guidelines, and are not ADA compliant
- the existing sign on Emerson Street is old and outdated – too large for the area
- chain link fencing along west property boundary (canal) is rusted and in poor condition
- existing benches are old and in poor condition
- trash receptacles are painted 55 gallon drums
- trees are old and several have been removed
- the telephone pole barriers along Hartrey and Grey Avenues are in poor condition and inappropriate

*Butler Park – Pathway at North End*

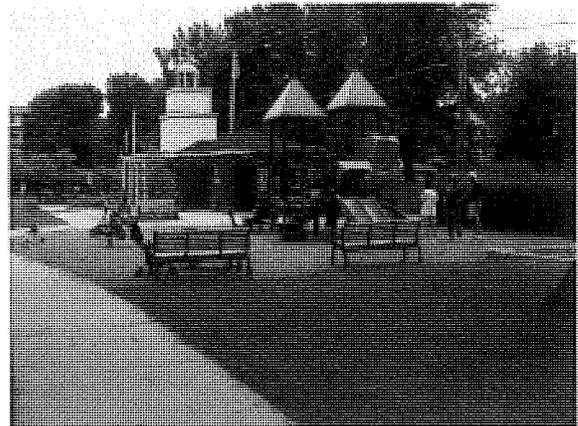
Ackerman Park – Building and Playground

- concrete surfacing in front of restroom building in poor and uneven condition
- turf areas around the building and open area are level and poorly drained creating poor turf conditions
- tennis court surfacing is cracked and in poor condition
- tennis court fencing is old and rusted
- tennis court posts and nets are old and worn
- the existing sign at the corner is old and outdated – too large for the area
- five benches are old and do not match newly installed benches
- trash receptacles are painted 55 gallon drums
- street trees along Central Avenue and McDaniel Street need to be added
- recently installed planting beds need to be increased in the number of shrubs

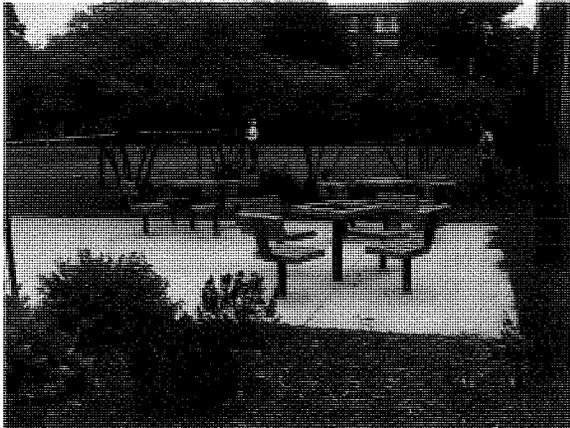
*Ackerman Park – Seating Area and Tennis Courts*

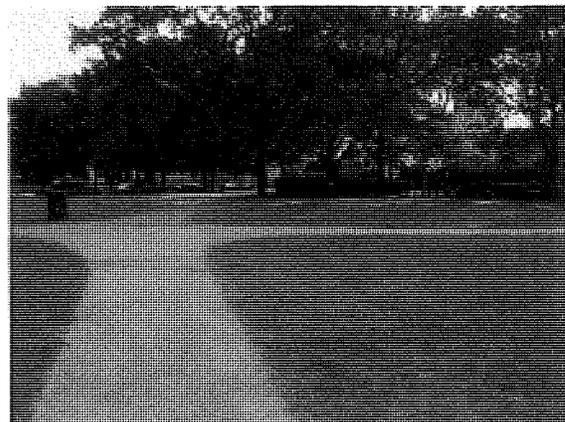
Alexander Park – Walkways

- pedestrian lighting is in poor condition and very ineffective/inefficient
- the concrete paving in the seating area is in poor condition, cracked, and uneven
- the asphalt path through the park is narrow and in poor condition
- the existing sign at the corner is old and outdated – too large for the area
- six benches are old and in poor condition
- trash receptacles are painted 55 gallon drums
- the drinking fountain is not ADA compliant
- the chain link fence along the north property boundary is old and rusted
- the existing playground structures are old, do not comply with safety guidelines, and are not ADA compliant

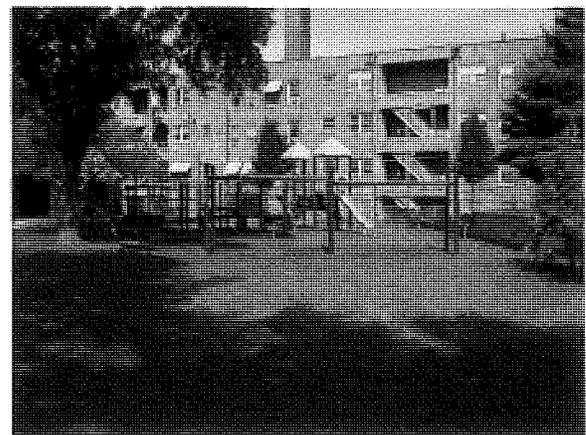
- turf areas around the building and open area are level and poorly drained creating poor turf conditions
- concrete surfacing in front of restroom building and the entrance from the alley is in poor and uneven condition
- the limestone path along the east boundary is narrow and in poor condition
- the softball field backstop is small and in poor condition
- basketball court asphalt surfacing is cracked and in poor condition
- the existing sign at the corner is old and outdated – too large for the area
- existing benches are old and in poor condition
- trash receptacles are painted 55 gallon drums
- the drinking fountain is not ADA compliant
- the chain link fence along the east property boundary is old and rusted
- the existing playground equipment is old, does not comply with safety guidelines, and are not ADA compliant

Baker Park - Playground

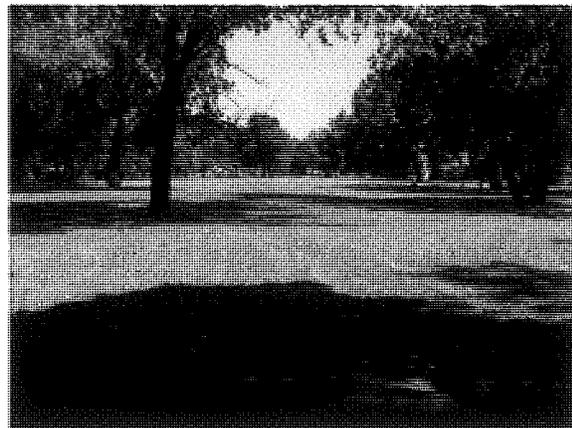
*Beck Park – View North*

- turf areas are level and poorly drained creating poor turf conditions
- concrete pavement at northeast corner is cracked, uneven and in poor condition
- the asphalt path through park is narrow and in poor condition
- the existing playground structures are old, do not comply with safety guidelines, and are not ADA compliant
- brick paving providing access to playground is in poor condition and uneven surfacing
- chain link fencing along west property boundary (canal) is rusted and in poor condition
- the existing sign at the corner is old and outdated – too large for the area
- existing benches are old and in poor condition
- trash receptacles are painted 55 gallon drums
- trees are old and several have been removed

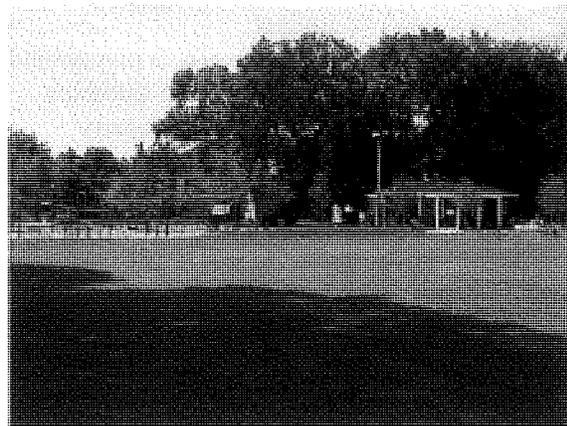
*Bent Park – Building and Playground*

- existing lighting around the building and playground is in poor condition and inefficient
- the asphalt service drive to the building is in poor condition
- tennis court color surfacing is worn
- tennis court fencing is old and in poor condition
- the basketball surfacing is in poor condition and cracked
- basketball and tennis courts do not have an accessible path
- soccer field needs to be regarded for better drainage
- the existing sign on Central Avenue is old and outdated – too large for the area
- existing benches are old and in poor condition
- trash receptacles are painted 55 gallon drums
- existing bus shelter on Central Avenue is in poor condition and poorly located in relationship to the park
- street trees are lacking along Central Avenue, Cowper Avenue, and Hastings Avenue
- trash receptacles are painted 55 gallon drums
- trees are old and several have been removed

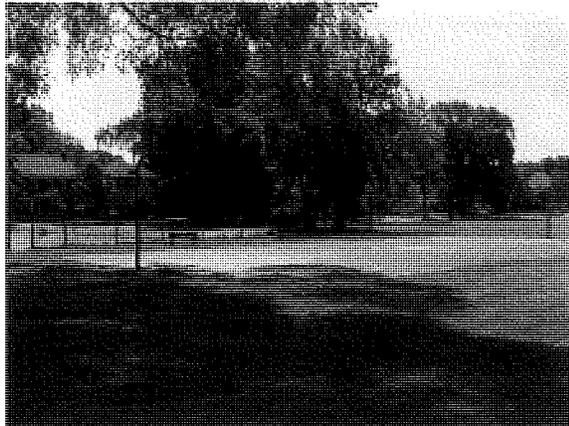
*Bent Park – Basketball and Tennis Courts*

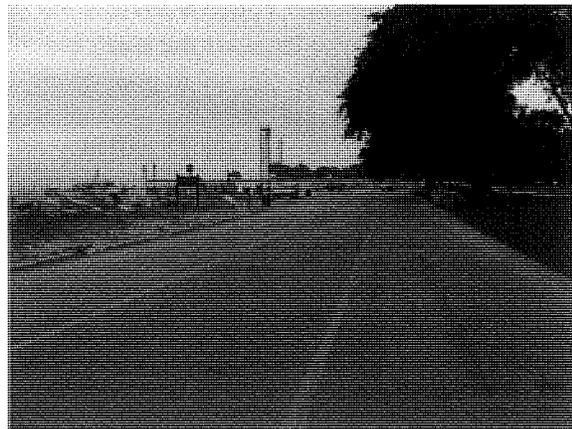
- dog beach is not ADA accessible
- the entrance drive needs to be resurfaced – paving is in poor condition
- parking lot for boat users is in poor condition – needs to be resurfaced and new curbing
- the concrete ramp for boat access is not long enough due to the low level of Lake Michigan
- the rip-rap breakwater needs to be modified
- signage for the breakwater needs to be modified and updated
- gates and fencing for the breakwater are in poor condition and need upgrading

*Boat Ramp – Access Drive and Boat Ramp*

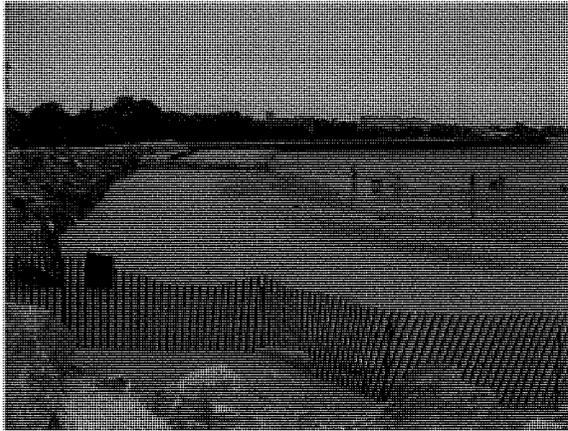
Boat Ramp – Dog Beach

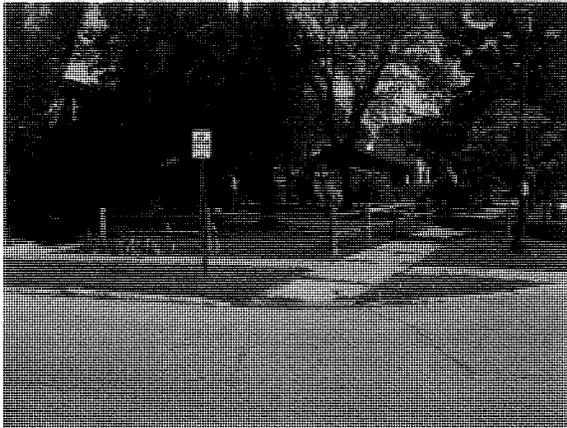
*Brummel-Richmond Totlot – View North*

- portions of the exterior sidewalk are poor condition
- the existing chain link fencing along the north boundary is rusted and in poor condition
- existing benches are old and in poor condition
- trash receptacles are painted 55 gallon drums

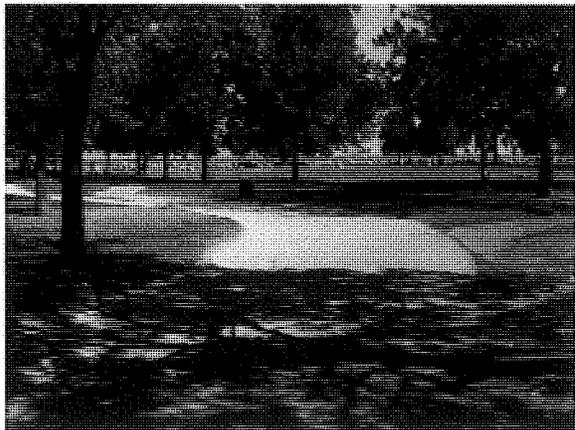
- turf areas are level and poorly drained creating poor turf conditions
- existing light fixtures are inadequate and inefficient
- existing limestone path and edging is in poor condition
- the existing cinder path and edging is in poor condition

*Burnham Shores Park – Path and Picnic Areas*

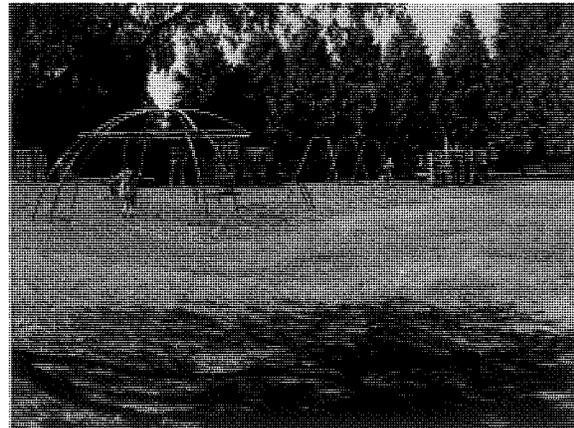
- tennis court surfacing is cracked and in poor condition
- tennis court fencing is old and rusted
- tennis court posts and nets are old and worn
- the existing playground structures are old, do not comply with safety guidelines, and are not ADA compliant
- existing benches are old and in poor condition
- trash receptacles are painted 55 gallon drums
- drinking fountain is not ADA compliant
- trees are old and several have been removed
- picnic tables are old and not ADA compliant

*Burnham Shores Park - Playground*

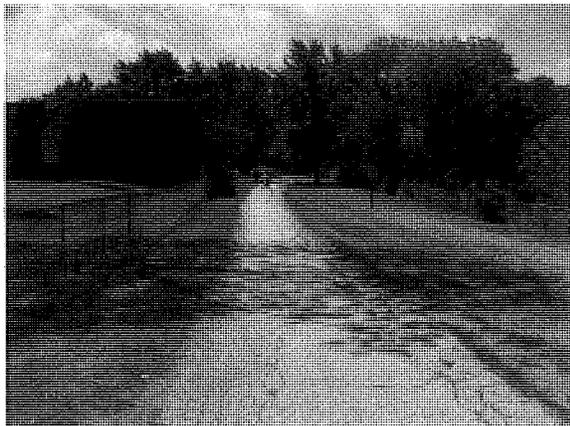
- turf areas are level and poorly drained creating poor turf conditions
- pathway through park is not lit
- asphalt path is in poor condition and poorly drained
- the existing playground structures are old, do not comply with safety guidelines, and are not ADA compliant
- the existing sign on Emerson Street is old and outdated – too large for the area
- chain link fencing along west property boundary (canal) is rusted and in poor condition
- existing benches are old and in poor condition
- trash receptacles are painted 55 gallon drums
- trees are old and several have been removed
- the telephone pole barriers along Hartrey and Grey Avenues are in poor condition and inappropriate

*Butler Park – Pathway at North End*

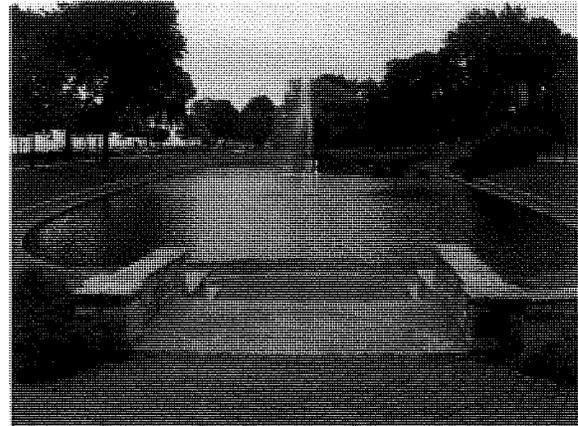
- the existing light fixtures are inadequate and inefficient
- the lagoon pump system is old and in poor condition
- the cinder path and edging is in poor condition
- the limestone path and edging is in poor condition
- brick paving around the lagoon is uneven and in poor condition
- lagoon bottom is in poor condition
- entrance to Greenwood Beach is in poor condition and ineffective
- ADA accessibility to the beach is lacking

Dawes Park - Lagoon

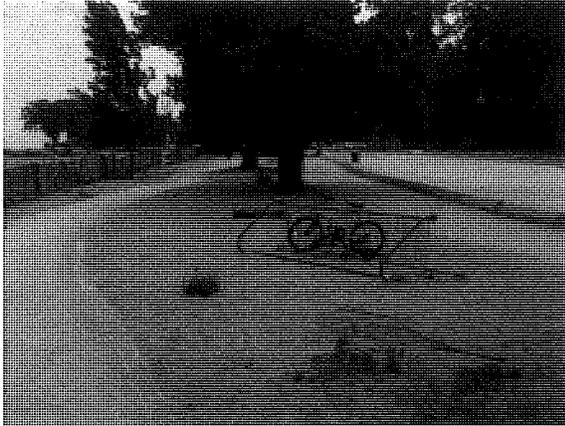
*Greenwood Beach – Path System and Fencing*

- the existing asphalt pavement through the park is in poor condition
- the existing signs (2) are in poor condition and inappropriate to the park and beach
- existing benches are old and in poor condition
- trash receptacles are painted 55 gallon drums
- bike parking areas are in poor condition
- picnic tables are in poor condition and not ADA compliant
- the snow fencing along the beach for control is in poor control and ineffective
- access to the breakwater is dangerous

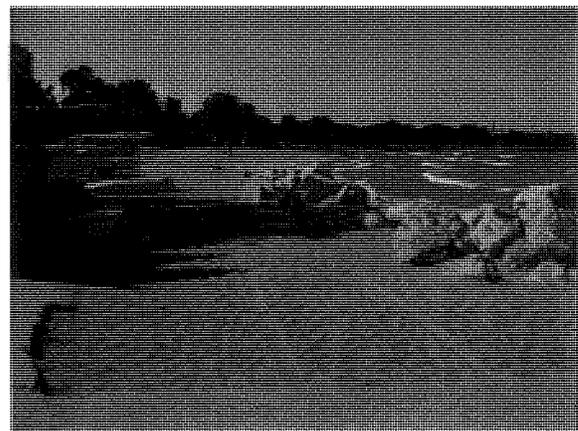
- the existing light fixtures are inadequate and inefficient
- entrance to Dempster Street Beach is in poor condition and ineffective
- the limestone path and edging is in poor condition
- the parking area is in poor condition and inefficient
- paths and drives are poorly designed
- bike parking areas are in poor condition
- the existing sign is in poor condition and inappropriate to the park and beach
- access to the breakwater is dangerous
- ADA accessibility to the beach is lacking
- the existing asphalt pavement through the park is in poor condition
- trash receptacles are painted 55 gallon drums
- the snow fencing along the beach for control is in poor control and ineffective

*Dempster Street Beach*

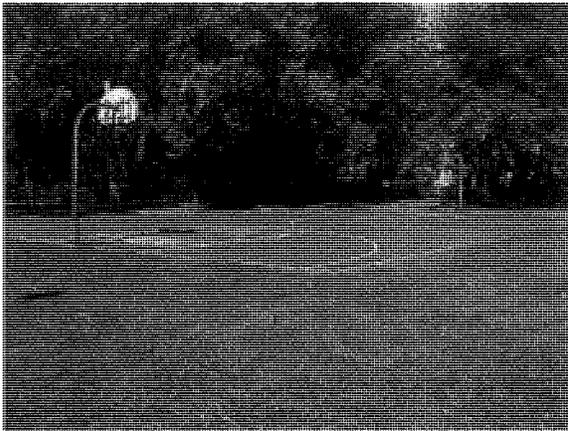
*Eggleston Park – Basketball Court*

- turf area are level and poorly drained creating poor turf conditions
- existing lighting fixtures in poor condition and inefficient
- exterior concrete sidewalks in poor condition
- existing limestone path is in poor condition
- basketball court surfacing is in poor condition
- benches are old and in poor condition
- trash receptacles are painted 55 gallon drums
- drinking fountain is not ADA compliant
- playground structures are not ADA compliant and do not comply with safety guidelines
- the existing sign is in poor condition and inappropriate to the park

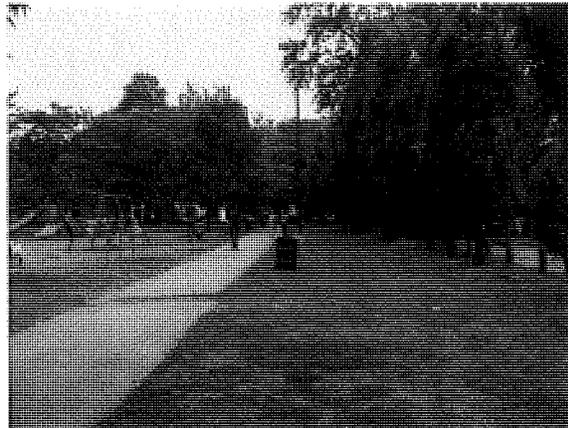
*Eiden Park – Path North-South*

- turf area are level and poorly drained creating poor turf conditions
- asphalt paving around drinking fountain and playground is in poor condition
- main asphalt path through park is in poor condition
- playground structures are not ADA compliant and do not comply with safety guidelines
- the existing sign is in poor condition and inappropriate to the park
- trash receptacles are painted 55 gallon drums

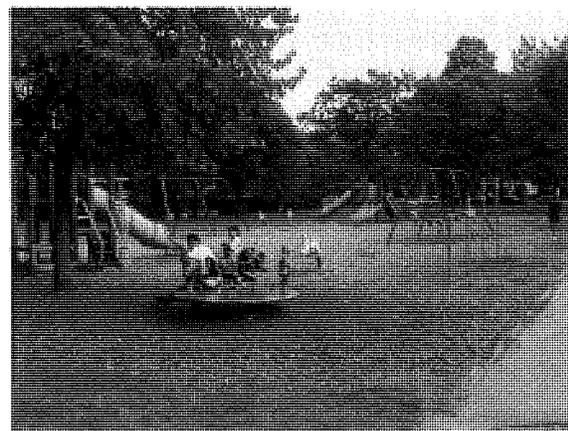
*Eiden Park - Playground*

- benches are old and in poor condition

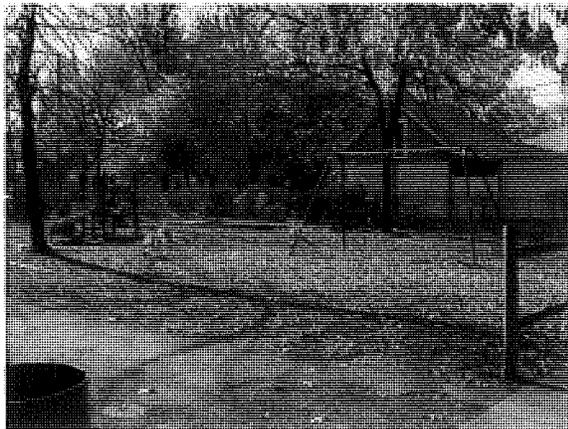
- main asphalt path through park is in poor condition
- playground structures are not ADA compliant and do not comply with safety guidelines

Fireman's Park - Playground

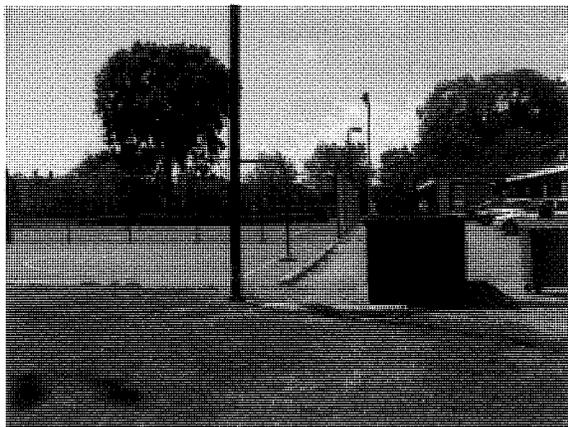
*Foster Field – Basketball Courts and Service Area*

- turf areas are level and poorly drained creating poor turf conditions
- existing lighting is poor and inefficient
- parking lot is poorly designed and inadequate
- pick-up/drop-off area is inadequate
- tennis court surfacing is in poor condition
- tennis court fencing is in poor condition
- basketball court surfacing is in poor condition
- baseball field lighting is inefficient
- ballfield backstops, dugouts, field fencing and bleachers are in poor condition
- playground structures are not ADA compliant and do not comply with safety guidelines
- existing chain link fencing is in poor condition
- drinking fountain is not ADA compliant
- the existing sign is in poor condition and inappropriate to the park
- benches are old and in poor condition
- trash receptacles are painted 55 gallon drums

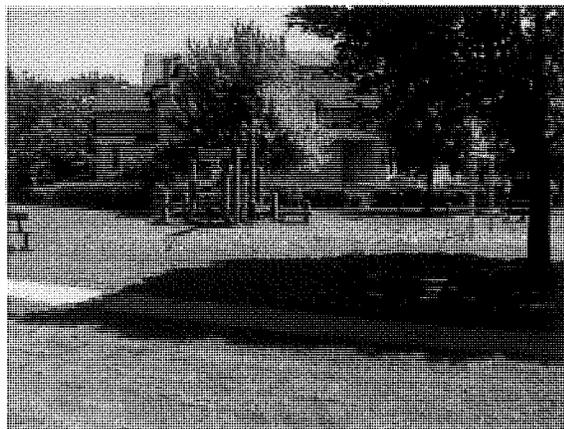
*Gilbert Park - Playground*

- existing asphalt walks are in poor condition
- the limestone path and edging is in poor condition
- existing playground structures are not ADA compliant and do not meet safety guidelines

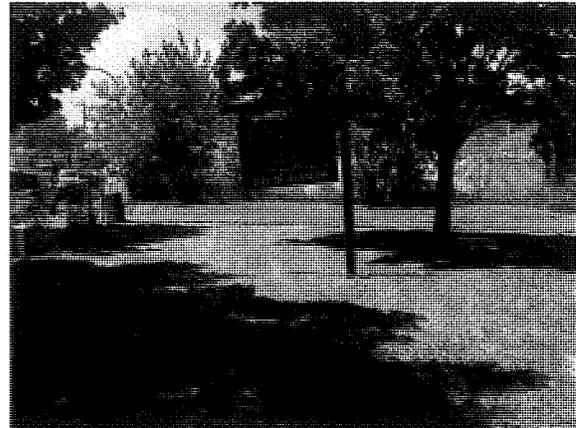
*Gilbert Park – Sign and Entrance to Park*

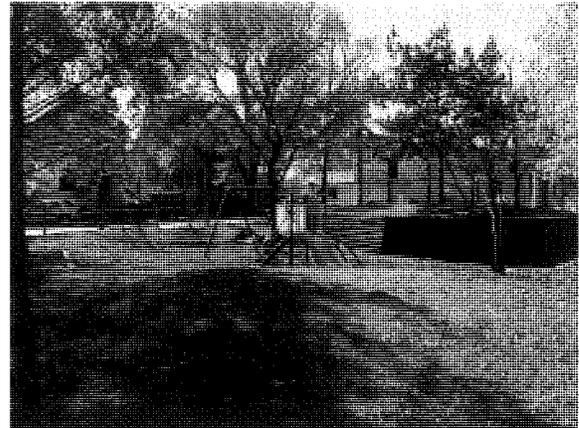
- existing limestone walk to playground is in poor condition
- concrete sidewalk is in poor condition
- existing stairs are in poor condition and unsafe
- existing playground structures are not ADA compliant and do not meet safety guidelines
- the existing sign is in poor condition and inappropriate to the park
- existing benches are old and in poor condition
- existing retaining wall needs to be repaired

Hobart Park - Playground

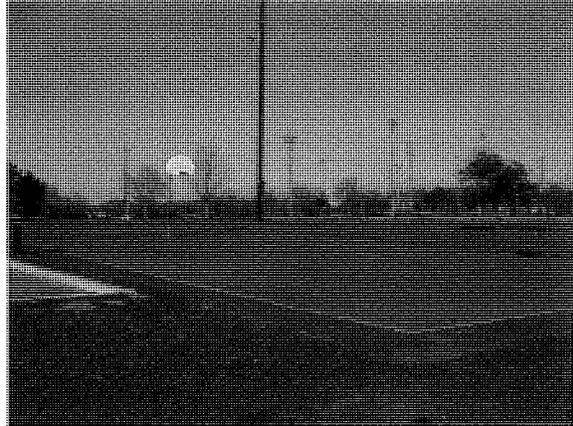
*James Park - Basketball Court*

- athletic turf areas are level and poorly drained creating poor turf conditions
- turf areas lack underdrain system and irrigation system
- no parking lot lighting
- pedestrian system lacks lighting for safety and security
- sledding hill lights are in poor condition and inefficient
- entrance drive and parking lot paving is in poor condition
- tennis court fencing is in poor condition
- tennis court lighting is in poor condition and inefficient
- basketball court surfacing is in poor condition

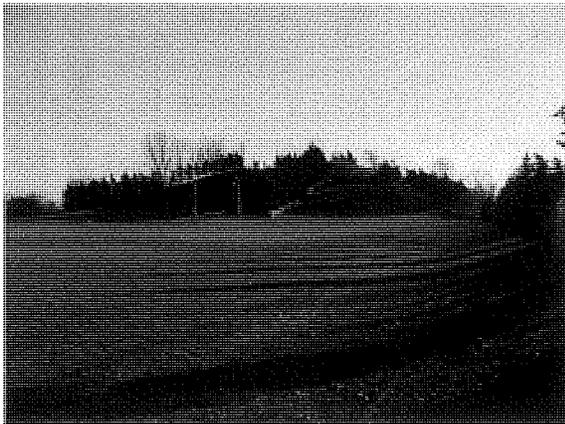
*James Park - Sled Hill*

- hill facilities, including steps, fencing and walls are in poor condition
- athletic field facilities, including backstops, benches, bleachers, and fencing are in poor condition
- the existing signs are in poor condition and inappropriate to the park
- unused ski-hill facilities need to be removed
- existing benches are old and in poor condition
- trash receptacles are painted 55 gallon drums
- picnic table is old and in poor condition
- existing chain link fencing on west side is in poor condition
- fitness station is old and in poor condition
- landscape throughout park is sparse and lacking overall

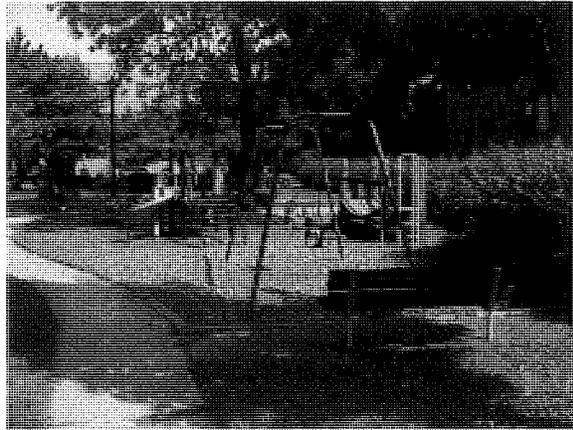
- existing concrete paving is in poor condition
- existing playground structures are not ADA compliant and do not meet safety guidelines
- the existing signs are in poor condition and inappropriate to the park
- existing benches are old and in poor condition

*Kelly Park - Playground*

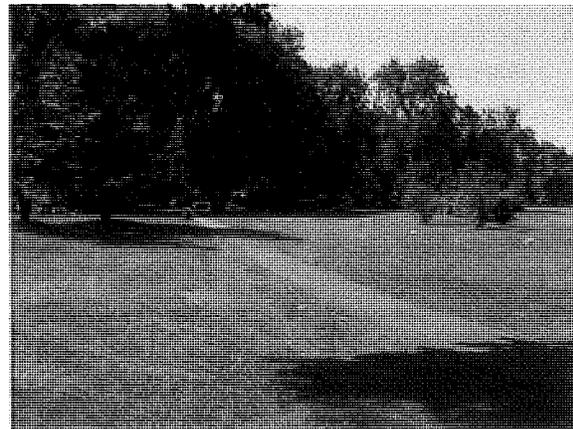
*Leahy Community Park - Path*

- turf athletic fields are level and poorly drained creating poor turf conditions
- existing light fixtures are in poor condition and inefficient
- the existing asphalt path through park is in poor condition
- accessible walks to playground, building, and tennis court are lacking
- tennis court paving, fencing, and lighting is in poor condition
- the existing sign is in poor condition and inappropriate to the park
- existing benches are old and in poor condition
- trash receptacles are painted 55 gallon drums
- drinking fountain is not ADA compliant
- picnic table is old and in poor condition
- ballfield backstop, fencing, benches, and bleachers are in poor condition
- playground is not ADA compliant and does not comply with safety guidelines

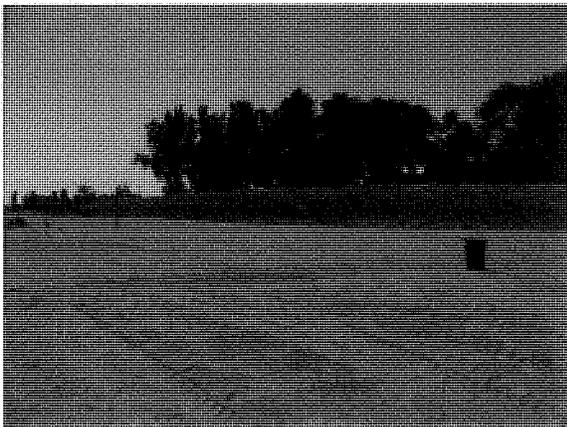
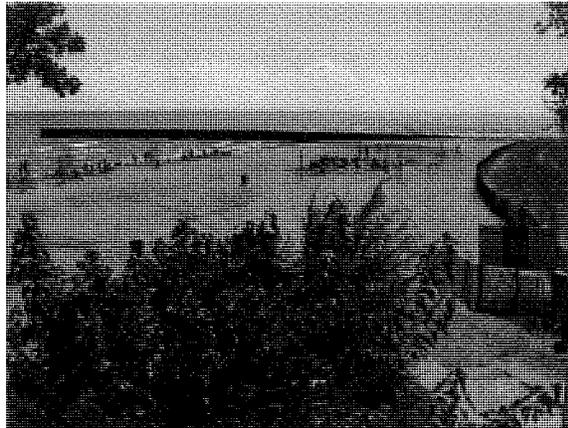
*Lighthouse Landing Beach*

- stone paving is uneven and old – east of Art Center
- entrance to beach is in poor condition and ineffective
- ADA accessibility to the beach is lacking
- parking lot needs sealing and line stripping
- the existing sign is in poor condition and inappropriate to the park and beach
- existing benches are old and in poor condition
- trash receptacles are painted 55 gallon drums
- bike parking areas are in poor condition
- picnic tables are in poor condition and not ADA compliant
- drinking fountain is not ADA compliant
- the snow fencing along the beach for control is in poor condition and ineffective
- access to the breakwater is dangerous

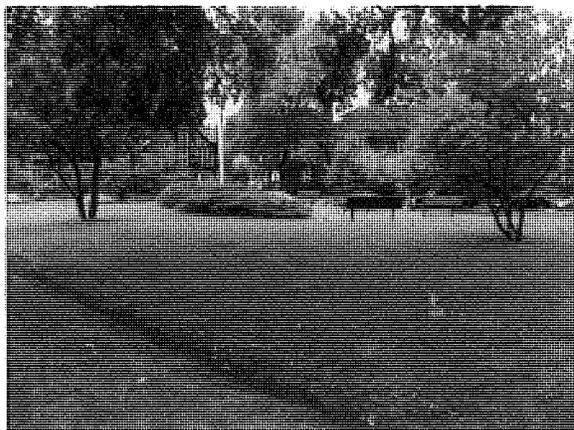
- existing cinder paving and edging is in poor condition
- paving in seating area is in poor condition
- the existing sign is in poor condition and inappropriate to the park
- existing benches are old and in poor condition
- trash receptacles are painted 55 gallon drums
- concrete water trough is in poor condition

*Lunt Park – Seating Area*

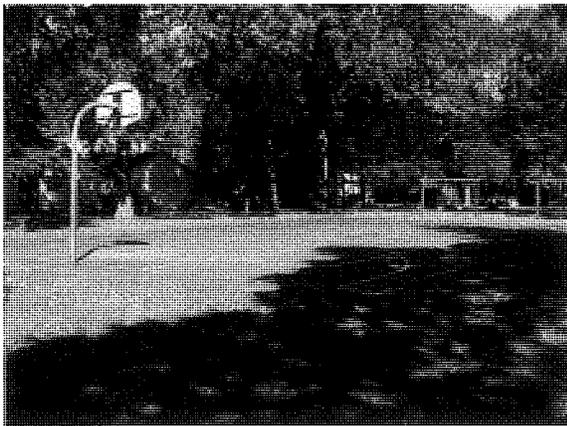
- the existing light fixtures are in poor condition and inefficient.
- limestone screening path are in poor condition.
- basketball court paving and color coating is in poor condition.
- the existing sign should be replaced with a new system sign and related landscape planting.
- existing benches are in poor condition.
- existing trash receptacles are in poor condition.
- existing picnic tables are in poor condition.
- existing drinking fountain is not ADA compliant.
- existing playground equipment does not meet ADA and ASTM safety standards.

McCulloch Park – Basketball Court

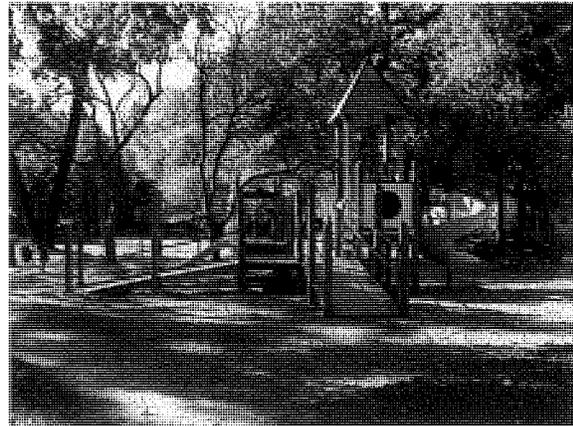
McCulloch Park - Playground

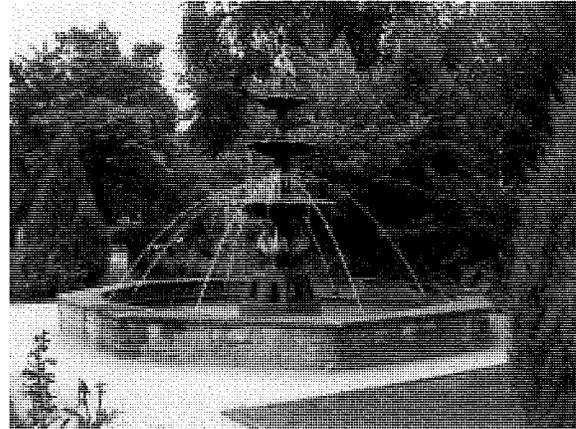
- no pedestrian lighting exists.
- existing irrigation system does not function.
- brick walls are failing.
- the existing sign needs to be upgraded.
- fencing is in poor condition along boundary

*Merrick Rose Garden*

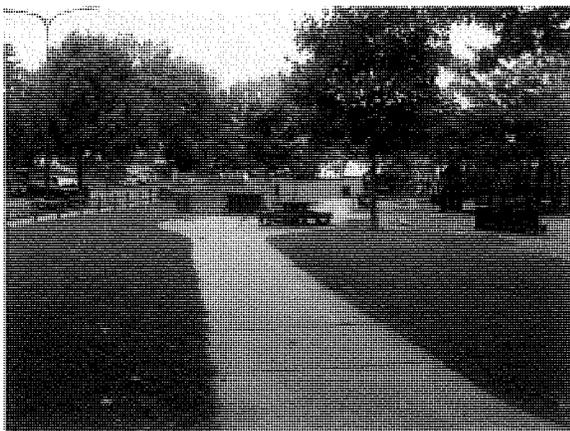
- turf areas should be level and poorly drained creating poor turf conditions.
- the existing sign should be replaced with a new system identification sign and related landscape plantings.
- existing benches throughout the park are in poor condition.
- existing trash receptacles should be replaced throughout the park.
- new bike rack should be installed.

*Penny Park – Playground and Seating Area*

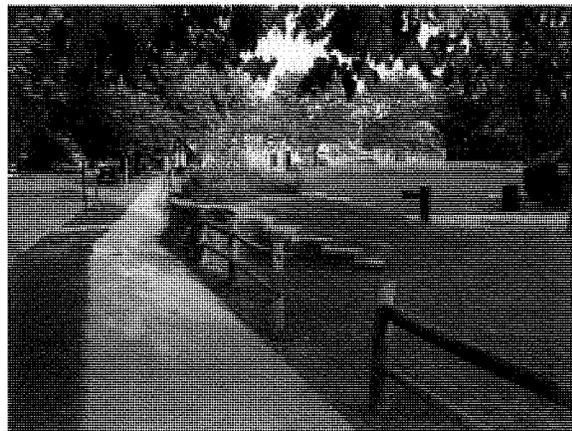
- existing playground equipment should be upgraded and renovated.
- new tree plantings and landscape should be provided throughout the park to replace old trees and those removed.
- existing chain link fencing along the south boundary is in poor condition

*Penny Park – Entrance Area*

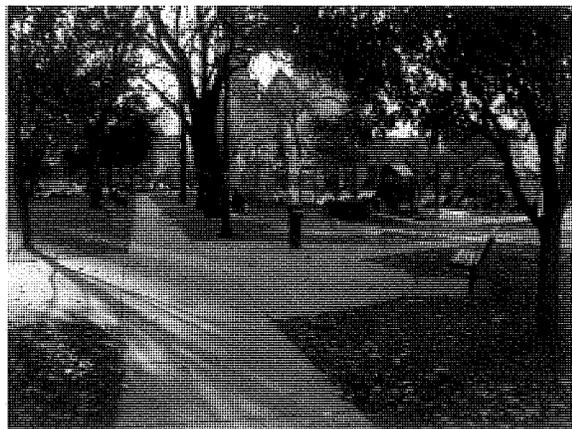
- additional pedestrian lights are needs along the walks.
- edging around sponsor bricks is in poor condition.

*Raymond Park – Paths and Playground*

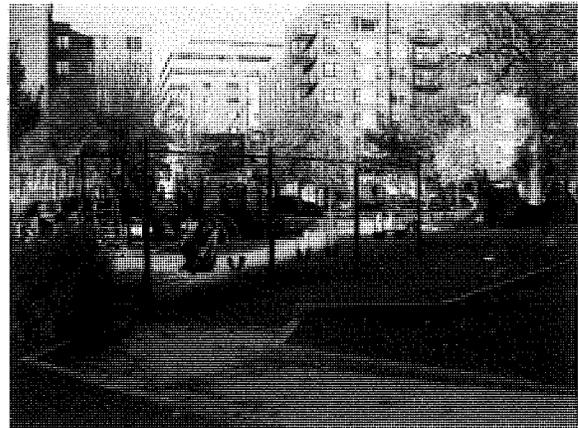
Raymond Park - Playground

- existing playground equipment does not meet ADA and ASTM safety standards.
- the existing signs (two) should be replaced with two new system identification signs and related landscape plantings.
- existing park benches are in poor condition.
- existing trash receptacles should be replaced.

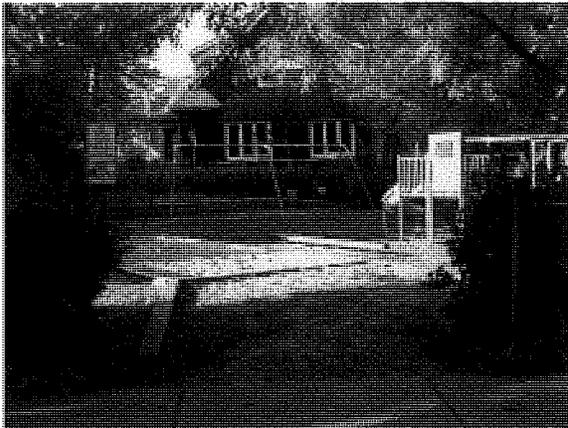
Sargent Park - Playground

- existing benches are in poor condition.
- existing trash receptacle should be replaced.
- existing playground equipment does not meet ADA and ASTM safety standards.
- ADA accessibility to playground equipment is lacking.
- the existing chain link fencing is in poor condition.
- additional trees and landscape should be provided in the park.

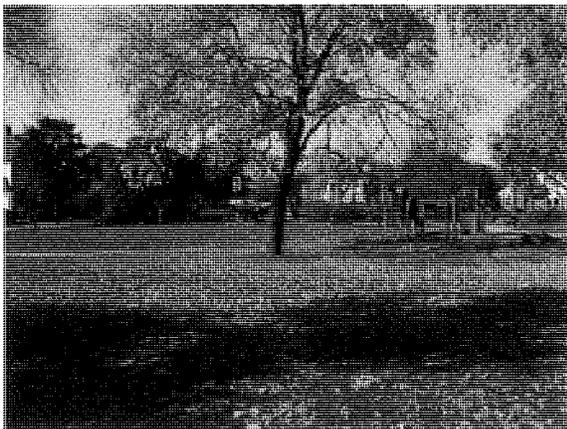
- pedestrian lights along park walk is lacking.
- existing limestone screenings pathways is in poor condition.
- existing playground equipment does not meet ASTM safety standards and ADA accessibility requirements.
- existing wood retaining wall is in poor condition.
- existing chain link fencing along east property line is in poor condition.

*Smith Park – Open Space and Playground*

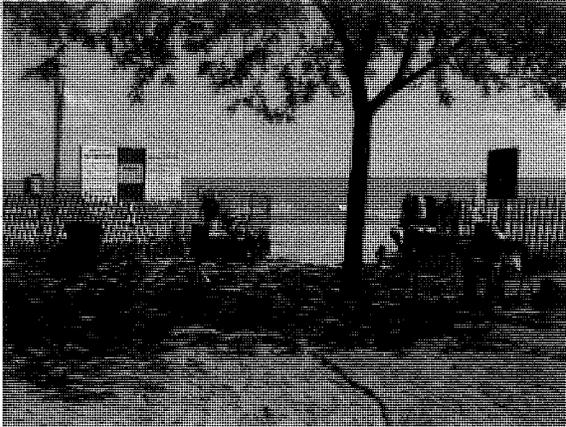
*South Boulevard Park/Beach – Beach Entrance*

- new entrance to the beach should be developed with paving and fencing in relationship with new restroom/beach entrance building.
- limestone screenings path and edging are in poor condition.

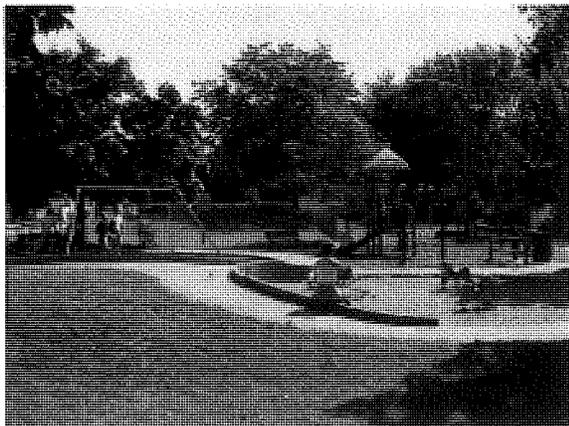
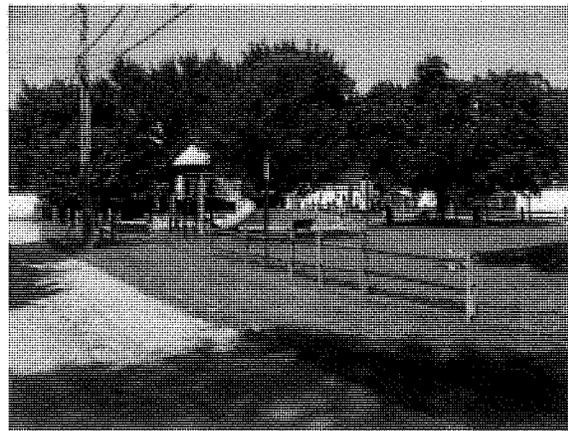
- park is poorly accessible.
- playground equipment is not ADA compliant and does not comply with safety guidelines.
- wood fencing is in poor condition.
- existing benches are old and in poor condition.
- trash receptacles are painted 55 gallon drums.
- picnic tables are old and not ADA compliant.

Southwest Park - Playground

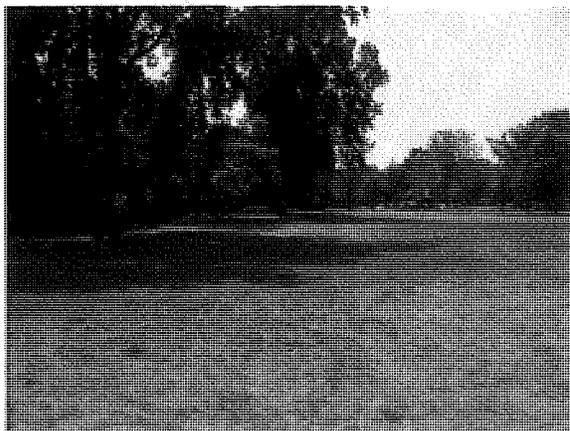
- poor drainage exists on the west side of the building.
- turf areas are level and poorly drained creating poor turf conditions.
- provide more security lighting.
- provide electrical outlet throughout park to help with programs.
- add more lighting in parking lot.
- parking is insufficient.
- construct a drop-off zone for children.
- players benches are in poor condition
- provide bollards at main entry walkway to prevent vehicular traffic.

Tallmadge Park – Open Space/Field

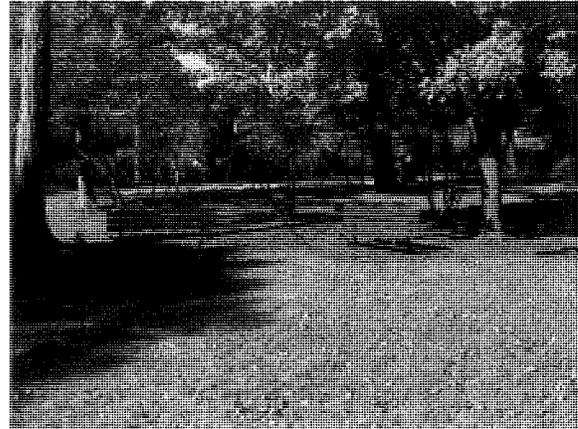
- no accessible paths are provided in the park.
- existing playground equipment for tots does not meet ADA and ASTM safety standards.
- existing chain-link fencing is in poor condition.
- the existing sign should be replaced with a new system sign and related landscape planting.
- existing benches should be replaced.
- existing trash receptacles should be replaced throughout the park.
- additional landscape planting should be provide along the railroad tracks as a buffer/screen.
- new tree plantings and landscape should be provided throughout the park to replace old trees and those removed.

*Torgerson Park – Seating Area*

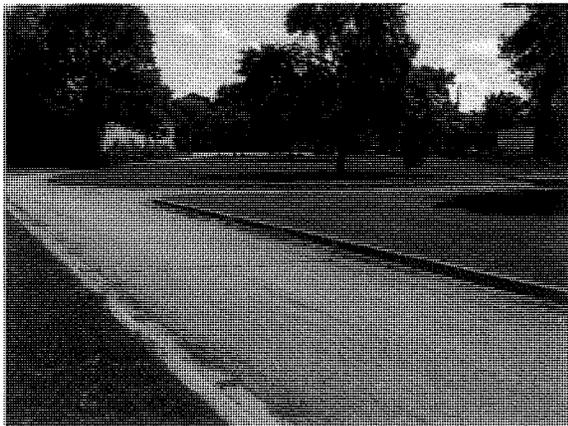
*Twiggs Park – Canal Lands B (east area)*

- pathway through park is in poor condition.
- extend asphalt pathway from Twiggs to Canal Lands B.
- existing chain link fencing along canal boundary is in poor condition.

- existing telephone pole guardrail should be replaced with a new barrier where streets end at park's edge.
- provide a new system sign with related landscape planting .
- existing trash receptacles should be replaced throughout the park.
- new tree plantings and landscape should be provided throughout the park to replace old trees and those removed.

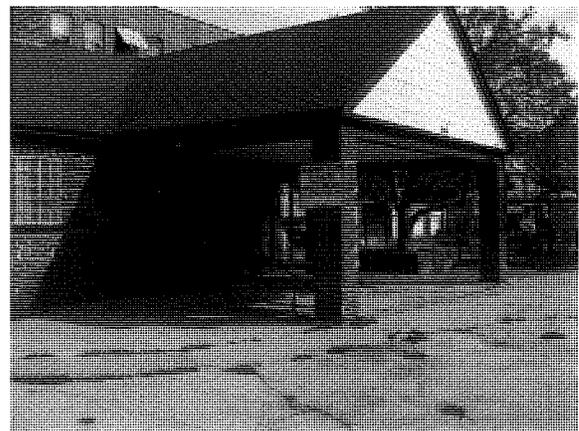
- brick and trim are in particularly poor condition

*Baker Park Restroom Building*

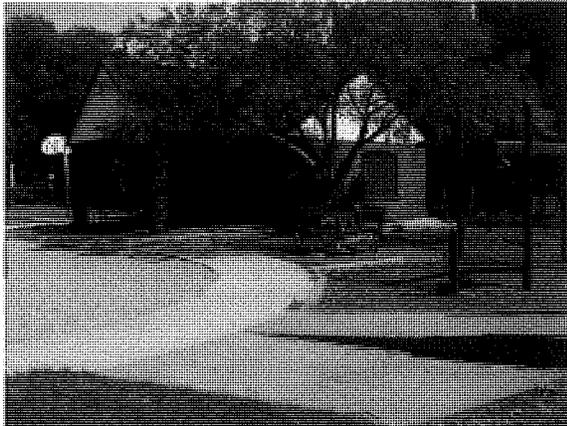
*Baker Park Restroom Building*

- steps up into toilet room require additional accessible ramp
- obvious signs of settlement are compromising the brick walls
- poor lighting
- poor signage

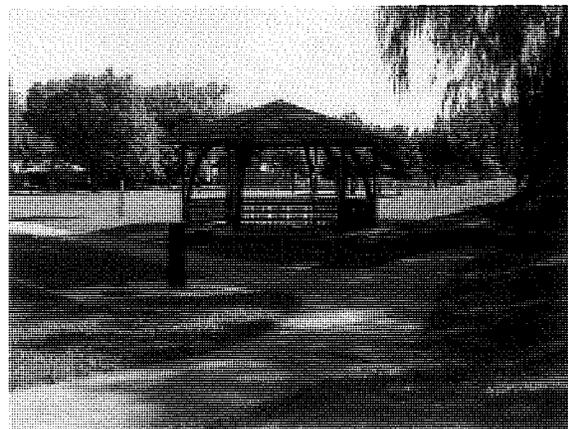
*Cartwright Park Gazebo*

- re-roof soon - many asphalt singles are missing and/or broken.
- the wood structure should receive routine stain or preservatives.
