# PARKS STRATEGIC PLAN

## PARKS/FORESTRY and RECREATION DEPARTMENT

City of Evanston, Illinois

### RECOMMENDED PARK IMPROVEMENTS AND COSTS

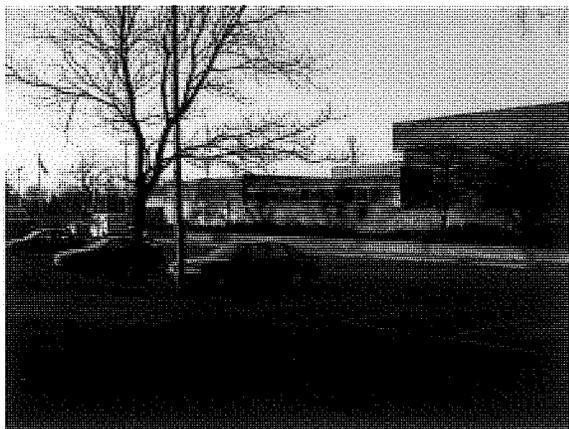
*Crown Community Center*

Crown Community Center is a one story, masonry building containing approximately 13,000 square feet. The building is one of the major recreational buildings in the community, and contains a number of programs/activities, including an ice skating rink, gymnasium, locker room/showers, program/multi-purpose rooms, restrooms, and administrative offices.

- the main ice rink east and west walls reveals significant movement cracks. Based on site observations, the north wall appears to be moving, potentially due to subsurface frost at the foundation level related to the ice rink cooling elements. The movement of the north wall has dislodged the roof trusses at the bearing points of the south wall. Tests should be performed at the footing level of the north wall to establish soil stability and structural engineer should provide remedial solution for repair of the north, east, and west walls, and truss bearing locations of the south wall of the main rink.

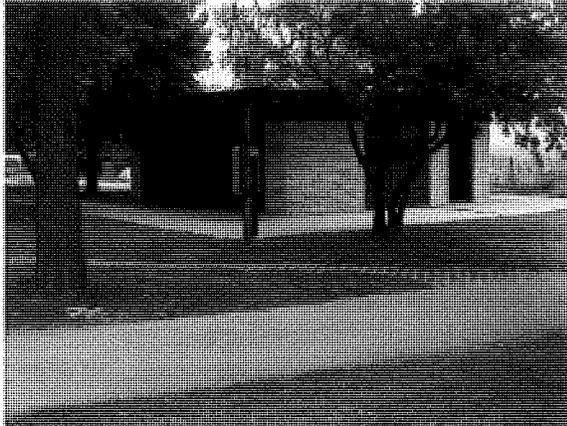
*Dawes Park – Greenwood Beach Restroom*

- facility appears to be too small and improperly placed for the program requirements.
- toilet rooms are not handicap accessible.
- toilet room fixtures and partitions and interior finishes have outlived their useful life.
- exterior shower does not drain to a compliant drain and sanitary sewer system.
- shower use is deteriorating and discoloring the exterior stone.
- exterior vending machine sits in the open
- tree branches obstruct roofing.
- exterior lighting is poor.
- routine caulking/sealant requires maintenance.
- signage is not handicapped compliant.

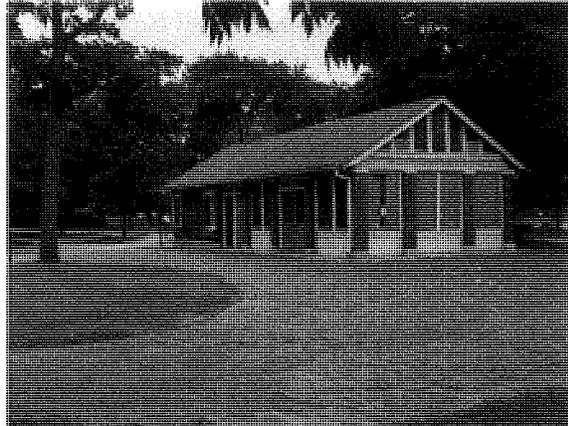
*Dawes Park Lagoon Building*

The Dawes Park Lagoon Building, a historical structure, is a one story, masonry and wood building containing. The building contains two restrooms and a concession area, and a picnic area.

- brick mortar in poor condition
- flashings are in poor condition
- miscellaneous carpenter details are mission and/or in poor condition
- paint/stain in poor condition
- caulking/sealant in poor condition
- interior lighting is poor
- baby changing station in men's toilet room is missing
- toilet room accessories are missing
- toilet room ventilation is poor
- ADA compliant signage at toilets rooms is missing
- toilet rooms do not have required five foot diameter wheelchair turning radius

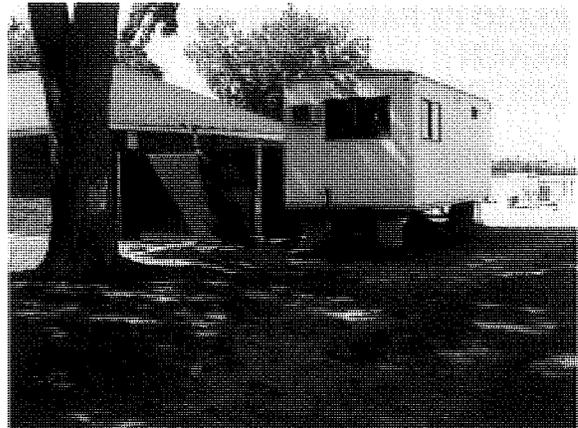
*Dempster Street Beach Aquatics Center*

- facility appears to be too small for program requirements
- facility sits too low to allow staff complete view of beachfront and lake front.  
Recommendation - Inclusion of tower (which would also improve radio horizon).
- refuse enclosure area dilapidated,
- truck trailer used as program storage for aquatic events.
- exterior brick and wood trim deteriorating
- grade slopes toward building in multiple locations.
- paint/stain and caulking/sealant require routine maintenance.
- under-counter refrigerator undersized for staff requirements.
- settlement cracks have appeared at the joints. Steel lintels are corroding.

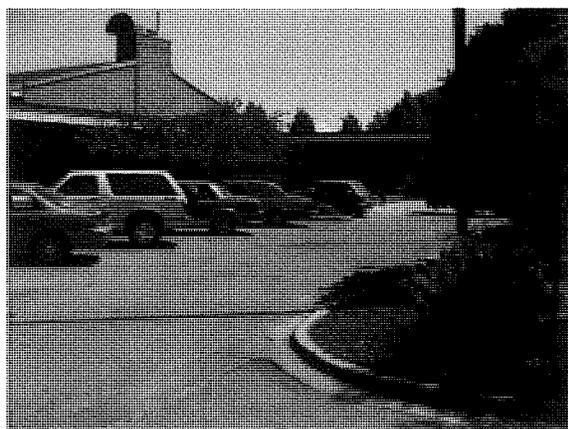
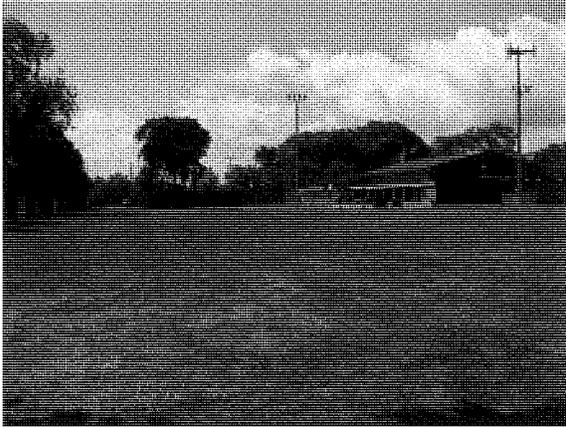
*Fleetwood-Jourdain Community Center*

- brick needs cleaning and tuckpointing
- second floor office area is not handicap accessible
- existing finishes, such as ceiling tiles and floor tiles, require replacement
- fitness room too small for program requirements
- arts and crafts room, computers, and computer area outdated. Electrical and phone upgrades required.
- replace gymnasium curtain with automated curtain
- replace manual roll away bleachers with automated bleachers
- replace tack board system at hall

- provide enclosed storage area of program necessities near meeting room.
- provide adequate refuse enclosure
- drinking fountain not ADA compliant
- non-compliant ADA entry ramp at front entrance
- poor exterior signage and lighting
- men's and women's locker and toilet rooms in poor condition
- no stage accessibility

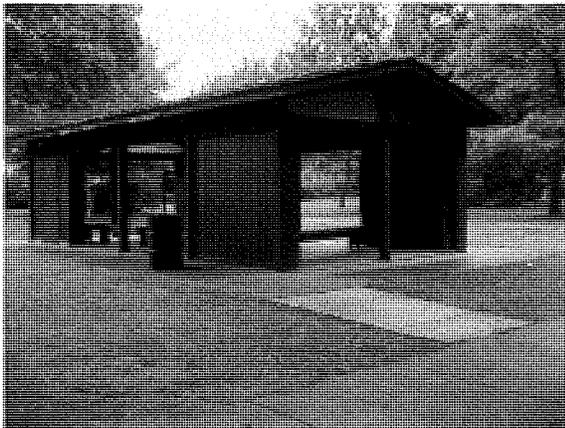
*Larimer Park Shelter*

- Lighting is poor
- Roof is in poor condition
- Rakes and fascias and miscellaneous trim are in poor condition
- Normal paint/stain and sealant maintenance

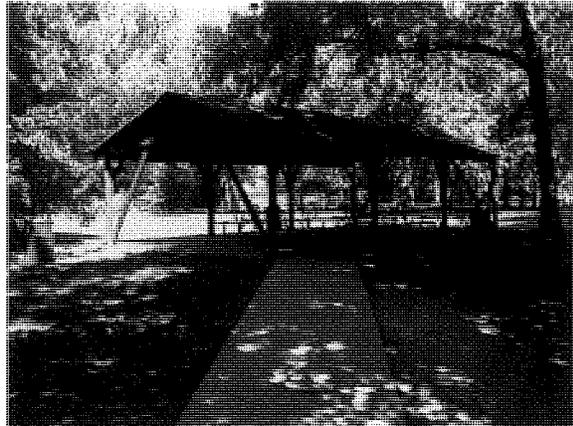
*Lawson Park Shelter*

- poor lighting.
- miscellaneous trim and rafter ends are in poor condition
- paint/stain at all surfaces of structure and underside roof deck

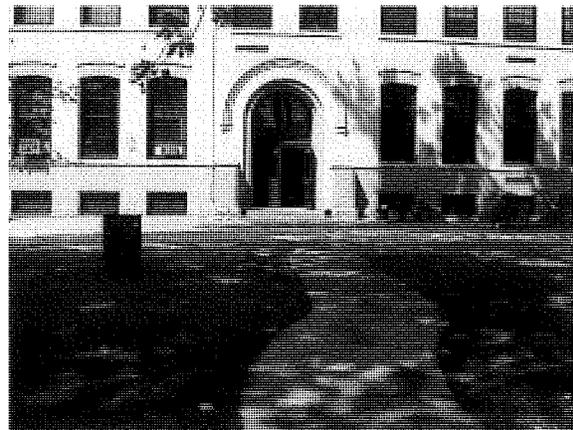
*Noyes Community Center*

- improve facility entrance sequence.
- improve facility telephone system to include voice mail.
- provide administrative area with computer networking capabilities.
- improve vending areas.
- provide refuse enclosure.
- repair entire existing exterior facade.
- refinish existing wood floors of hallways.
- consider replacing stair guardrails (spacings wider than current codes allow).
- routine paint and plaster patching at interior.
- provide proper closure for previously blocked up theater clerestory windows.

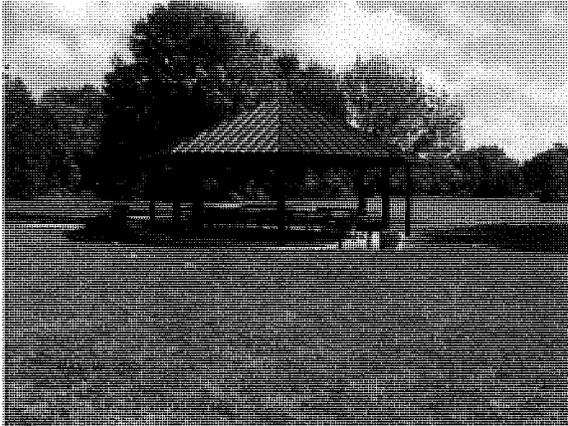
*Twiggs Park Gazebo*

- structure should be added to routine maintenance cycle for paint at the steel superstructure and stain of wood ceiling.
