Illinois Environmental Protection Agency
Delegated Agency Solid Waste Program
Transfer/Storage Inspection

Facility:	Veolia-Evanston Transfer Station				
CCDEC ID:		IEPA ID or Other ID:		0310810003	
Address:	1711 Church Street				
City:	Evanston	Date:	10/22/20	Time:	7:30 AM
Inspector:	Andrew Nowak			Badge No.:	128

Inspection Report

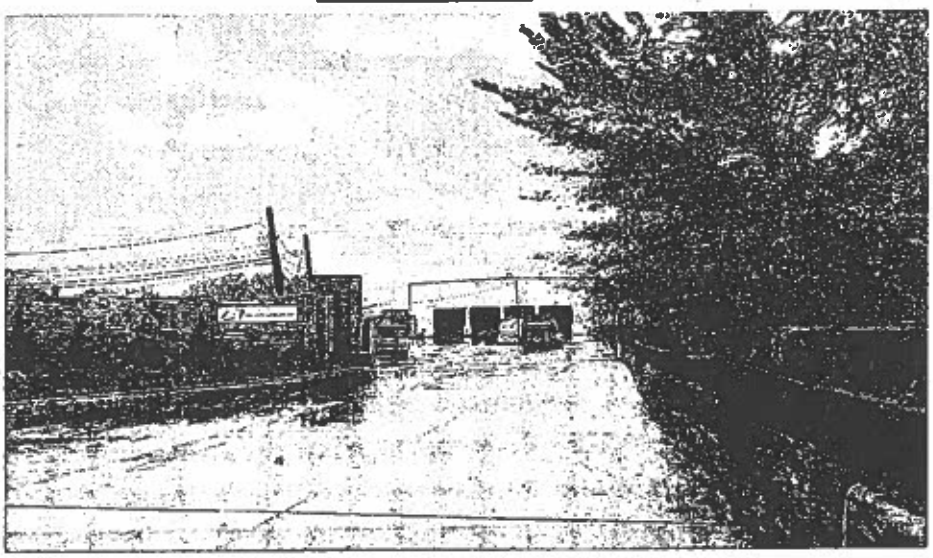
Photograph No.:	1	Direction:	North
Description:	View of the site entrance

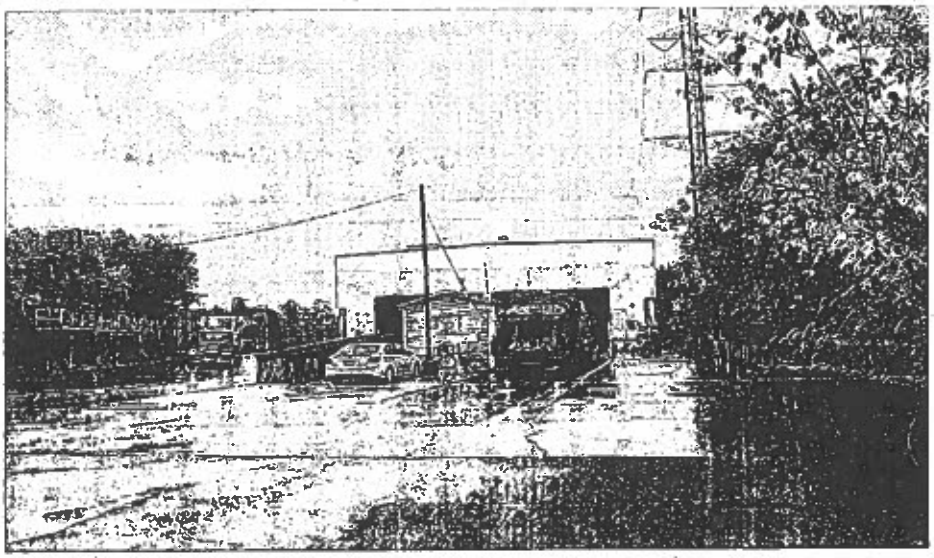
Photograph No.:	2	Direction:	North
Description:	View of the site scale

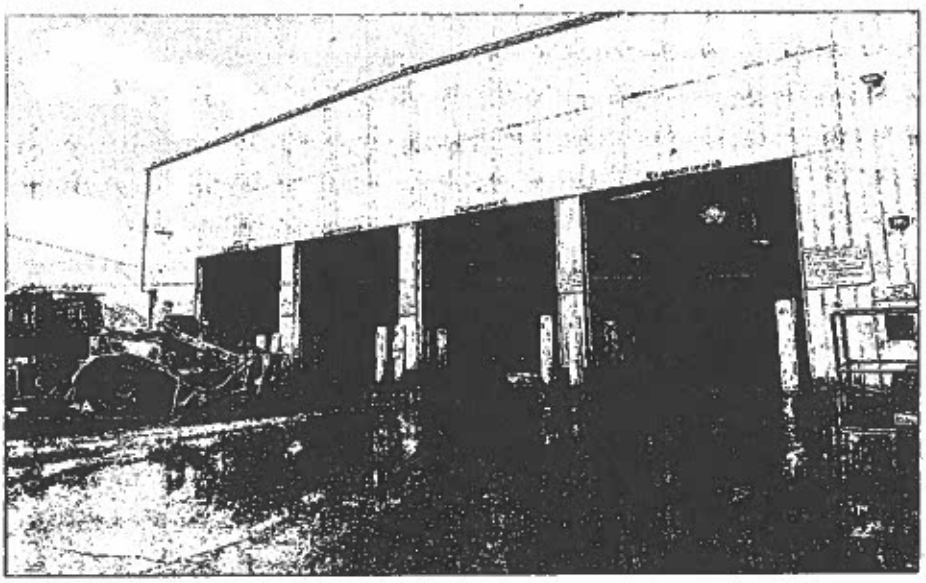
Photograph No.:	3	Direction:	North
Description:	View of transfer station building

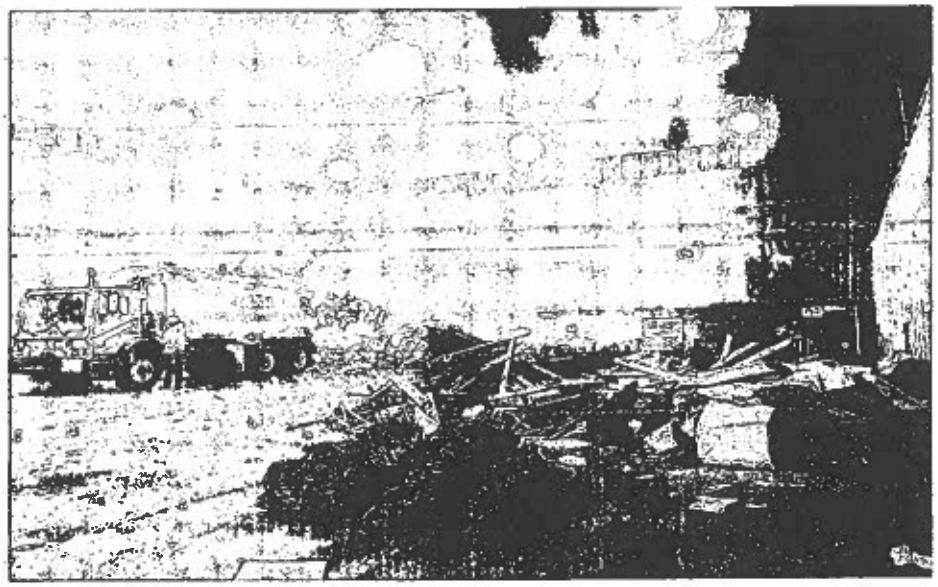
Engineer Nowak observed piles of MSW in the transfer station building. One side was for garbage trucks and the other side was for smaller hauling trucks. The building's misting system was operating during the inspection. Engineer Nowak observed a fire extinguisher certified by Cintas in November 2019.

Photograph No.:	4	Direction:	North
Description:	View of a garbage truck depositing MSW and the MSW piles

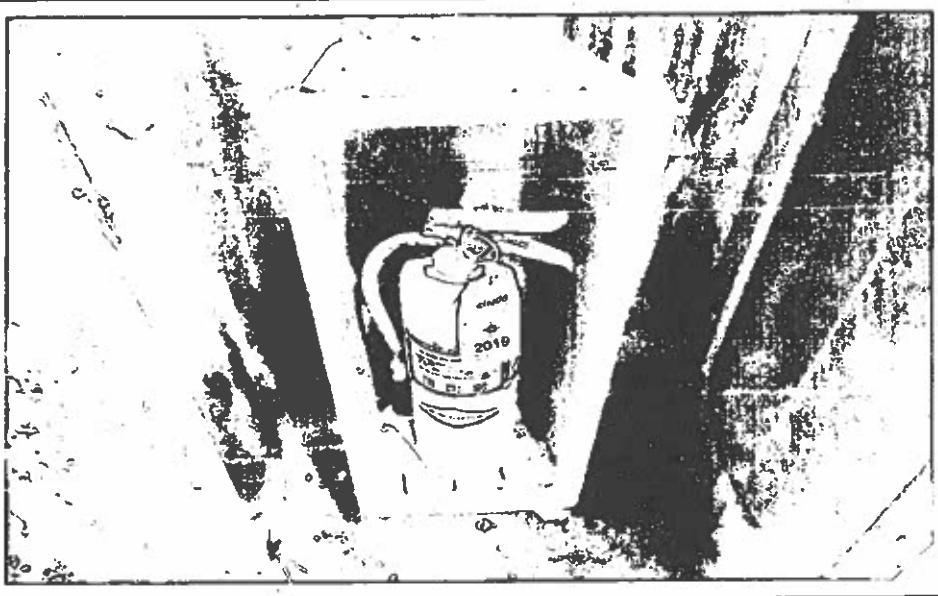
Photograph No.:	5	Direction:	South
Description:	View of fire extinguisher

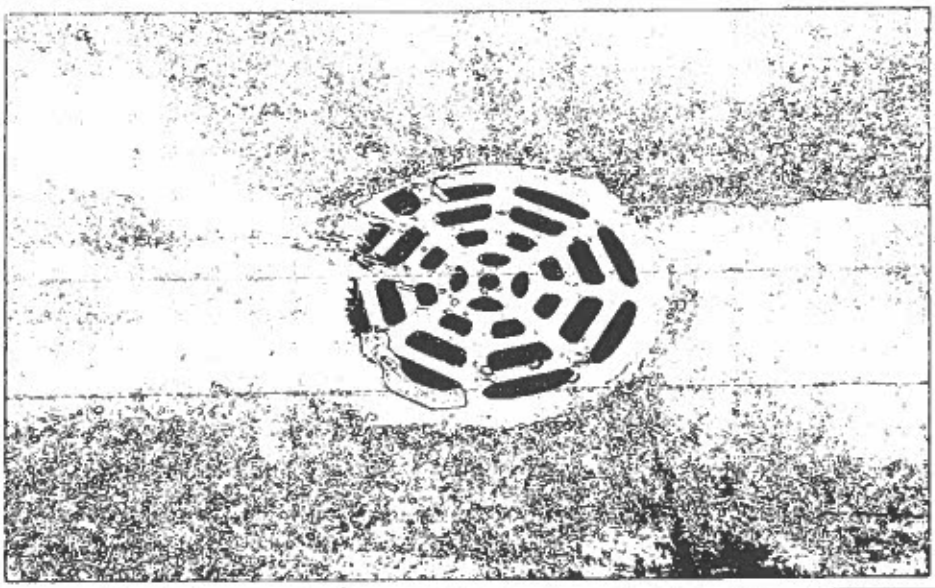
Engineer Nowak toured the site. A garbage truck was weighing in on the scale near the site entrance. Approaching the transfer station building, Engineer Nowak observed a small oil sheen running just north of a storm sewer, but it had not yet reached the sewer. The staff member operating in the scale office, Xavier, told Engineer Nowak he would tell another staff member to get oil dry from the offices across the street and clean up the spill right away.

Photograph No.:	7	Direction:	North
Description:	View of the storm sewer

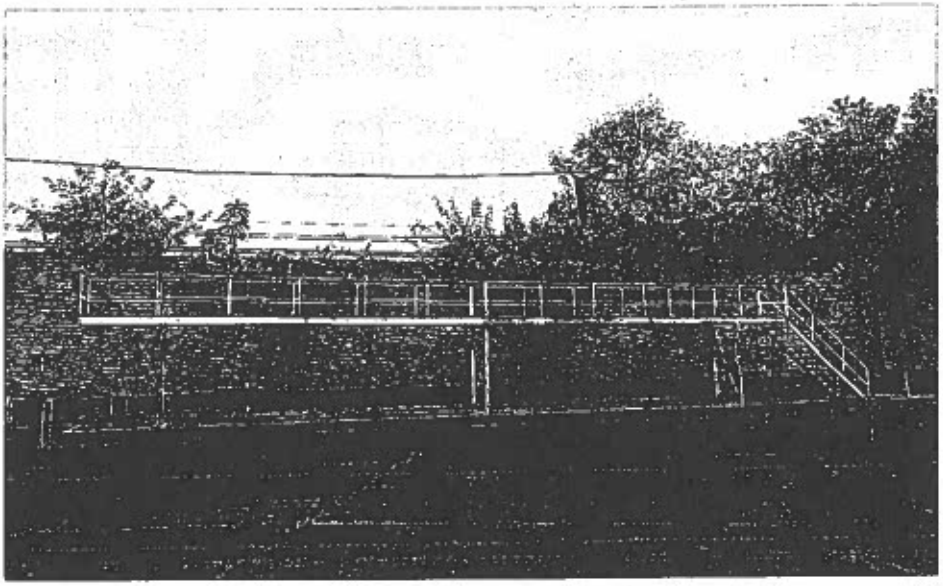
Photograph No.:	8	Direction:	West
Description:	View of the tarping station
