Illinois Environmental Protection Agency
Delegated Agency Solid Waste Program
Transfer/Storage Inspection

COOK COUNTY
DEPARTMENT OF ENVIRONMENT AND SUSTAINABILITY
SOLID WASTE INSPECTION REPORT

Facility:	Veolia-Evanston Transfer Station				
CCDEC ID:		IEPA ID or Other ID:		0310810003	
Address:	1711 Church Street				
City:	Evanston	Date:	1/6/2021	Time:	10:00 am
Inspector:	Travis Wood			Badge No.:	122

Inspection Report

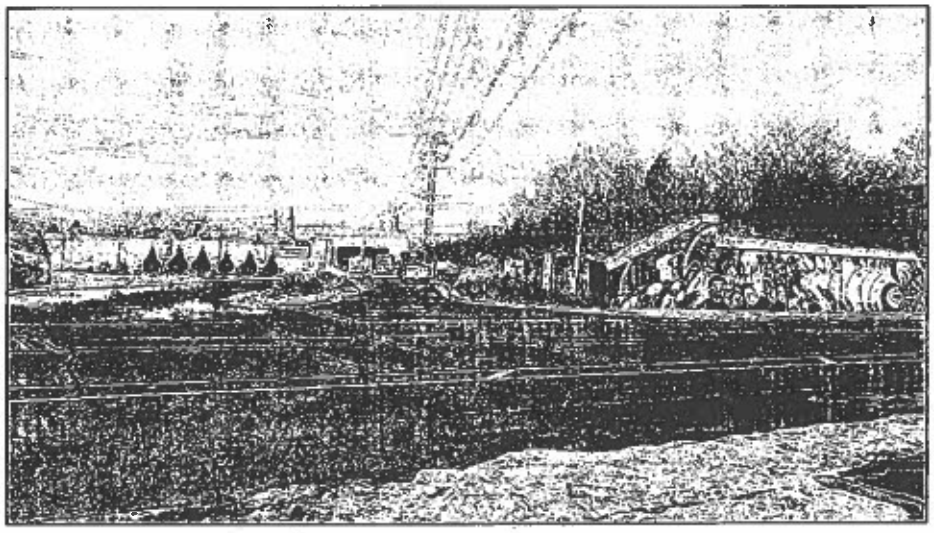
Photograph No.:	1	Direction:	North
Description:	View of site entrance, no litter observed off site

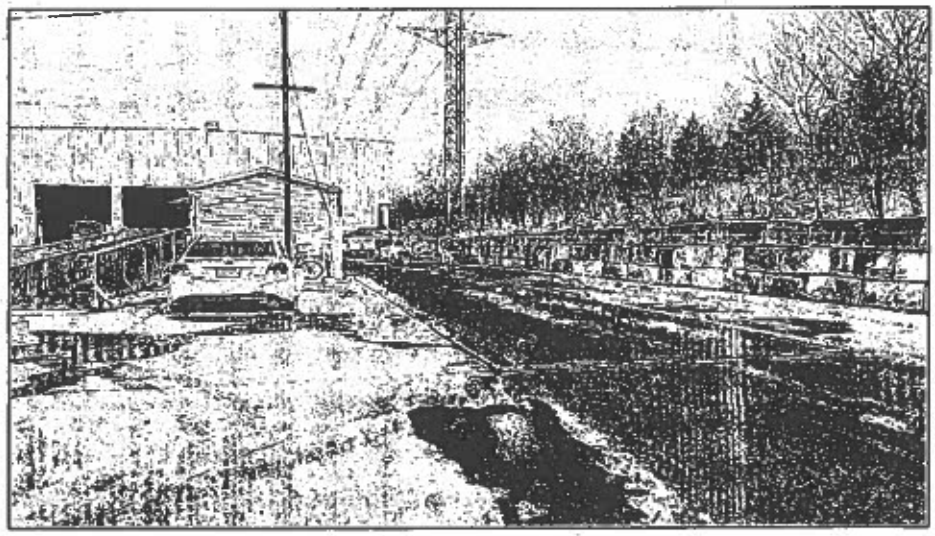
Photograph No.:	2	Direction:	Northeast
Description:	View of site scale and scale office

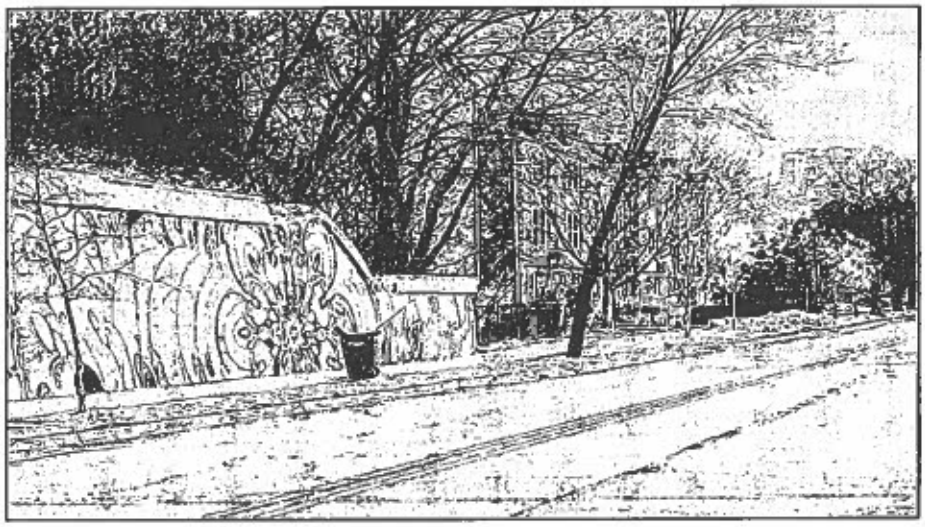
A staff member was seen picking up litter along Church Street on the south border of the site. Mr. Ray explained that the crew patrols the townhomes to the east, and along

Photograph No.:	3	Direction:	Northeast
Description:	View of staff patrolling area adjacent to site for litter

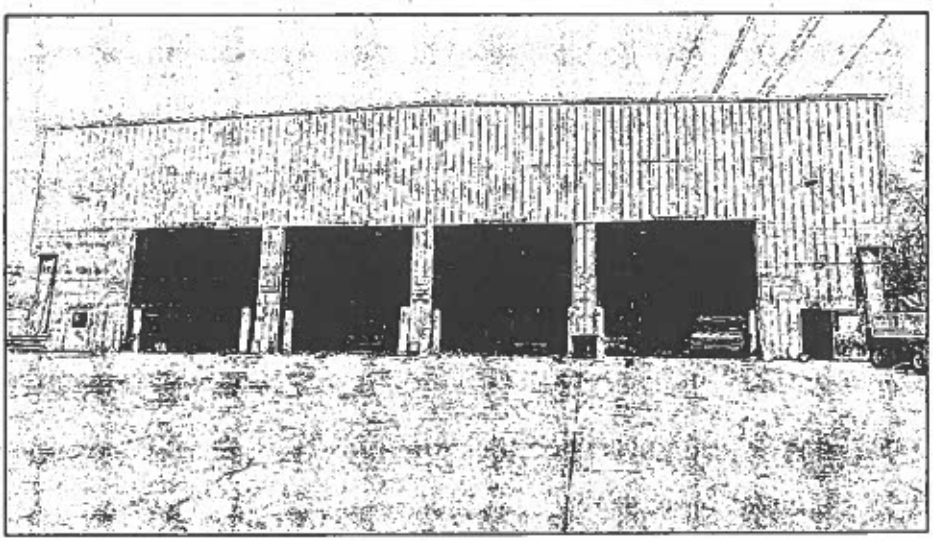
Photograph No.:	4	Direction:	North
Description:	View of transfer station building

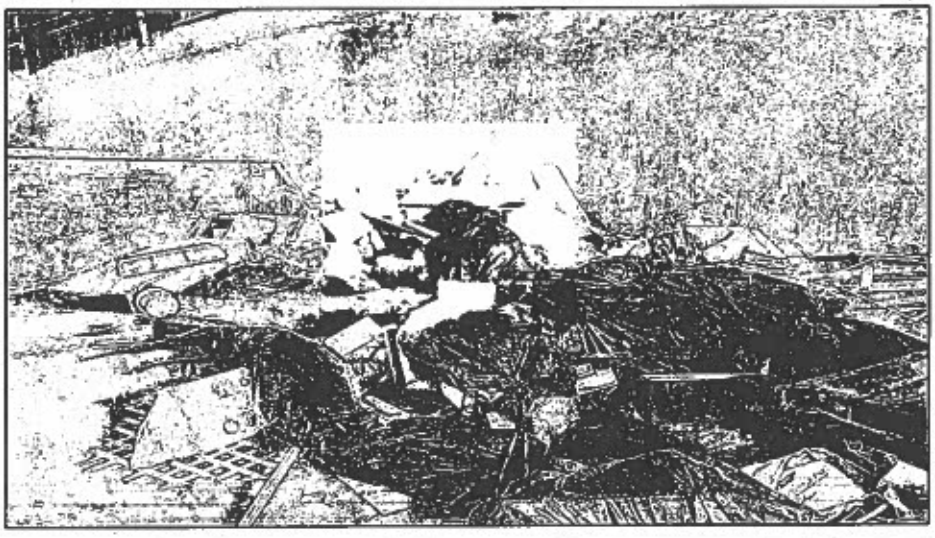
Photograph No.:	5	Direction:	Northeast
Description:	View of material dropped off by small trucks

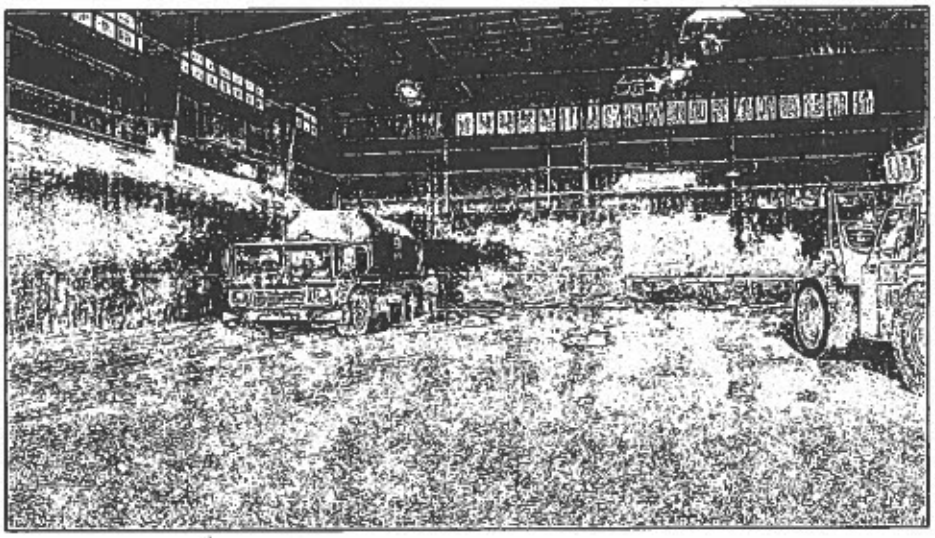
Engineer Wood observed very little MSW in the transfer station building. One side was for garbage trucks and the other side was for smaller hauling trucks. At the time of inspection, small hauling trucks were dumping material onto the tipping floor. One garbage truck was preparing to empty MSW onto floor. Engineer Wood observed a fire extinguisher serviced by Cintas in March of 2020 as well as a sprinkler system maintained by Cintas.

Photograph No.:	6	Direction:	North
Description:	View of tipping floor, garbage truck with incoming load

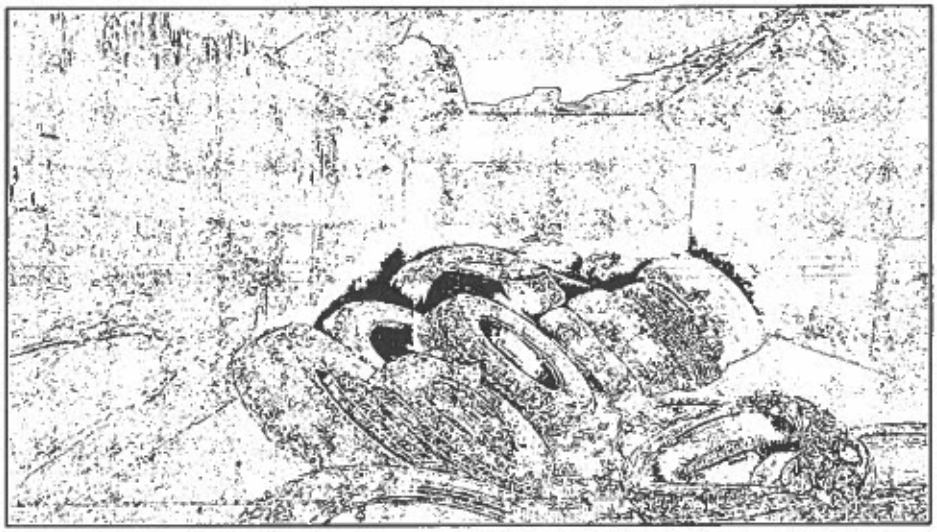
On the west side of the site, a covered tire bin containing roughly 16 tires was observed; Shred all picks up the tires from the site.

Photograph No.:	7	Direction:	South
Description:	View inside tire bin

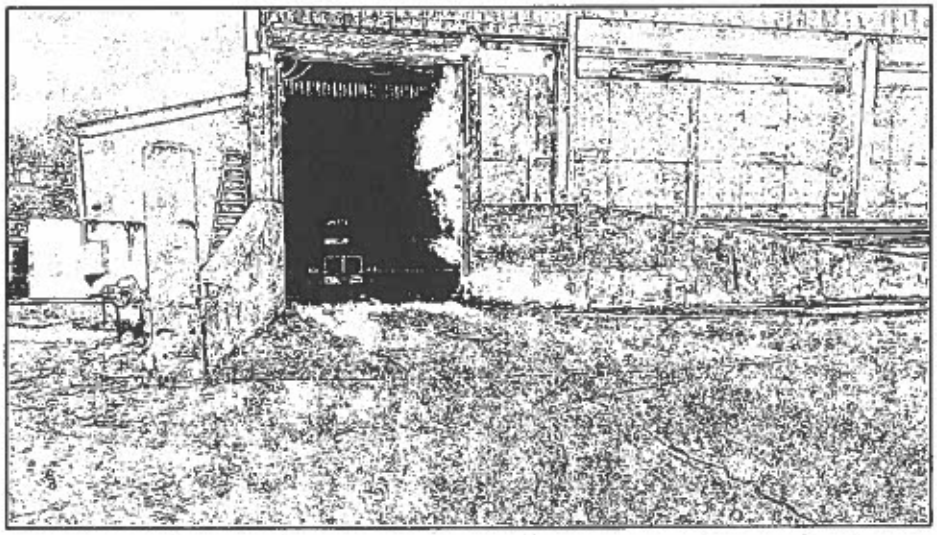
Photograph No.:	8	Direction:	East
Description:	View of outbound truck waiting to be loaded.
