Illinois Environmental Protection Agency
Delegated Agency Solid Waste Program
Transfer/Storage Inspection

COOK COUNTY
DEPARTMENT OF ENVIRONMENT AND SUSTAINABILITY
SOLID WASTE INSPECTION REPORT

Facility:	Veolia-Evanston Transfer Station				
CCDEC ID:		IEPA ID or Other ID:		0310810003	
Address:	1711 Church Street				
City:	Evanston	Date:	9/15/20	Time:	8:00 AM
Inspector:	Travis Wood			Badge No.:	122

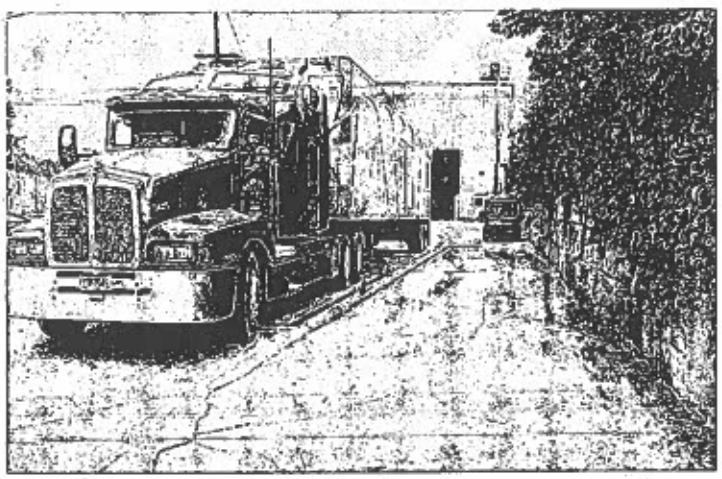
Photograph No.:	1	Direction:	North
Description:	View of truck on scale.

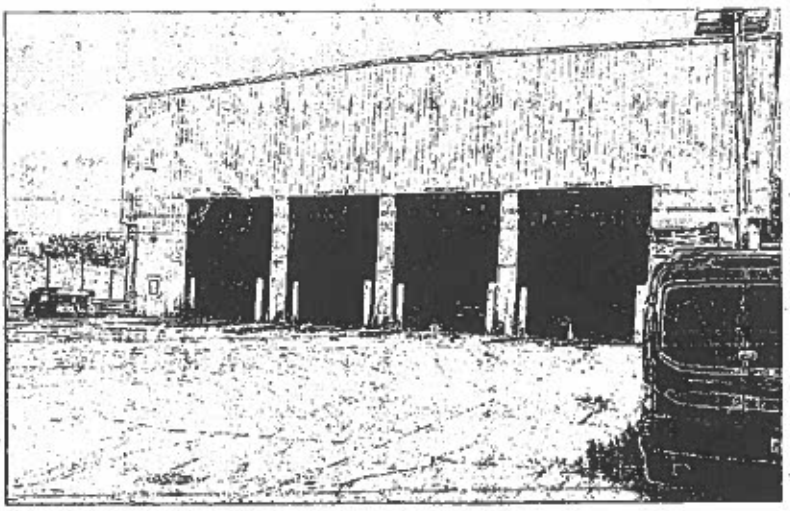
Engineer Wood observed piles of MSW in the transfer station building. One side was for garbage trucks and the other side was for smaller hauling trucks. At the time of inspection, a truck was adding to the larger of the two piles. The building's misting system, was operating during the inspection. Mr. Ray explained that the misters are used the entire time the facility is accepting waste. Engineer Wood observed a fire extinguisher certified September 2020 as well as a sprinkler system maintained by Cintas.

Photograph No.:	2	Direction:	North
Description:	View of transfer station building

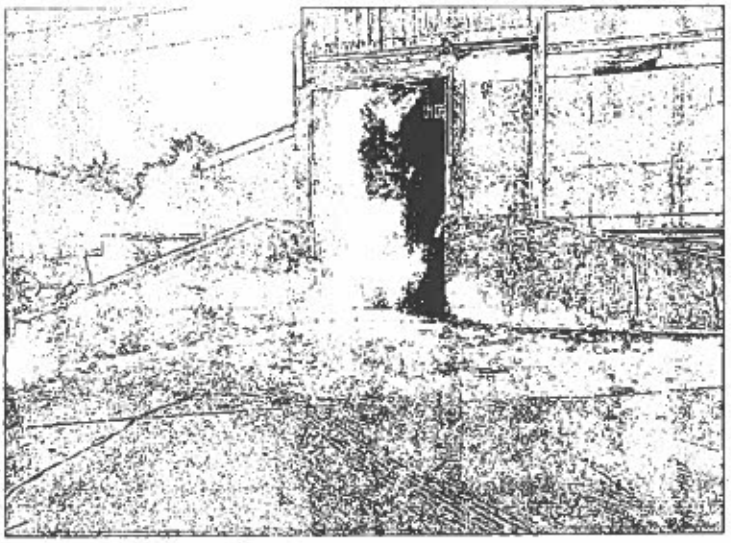
Photograph No.:	5	Direction:	Southeast
Description:	View of loading bay for outgoing MSW

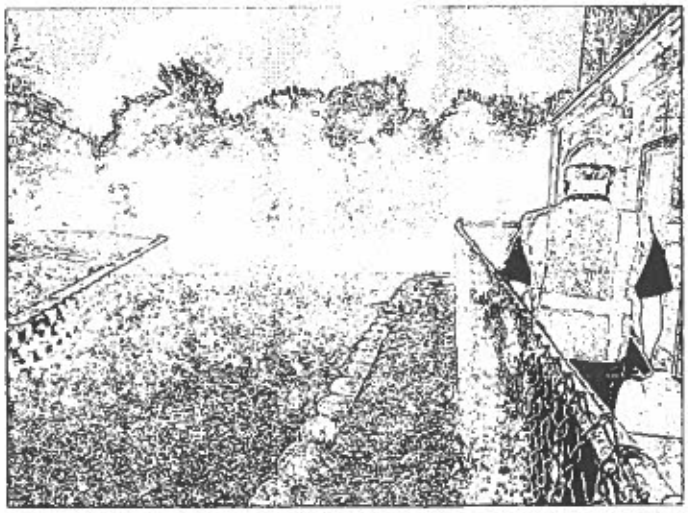
Engineer Wood observed the stormwater detention facility located on the north end of the site. No water was observed in the facility; Mr. Ray mentioned that the facility is functioning but not draining as designed and

Photograph No.:	6	Direction:	Southeast
Description:	View of stormwater detention facility

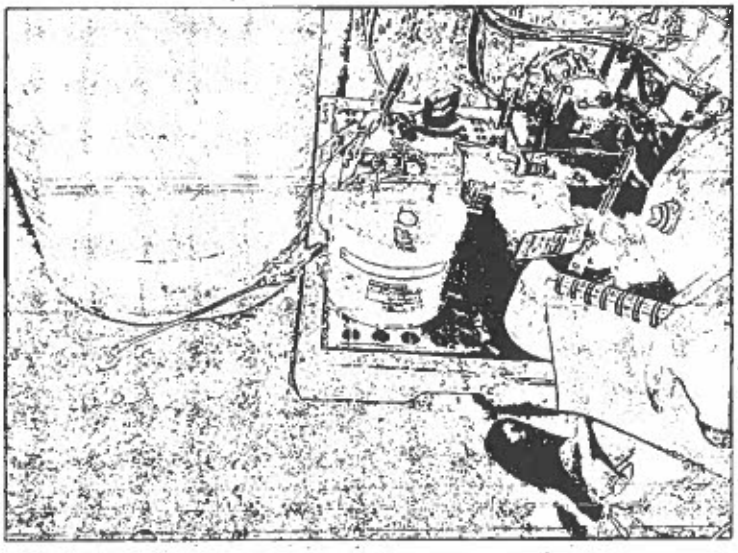
Photograph No.:	7	Direction:	Southeast
Description:	View of mister system tank (blue) and hand mister containers.

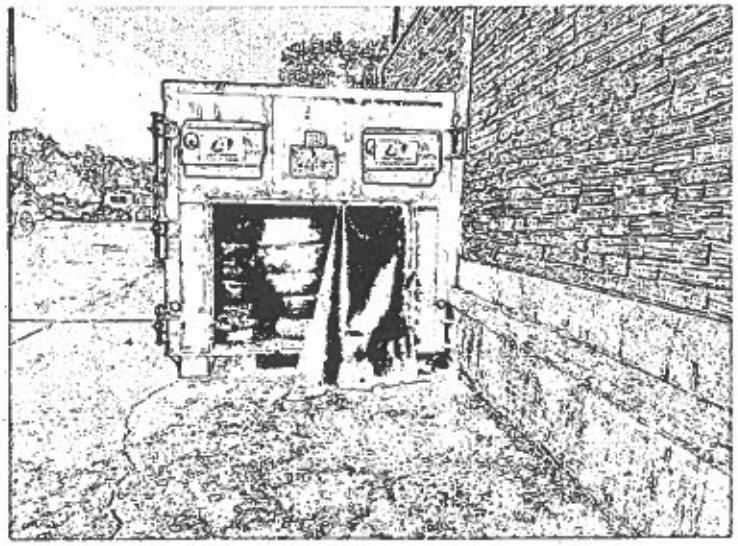
A staff member was seen picking up litter along Church Street on the south border of the site. Mr. Ray explained that the crew patrols the townhomes to the east, and along Church Street to the west. Garbage bins lined the west end wall to collect litter from the site. On the west side of the site, a tire bin full of tires was observed. Mr. Ray informed the engineers that an order was put in that day for Shred All to pick up the bin.

Photograph No.:	8	Direction:	South
Description:	View of tire bin

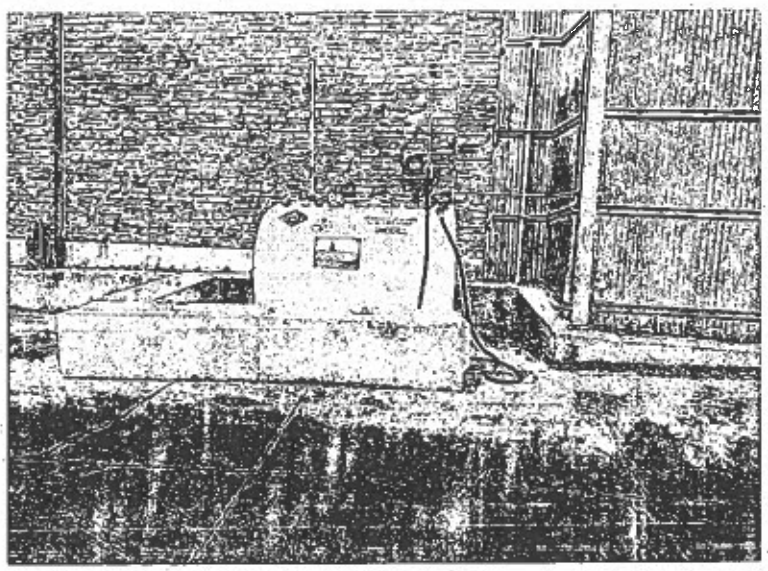
Photograph No.:	9	Direction:	West
Description:	View of double walled fuel tank and up to date fire extinguisher

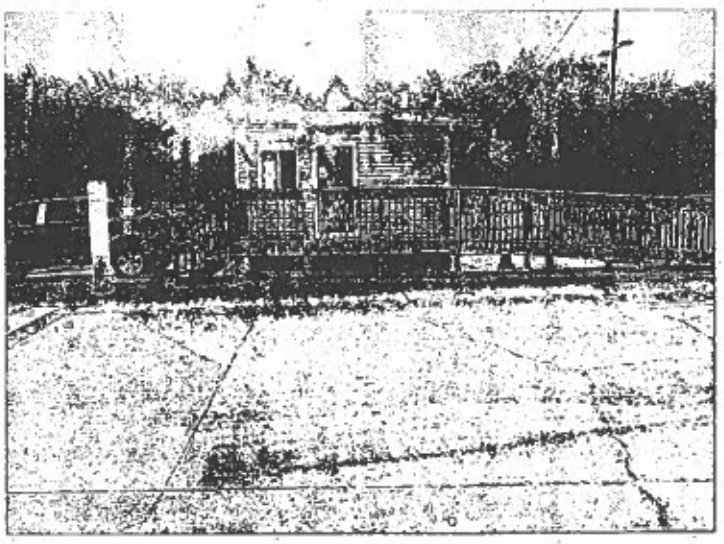
Photograph No.:	10	Direction:	Southeast
Description:	View of scale house
