Illinois Environmental Protection Agency
Delegated Agency Solid Waste Program
Transfer/Storage Inspection

COOK COUNTY
DEPARTMENT OF ENVIRONMENT AND SUSTAINABILITY
SOLID WASTE INSPECTION REPORT

Facility:	Veolia-Evanston Transfer Station				
CCDEC ID:		IEPA ID or Other ID:		0310810003	
Address:	1711 Church Street				
City:	Evanston	Date:	7/12/2021	Time:	7:30 am
Inspector:	Travis Wood			Badge No.:	122

Inspection Report

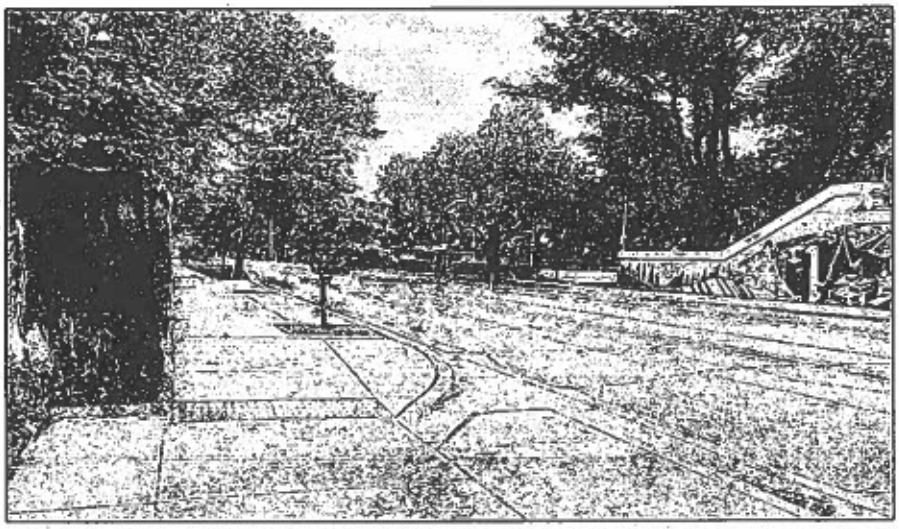
Photograph No.:	1	Direction:	East
Description:	View of roadway adjacent to site, no litter observed

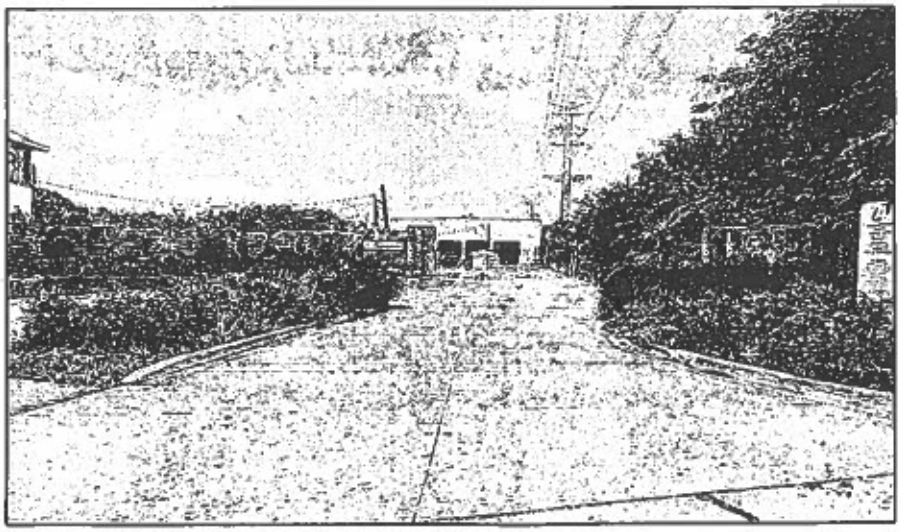
Photograph No.:	2	Direction:	Northeast
Description:	View of site entrance free from litter

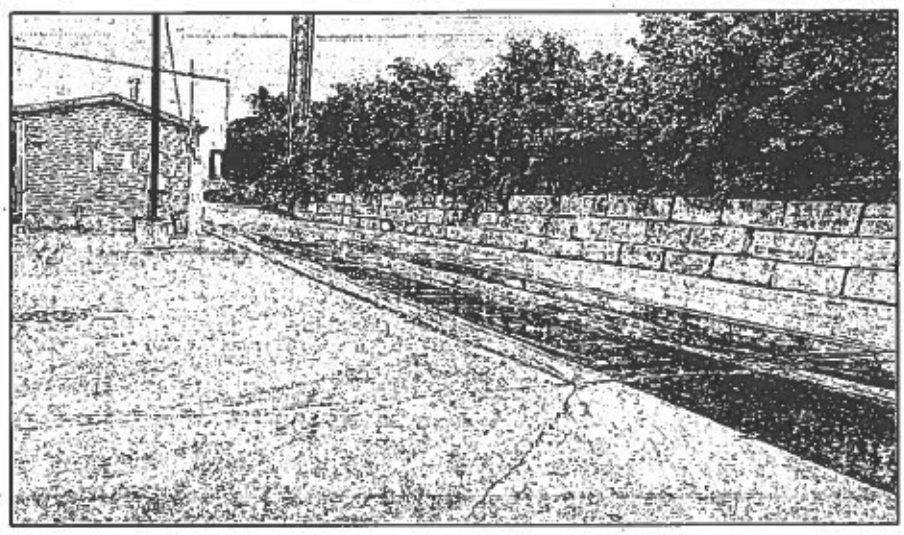
Photograph No.:	3	Direction:	Northeast
Description:	View of scale and scale house

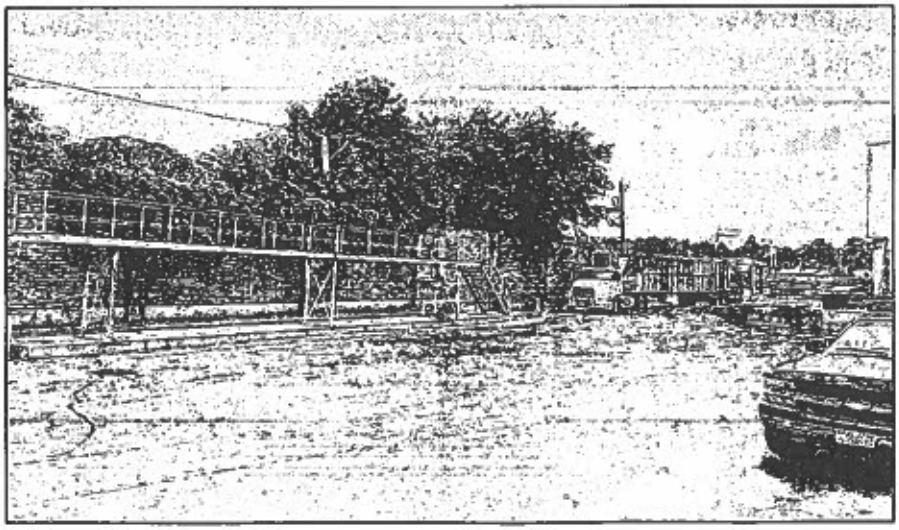
Photograph No.:	4	Direction:	Northwest
Description:	View of load checking and tarping platform

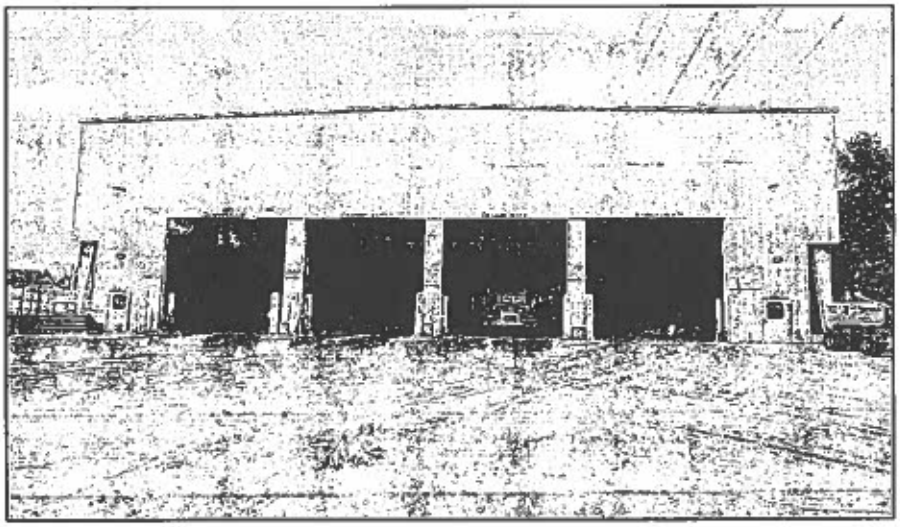
Photograph No.:	5	Direction:	Northeast
Description:	View of transfer station building

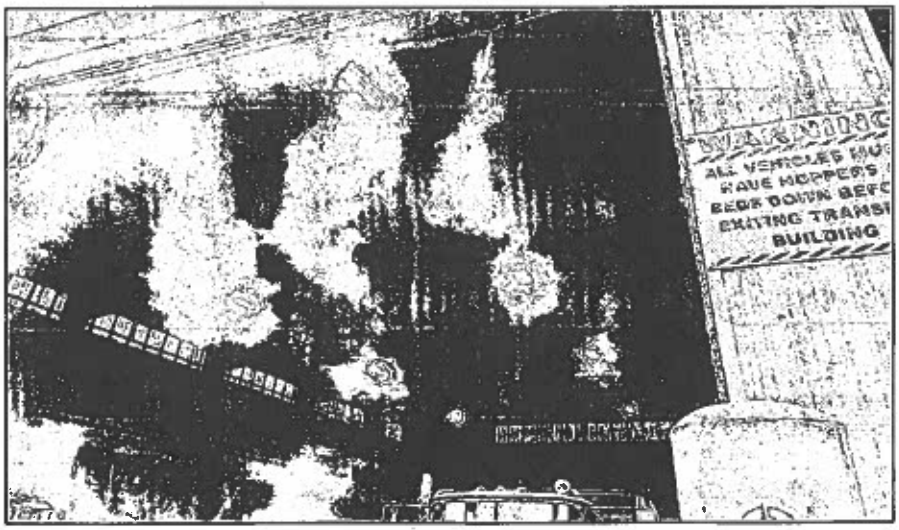
The odor control misting system was operating at the time of inspection; sprayers were observed above the bay doors and inside the transfer station building. No odor was detected at the time of the inspection. Engineer drove through the adjacent residential areas to check for any odor, none was observed. If an odor is noticed outside of the transfer station building, the staff will disperse an odor control powder by a hand cranked piece of equipment.

Photograph No.:	6	Direction:	East
Description:	View of odor misting system in operatoin

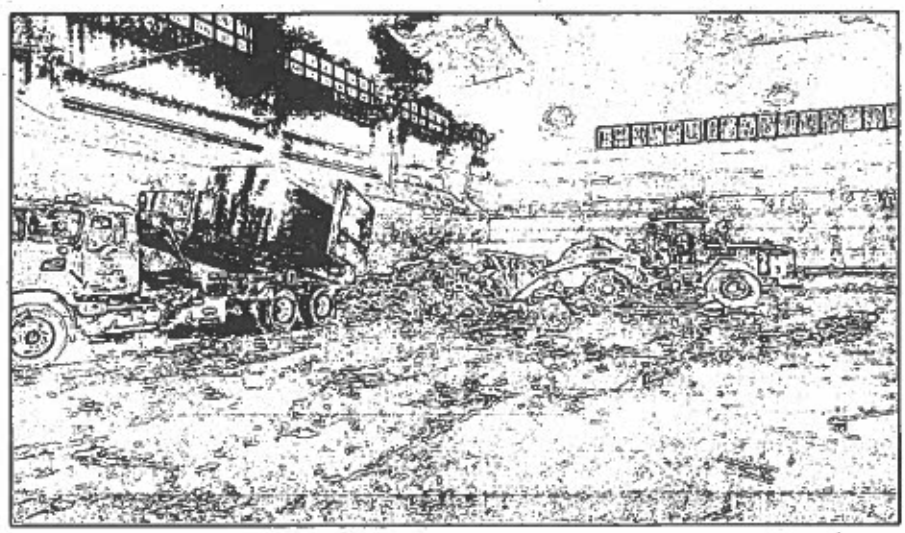
Engineer Wood observed MSW in the transfer station building. One side was for garbage trucks and the other side was for smaller hauling trucks. At the time of inspection, garbage trucks were observed tipping material in the transfer station building. An outbound truck was also being loaded with MSW.

Photograph No.:	7	Direction:	West
Description:	View of site activities and MSW pile in transfer station building

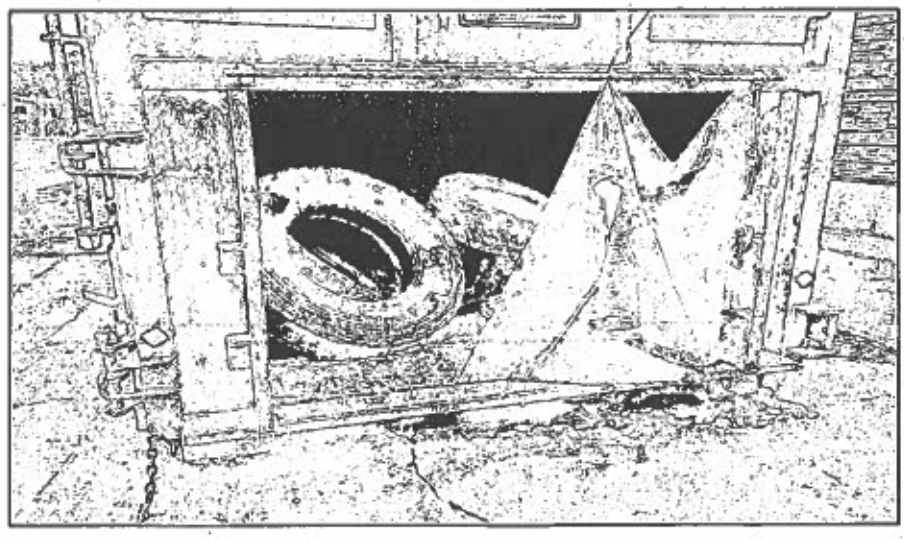
On the west side of the site, a covered tire bin was observed. Mr. Ray said that Pomp's tires, who services the company's fleet of trucks, has started to pick up any used tires when they are on site each month. The tires are picked up on the first Thursday of each month. Tires used to be sent to Shred-all.

Photograph No.:	8	Direction:	South
Description:	View of tire storage bin

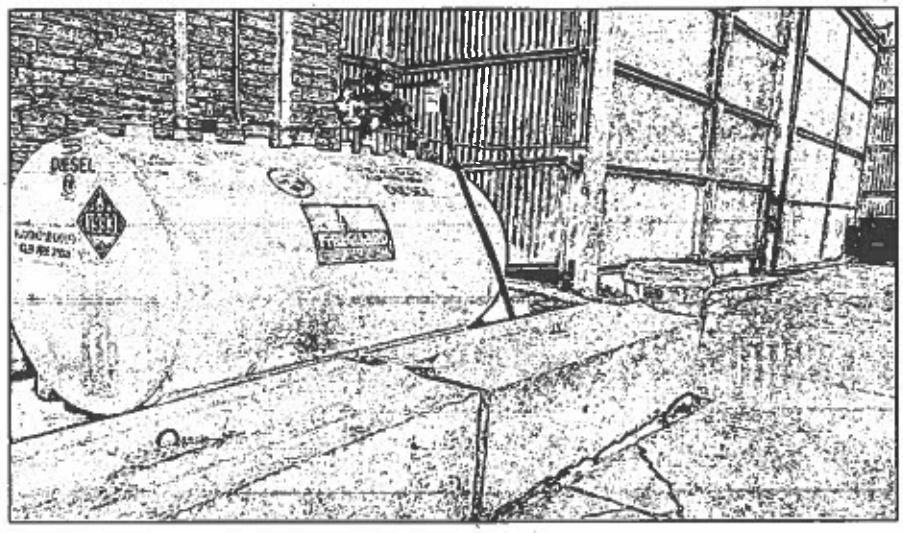
Photograph No.:	9	Direction:	Northwest
Description:	View of fueling area and spill kit

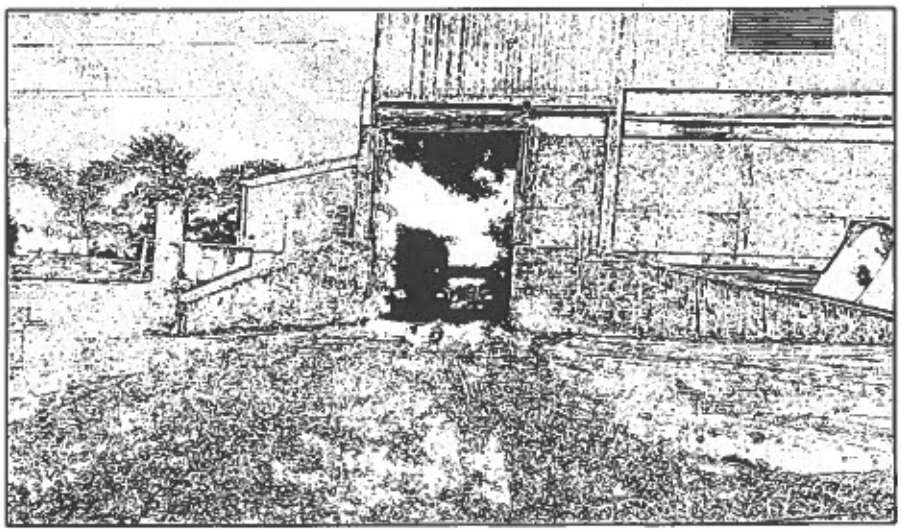
Photograph No.:	10	Direction:	Southeast
Description:	View of outbound truck in bay waiting to be loaded
