Illinois Environmental Protection Agency
Delegated Agency Solid Waste Program
Transfer/Storage Inspection

COOK COUNTY
DEPARTMENT OF ENVIRONMENT AND SUSTAINABILITY
SOLID WASTE INSPECTION REPORT

Facility:	Veolia-Evanston Transfer Station				
CCDEC ID:		IEPA ID or Other ID:		0310810003	
Address:	1711 Church Street				
City:	Evanston	Date:	01/10/2022	Time:	8:15 am
Inspector:	Travis Wood			Badge No.:	122

Inspection Report

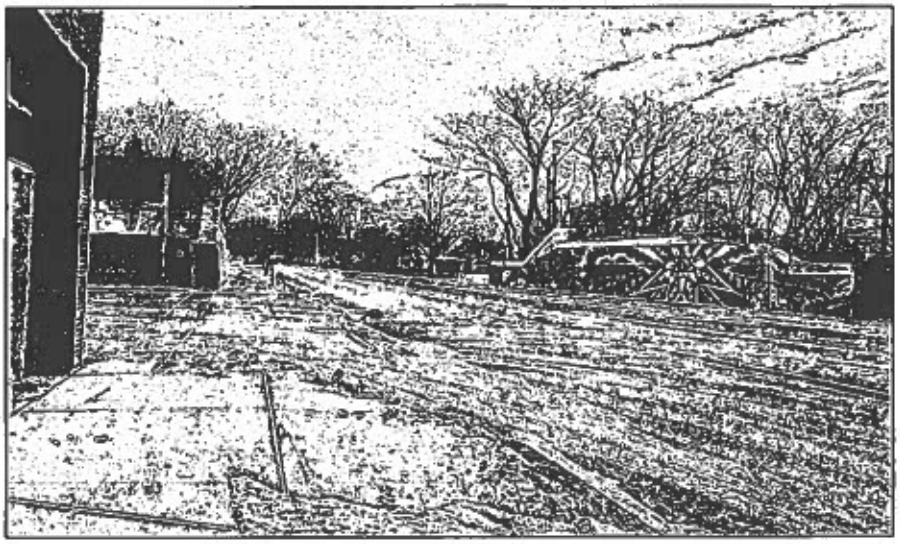
Photograph No.:	1	Direction:	East
Description:	View of roadway adjacent to site, no litter observed

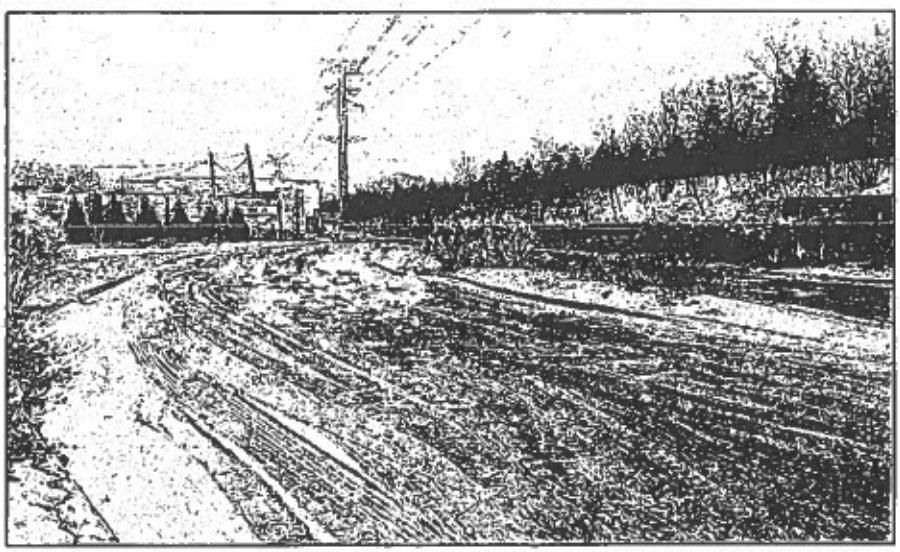
Photograph No.:	2	Direction:	North
Description:	View of site entrance free from litter

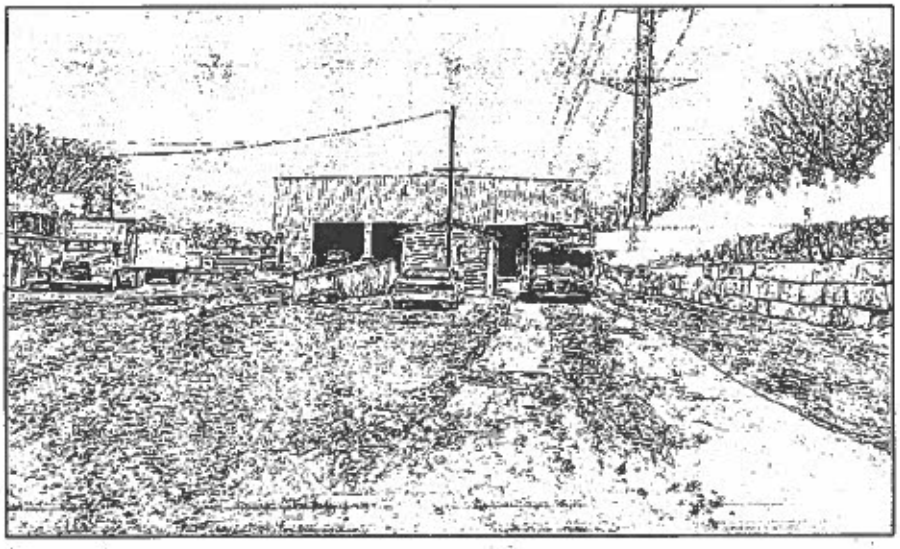
Photograph No.:	3	Direction:	Northeast
Description:	View of scale and scale house

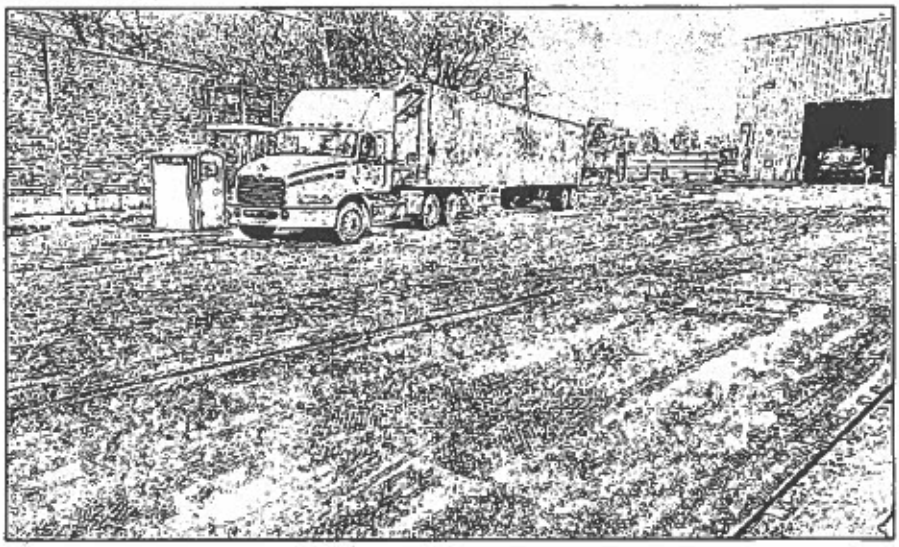
Photograph No.:	4	Direction:	Northwest
Description:	View of load checking and tarping platform

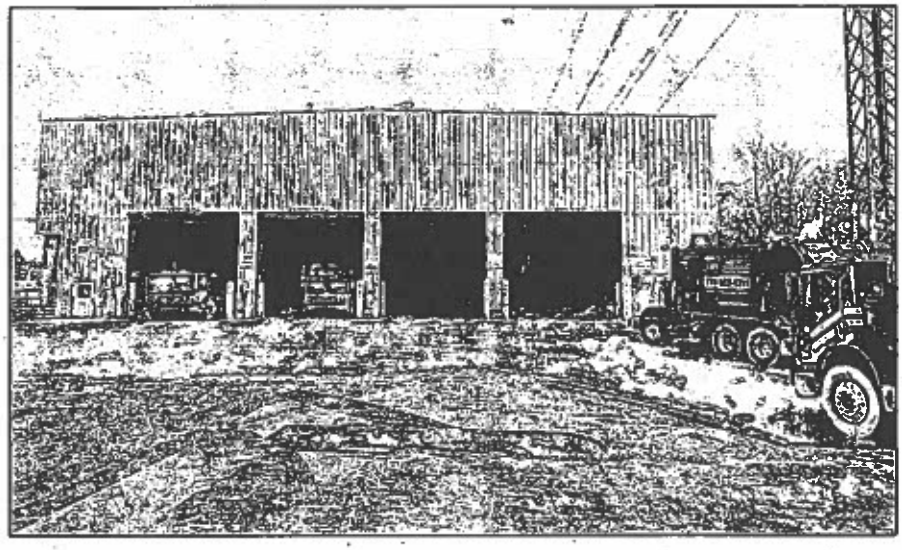
Photograph No.:	5	Direction:	Northeast
Description:	View of transfer station building

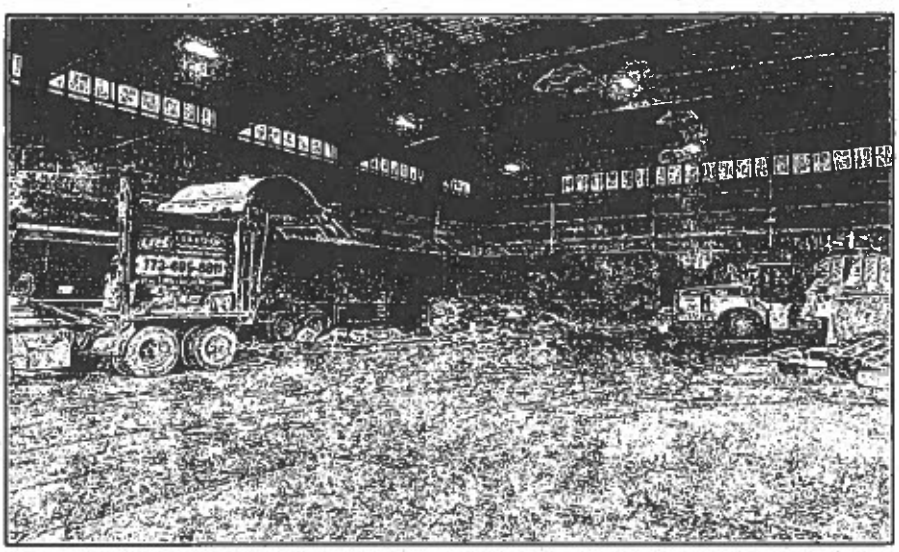
Engineer Wood observed MSW in the transfer station building. One side was for garbage trucks and the other side was for smaller hauling trucks. At the time of inspection, garbage trucks were observed tipping material in the transfer station building. An outbound truck was also being loaded with MSW.

Photograph No.:	7	Direction:	West
Description:	View of site activities and MSW pile in transfer station building

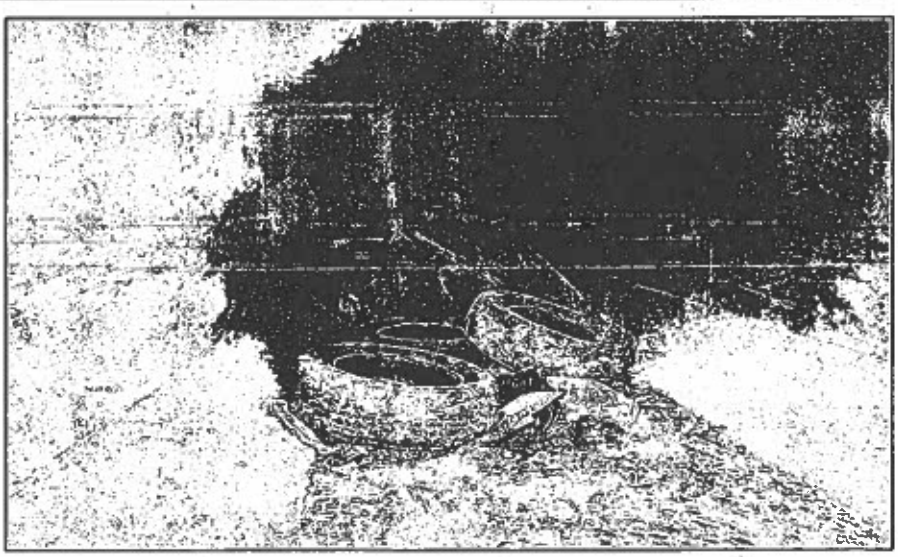
On the west side of the site, a covered tire bin was observed; Engineer observed roughly eight used tires. Pomp's Tires picks up any used tires when they are on site each month. The tires are picked up on the first Thursday of each month.

Photograph No.:	8	Direction:	South
Description:	View of tire storage bin

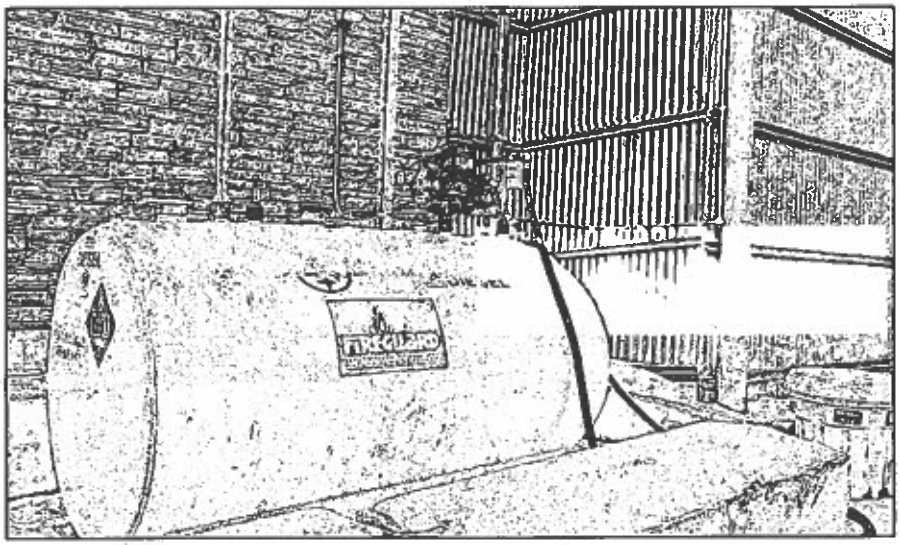
Photograph No.:	9	Direction:	Northwest
Description:	View of fueling area and spill kit

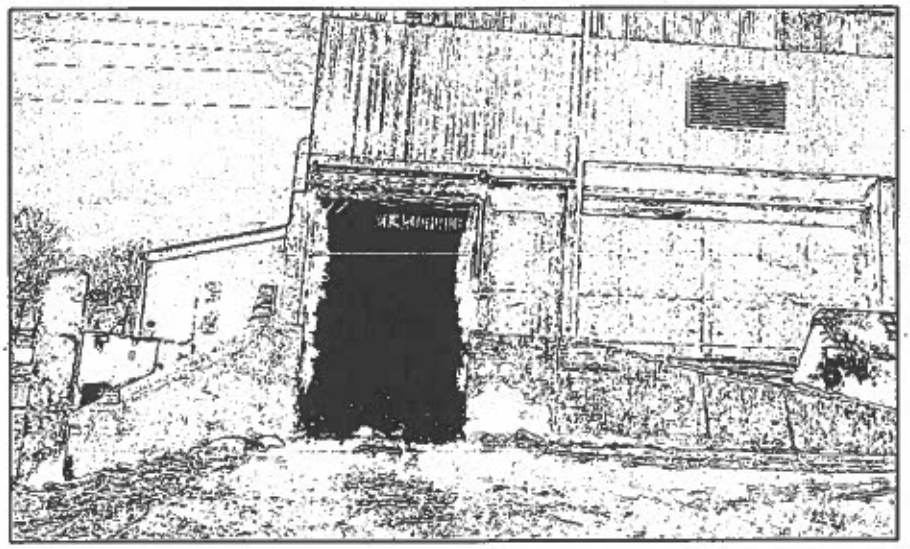
Photograph No.:	10	Direction:	Southeast
Description:	View of outbound truck loading area
