Illinois Environmental Protection Agency
Delegated Agency Solid Waste Program
Transfer/Storage Inspection

County:	Cook	BOL #:	0310810003	Region:	2 - Des Plaines
Site Name:	Advanced Disposal Services Transfer Station				
Site Address:	1711 Church Street	City:	Evanston		
Site Contact:	Douglas Ray	Phone:	630-373-0364		
Inspector:	Travis Wood	Email:	douglas.ray@advanceddisposal.com		
Date/Times:	02/28/2022 8:00 AM	Interviewed:	Douglas Ray		
Weather:	Sunny 34°F	Complaint #:	N/A

COOK COUNTY
DEPARTMENT OF ENVIRONMENT AND SUSTAINABILITY
SOLID WASTE INSPECTION REPORT

Inspection Report

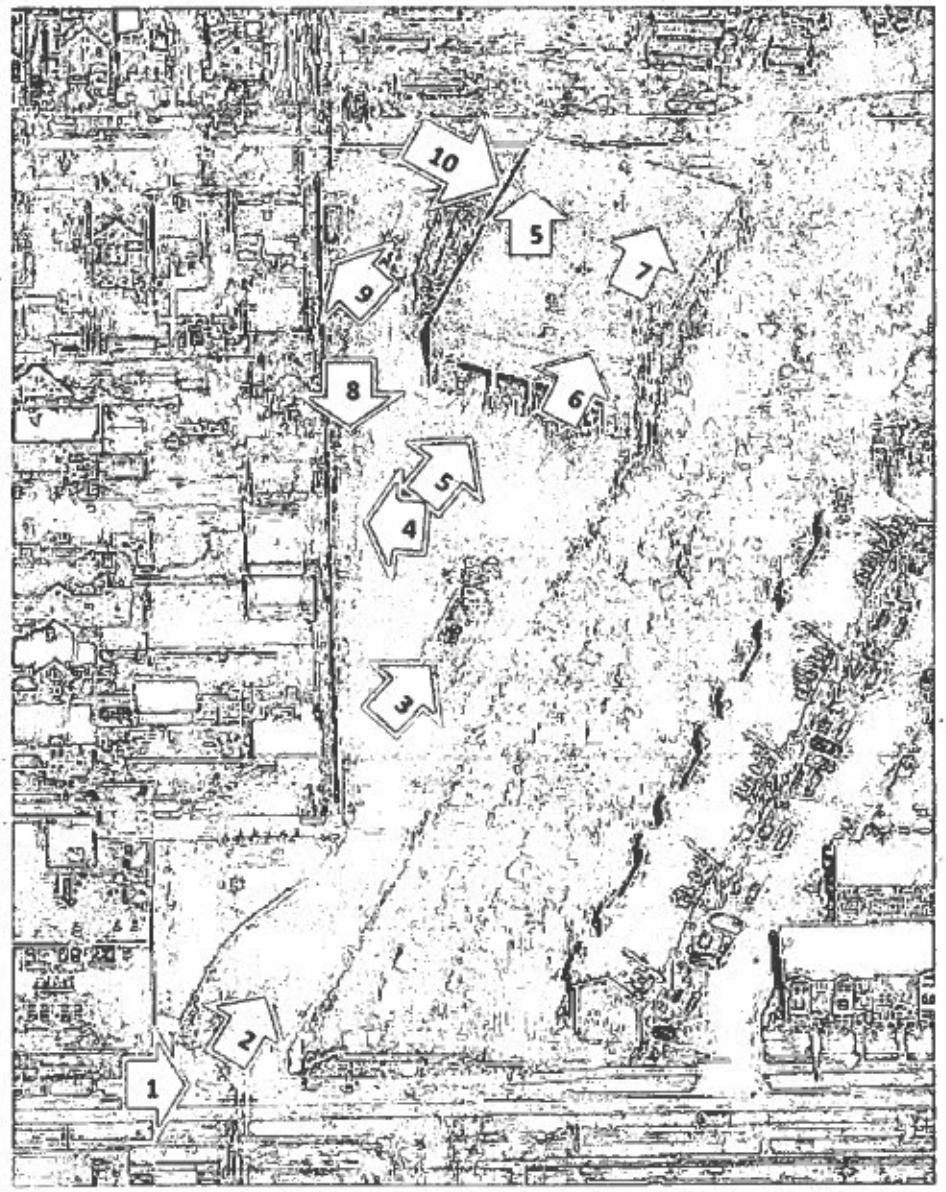
Site Map

Photo does not depict current conditions at the site at the time of inspection.

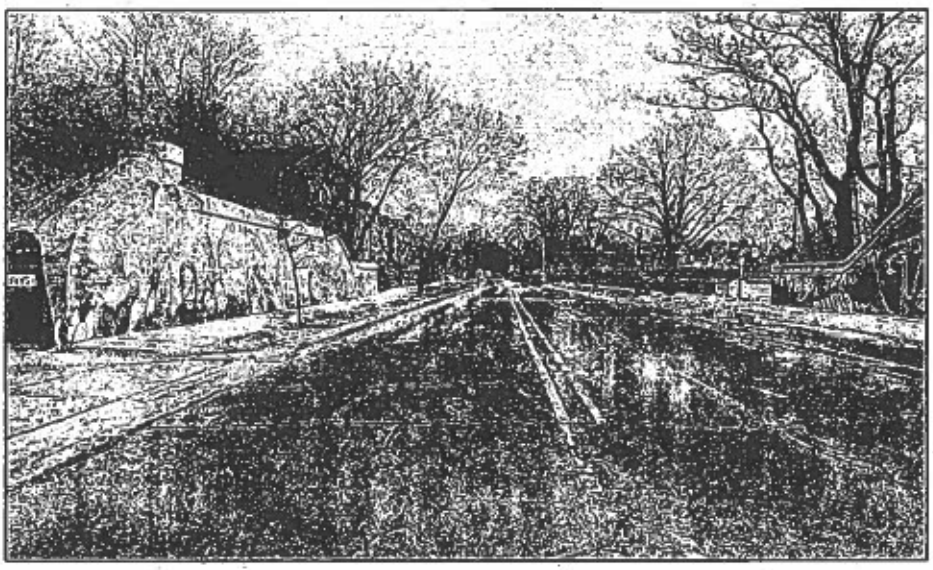
No malodor, runoff, litter, mud, or dust were present. No violations were observed during the inspection.

Photograph No.:	1	Direction:	East
Description:	View of roadway adjacent to site, no litter observed

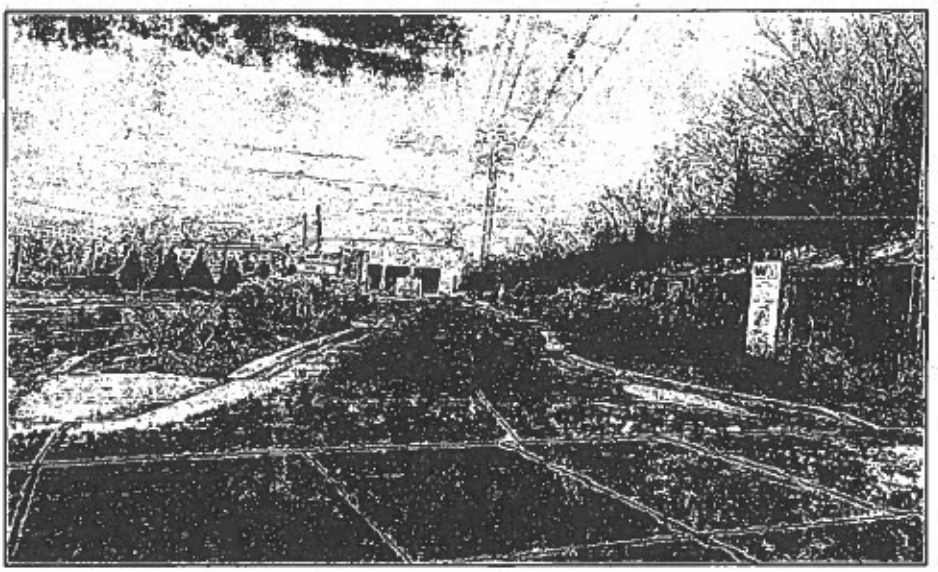
Photograph No.:	2	Direction:	Northeast
Description:	View of site entrance free from litter

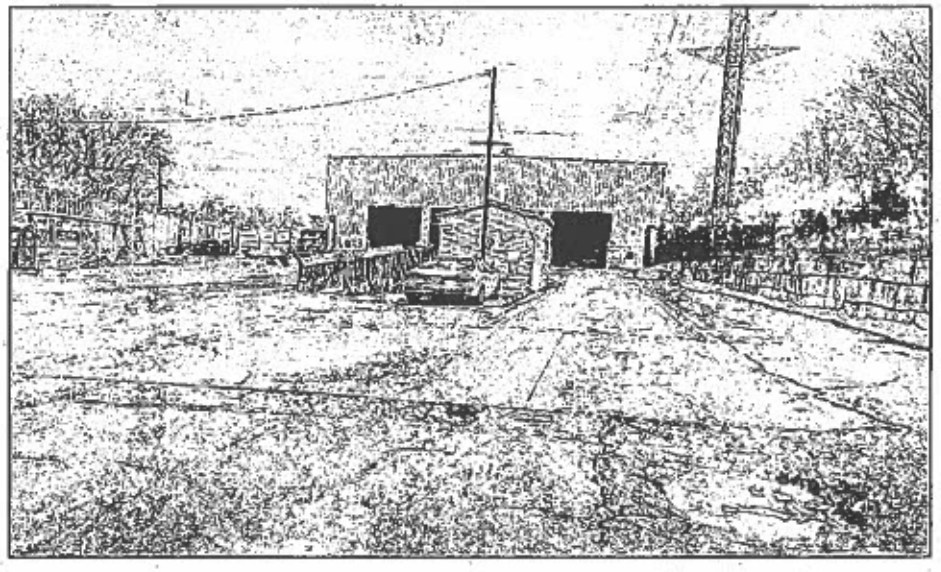
Photograph No.:	3	Direction:	Northeast
Description:	View of scale and scale house

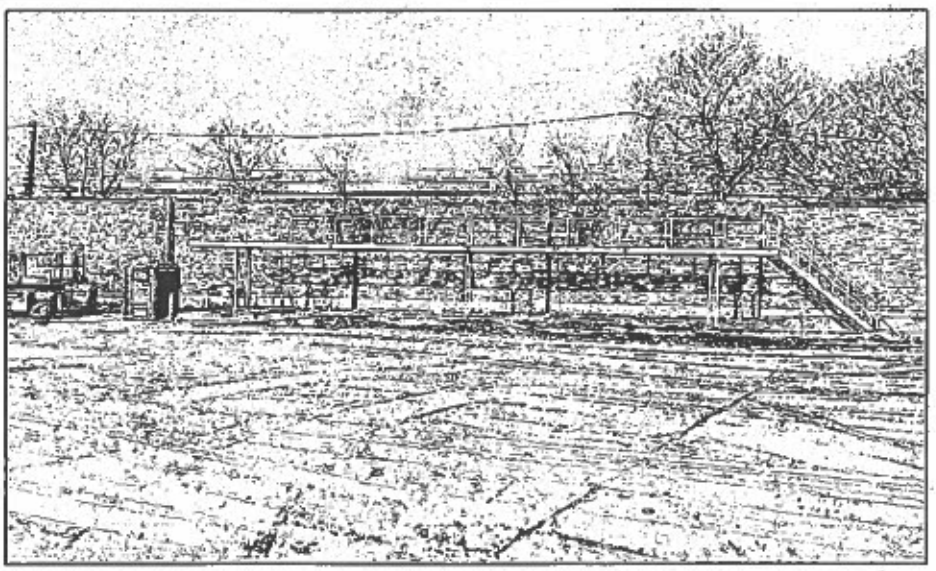
Photograph No.:	4	Direction:	West
Description:	View of load checking and tarping platform

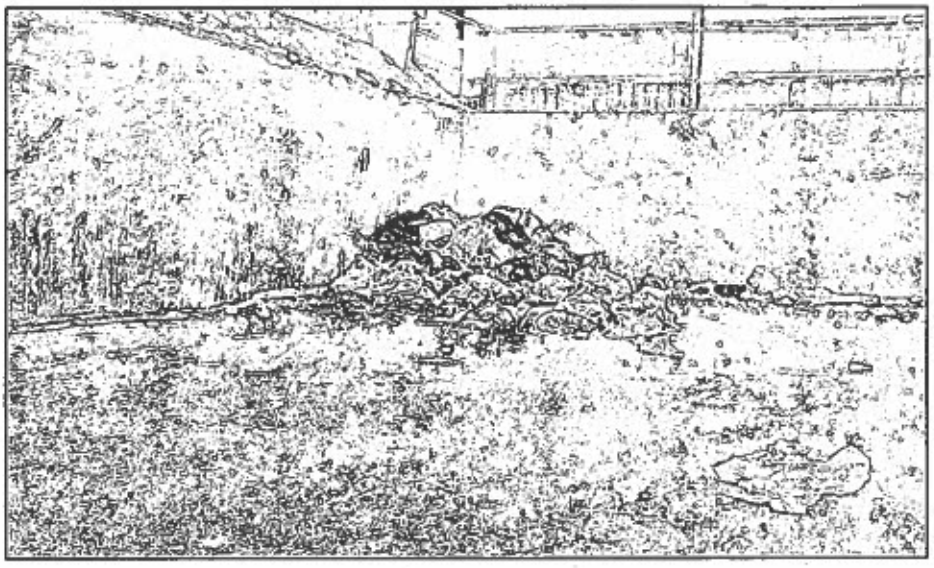
Engineer observed MSW in the transfer station building. One side was for garbage trucks and the other side was for smaller hauling trucks. At the time of inspection, garbage trucks were observed tipping material in the transfer station building. An outbound truck was also being loaded with MSW. A staff member was observed collecting any debris that may have escaped the tipping room.

Photograph No.:	5	Direction:	North
Description:	View of MSW pile in transfer station building

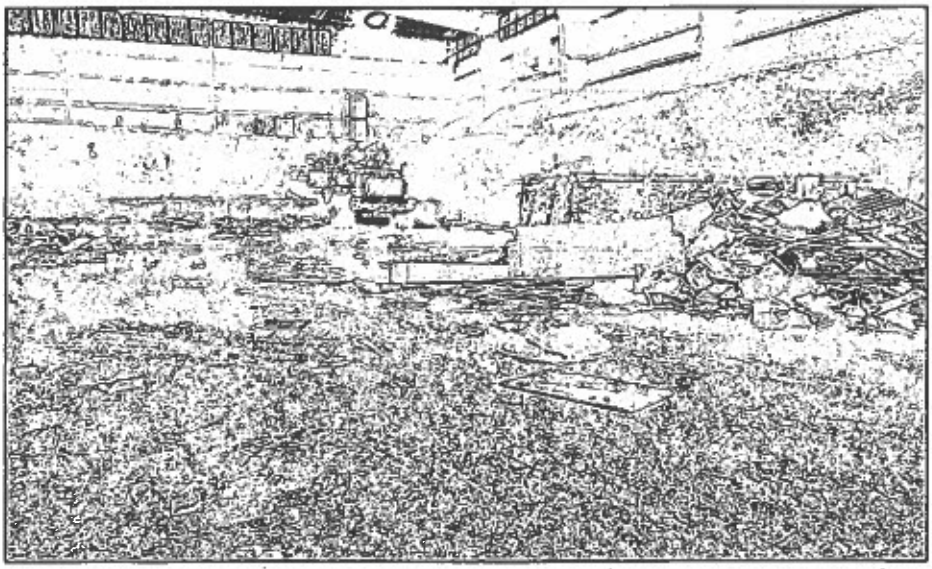
Photograph No.:	6	Direction:	Northeast
Description:	View of small contractor truck tipping area

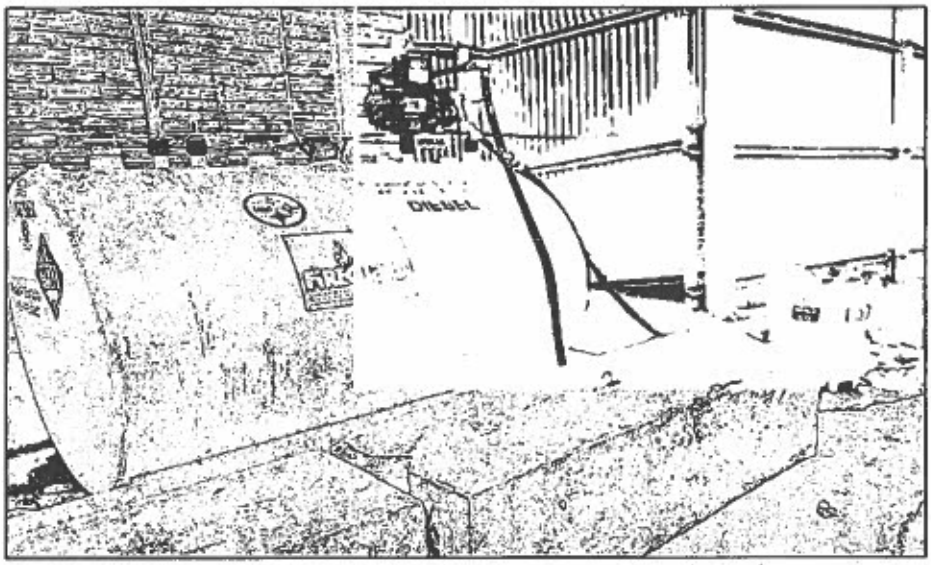
Photograph No.:	9	Direction:	Northwest
Description:	View of fueling area and spill kit

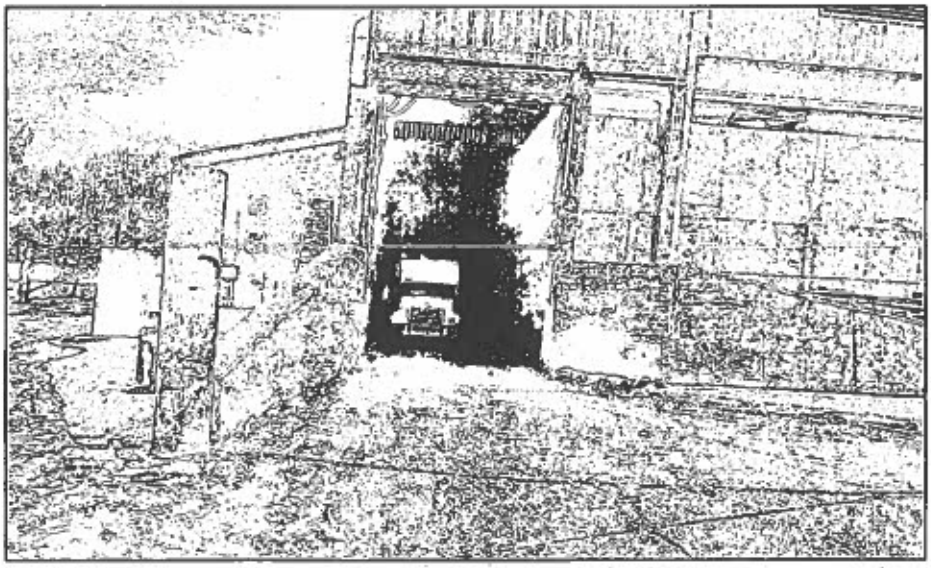
Photograph No.:	10	Direction:	Southeast
Description:	View of outbound truck loading area
