Illinois Environmental Protection Agency
Delegated Agency Solid Waste Program
Transfer/Storage Inspection

COOK COUNTY
DEPARTMENT OF ENVIRONMENT AND SUSTAINABILITY
SOLID WASTE INSPECTION REPORT

Facility:	Veolia-Evanston Transfer Station				
CCDEC ID:		IEPA ID or Other ID:		0310810003	
Address:	1711 Church Street				
City:	Evanston	Date:	07/28/2022	Time:	9:45 am
Inspector:	Travis Wood			Badge No.:	122

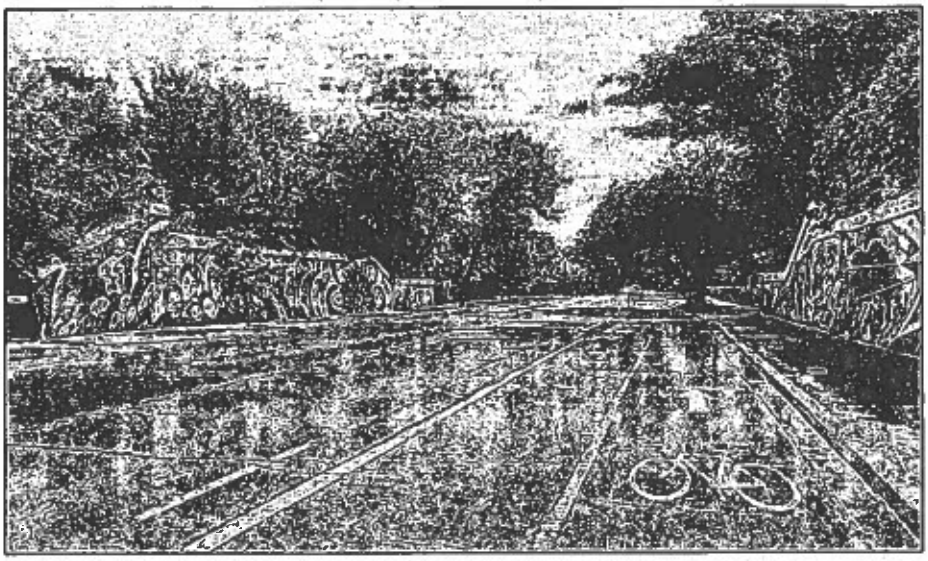
Photograph No.:	1	Direction:	Southeast
Description:	View of roadway adjacent to site, no litter observed

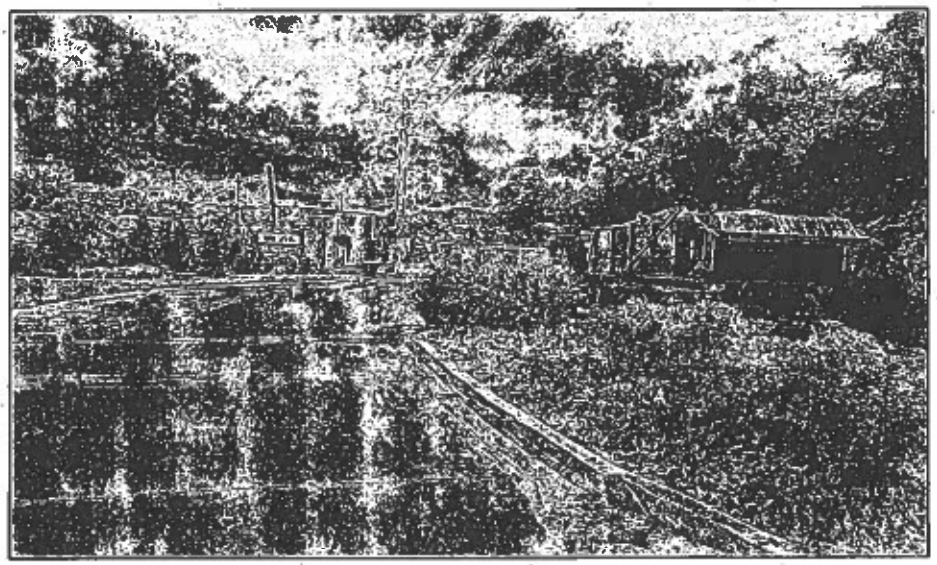
Photograph No.:	2	Direction:	Northeast
Description:	View of site entrance free from litter

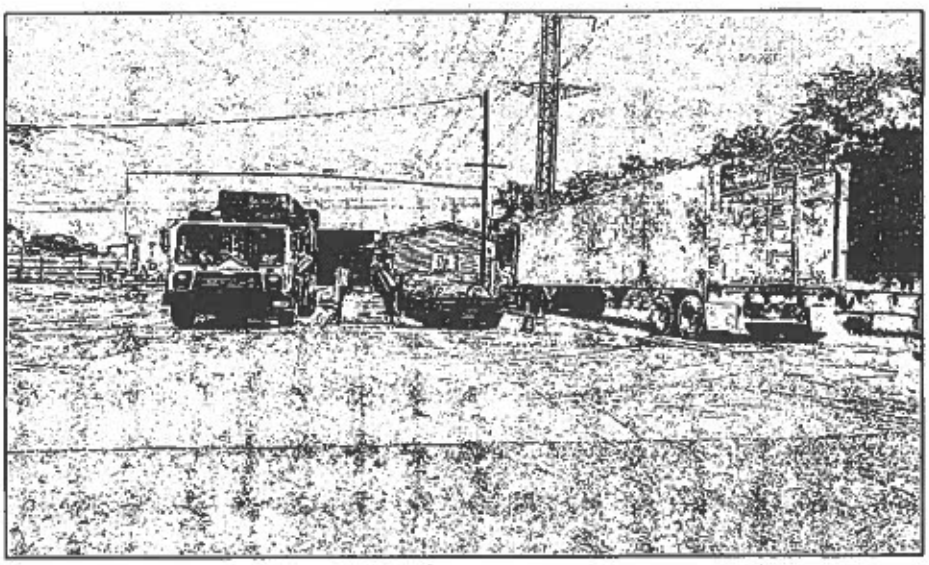
Photograph No.:	3	Direction:	Northeast
Description:	View of scale and scale house

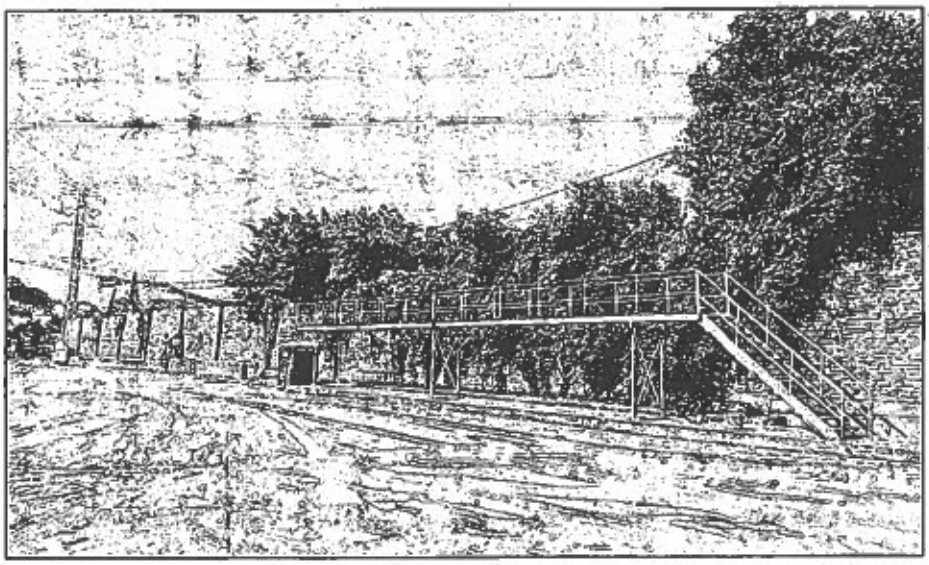
Photograph No.:	4	Direction:	Southwest
Description:	View of load checking and tarping platform

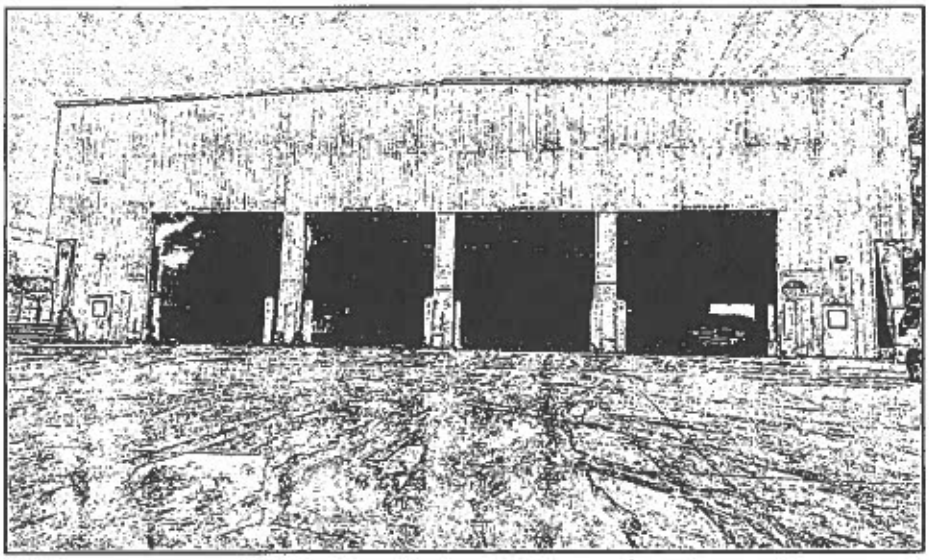
Engineer observed a small amount of MSW in the transfer station building. One side was for garbage trucks and the other side was for smaller hauling trucks. At the time of inspection, garbage trucks were observed tipping material in the transfer station building. An outbound truck was also being loaded with MSW. A staff member was observed collecting any debris that may have escaped the tipping room.

Photograph No.:	5	Direction:	North
Description:	View of MSW pile in transfer station building

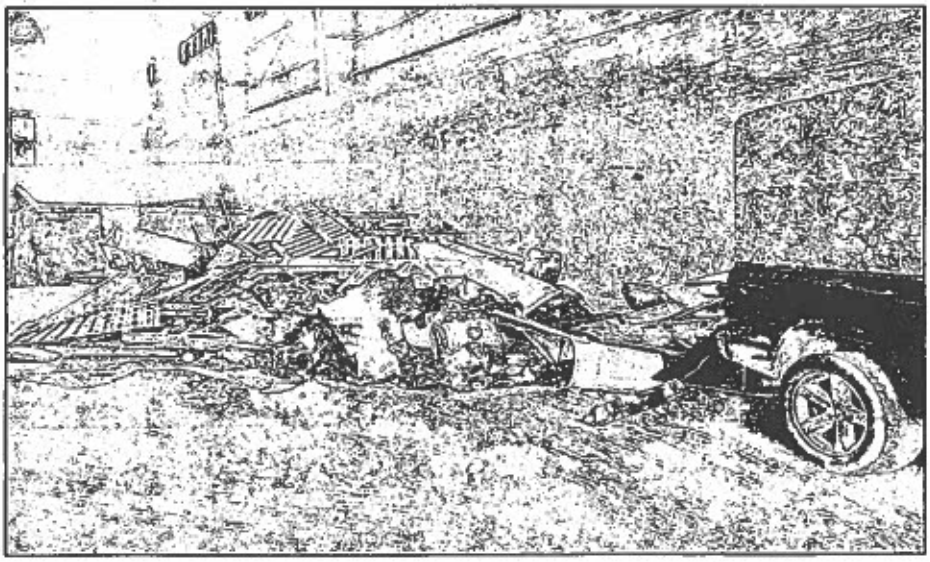
Photograph No.:	6	Direction:	Northeast
Description:	View of small contractor truck tipping area

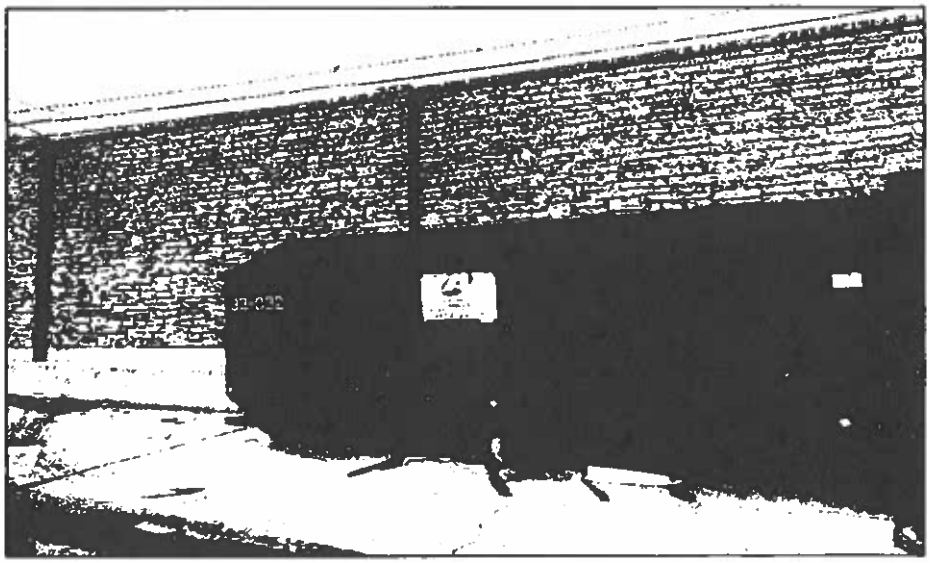
On the west side of the site, a covered tire bin was observed; Engineer did not observe any used tires in the bin. Pomp's Tires picks up any used tires when they are on site each month. The tires are picked up on the first Thursday of each month.

Photograph No.:	8	Direction:	Southwest
Description:	View of tire storage bin

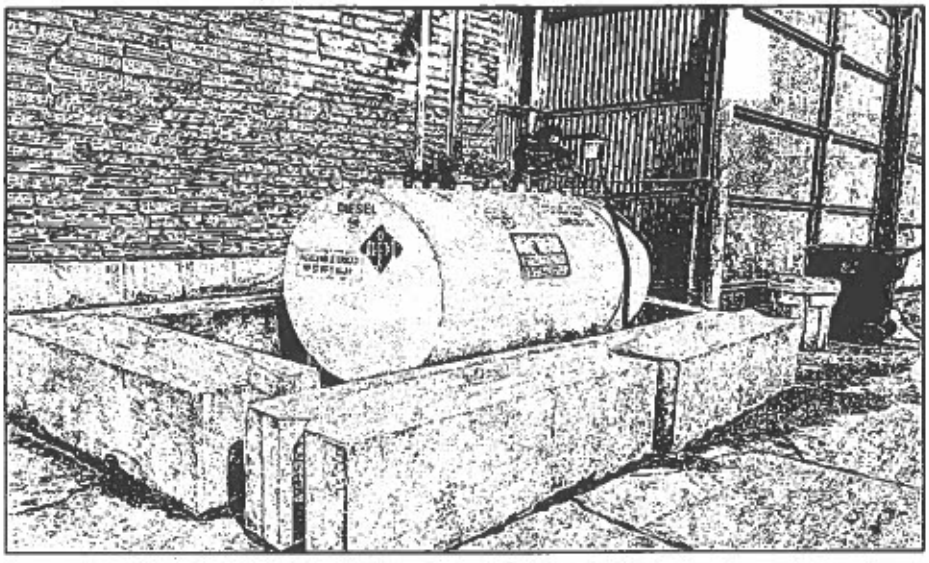
Photograph No.:	9	Direction:	Northwest
Description:	View of fueling area and spill kit

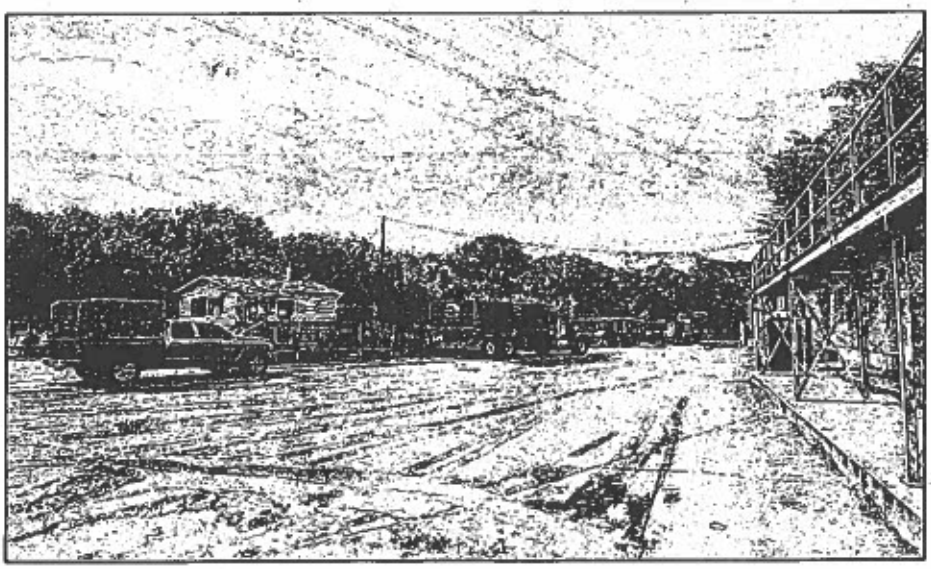
Photograph No.:	10	Direction:	South
Description:	View of site activities
