Illinois Environmental Protection Agency
Delegated Agency Solid Waste Program
Transfer/Storage Inspection

County:	Cook	BOL #:	0310810003	Region:	2 - Des Plaines
Site Name:	Evanston Transfer Station				
Site Address:	1711 Church Street	City:	Evanston		
Site Contact:	Doug Ray	Phone:	630-373-0364		
Inspector:	Travis Wood	Email:	ahartgrav@wm.com		
Date/Times:	09/28/2022 8:05 AM	Interviewed:	Amy Hartgraves		
Weather:	Sunny 49°F	Complaint #:	N/A

COOK COUNTY
DEPARTMENT OF ENVIRONMENT AND SUSTAINABILITY
SOLID WASTE INSPECTION REPORT

Inspection Report

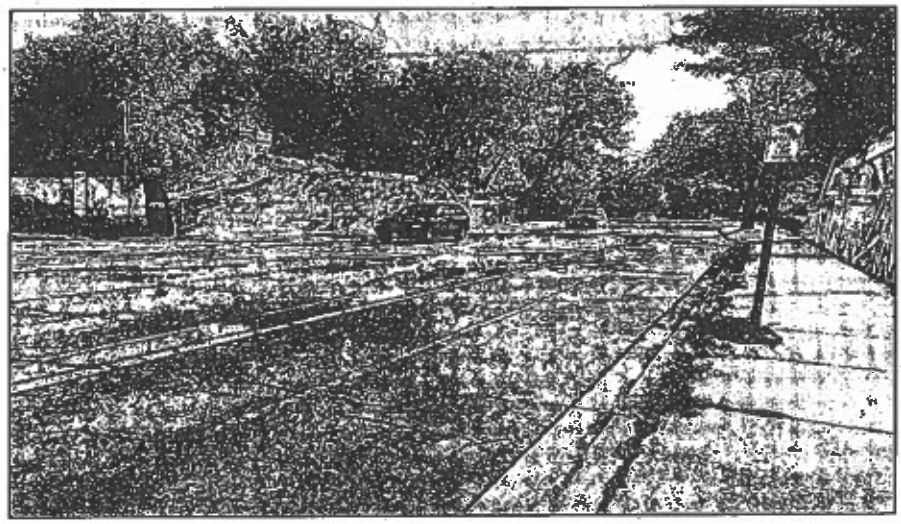
No malodor, runoff, litter, mud, or dust were present. No violations were observed during the inspection.

Photograph No.:	1	Direction:	Southeast
Description:	View of roadway adjacent to site, no litter observed

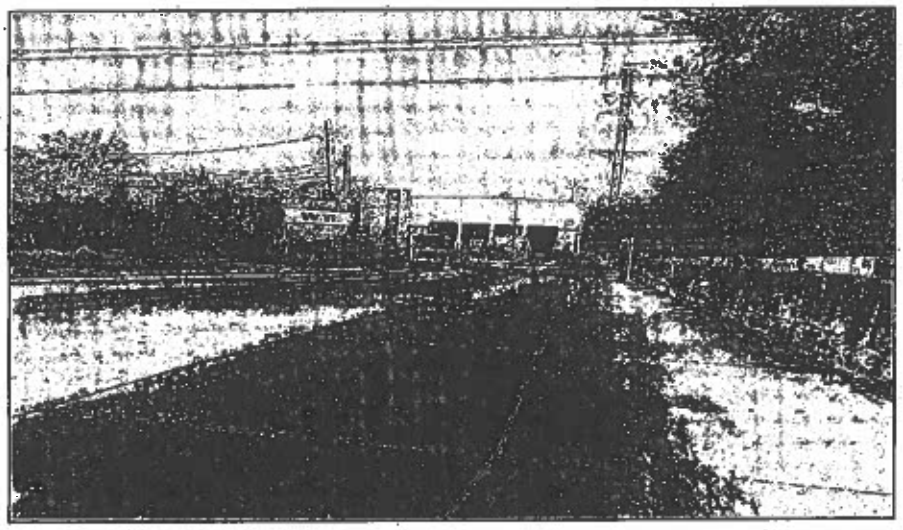
Photograph No.:	2	Direction:	Northeast
Description:	View of site entrance free from litter

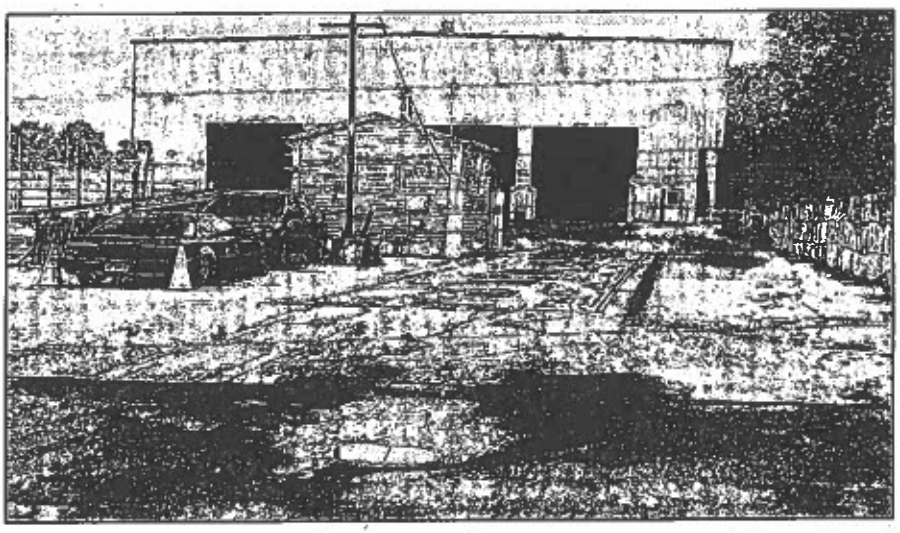
Photograph No.:	3	Direction:	Northeast
Description:	View of scale and scale house

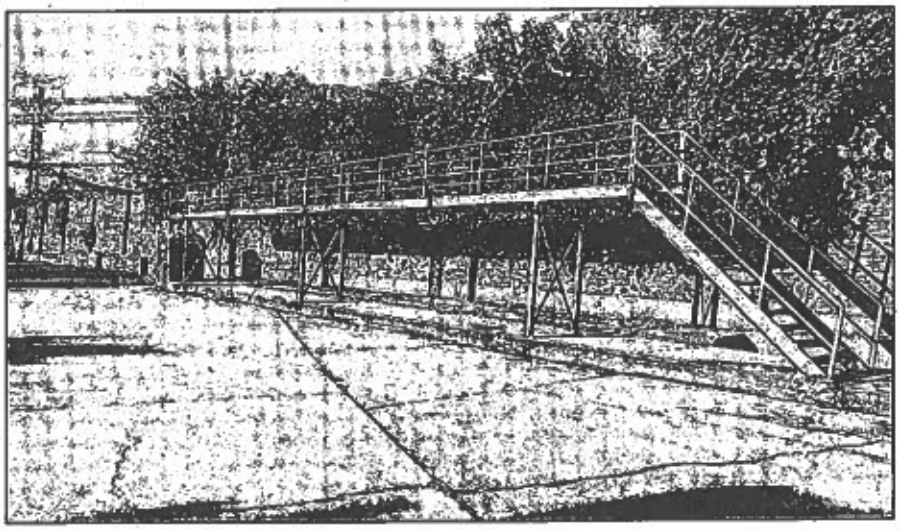
Photograph No.:	4	Direction:	Southwest
Description:	View of load checking and tarping platform

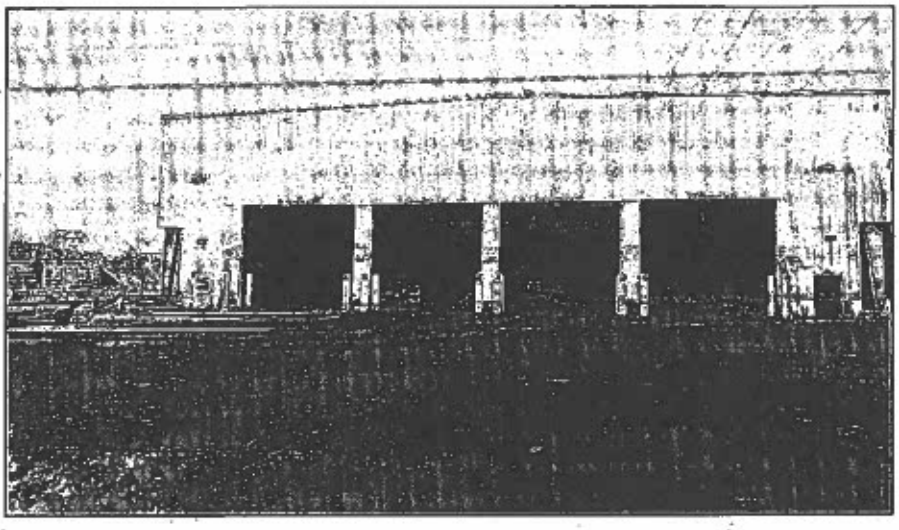
Engineer observed a small amount of MSW in the transfer station building. One side was for garbage trucks and the other side is for smaller hauling trucks. At the time of inspection, garbage trucks were observed tipping material in the transfer station building. An outbound truck was also being loaded with MSW. A staff member was observed collecting any debris that may have escaped the tipping room.

Photograph No.:	5	Direction:	North
Description:	View of MSW pile in transfer station building

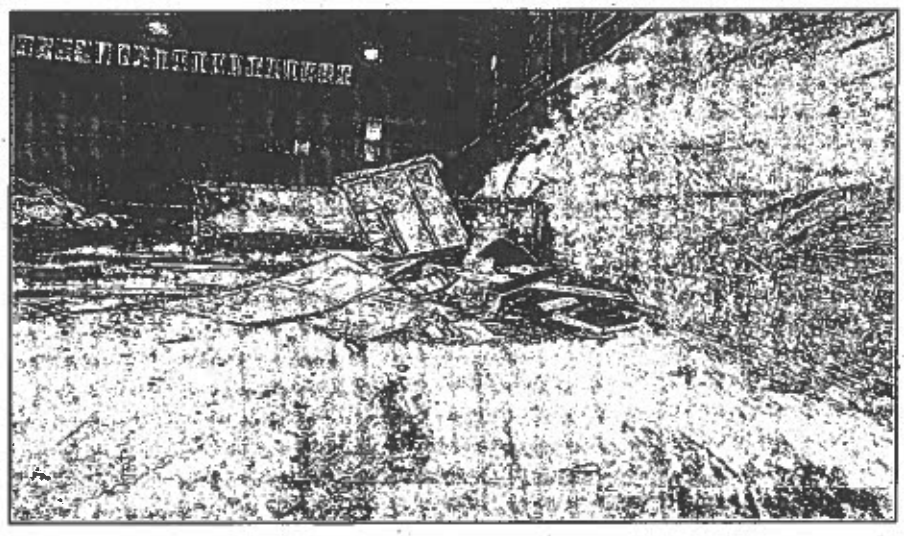
Photograph No.:	6	Direction:	Northeast
Description:	View of small contractor truck tipping area

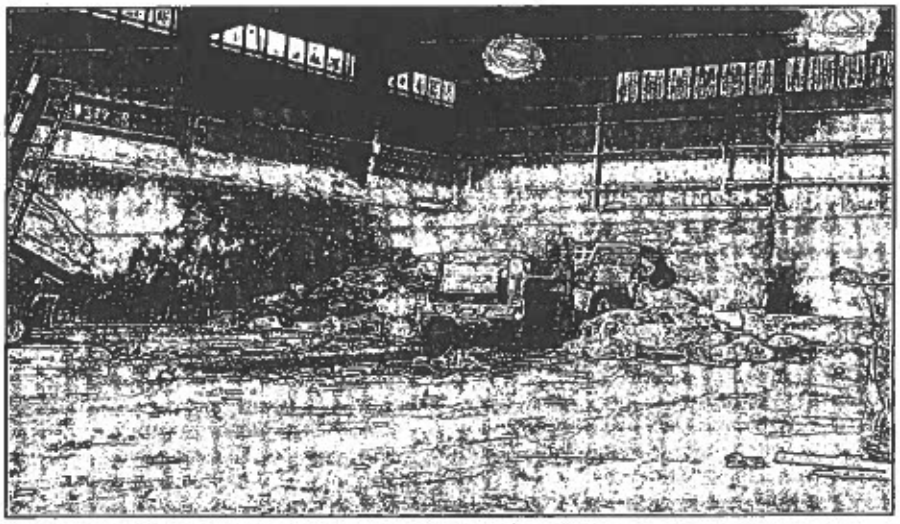
Photograph No.:	7	Direction:	Northeast
Description:	View of outbound truck loading activities

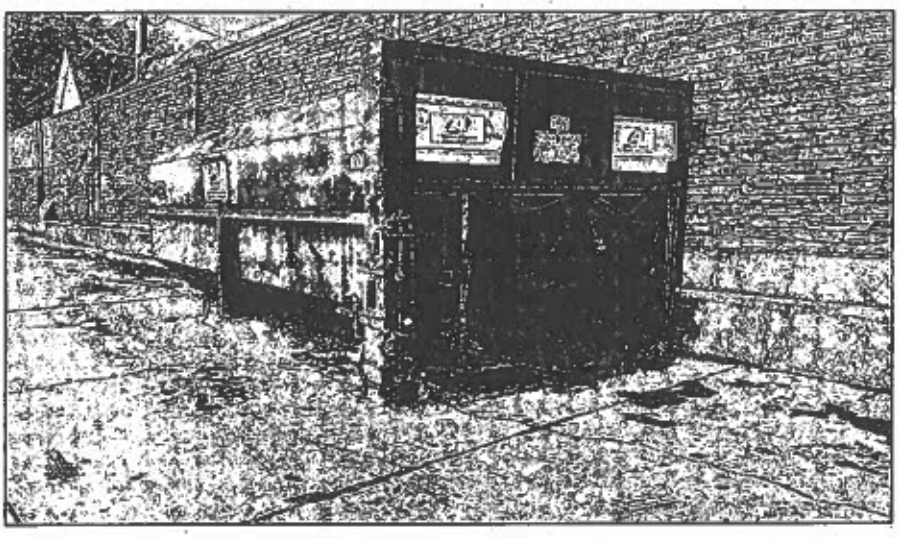
On the west side of the site, a covered tire bin was observed. Pomp's Tires picks up any used tires when they are on site each month. The tires are picked up on the first Thursday of each month.

Photograph No.:	8	Direction:	Southwest
Description:	View of tire storage bin

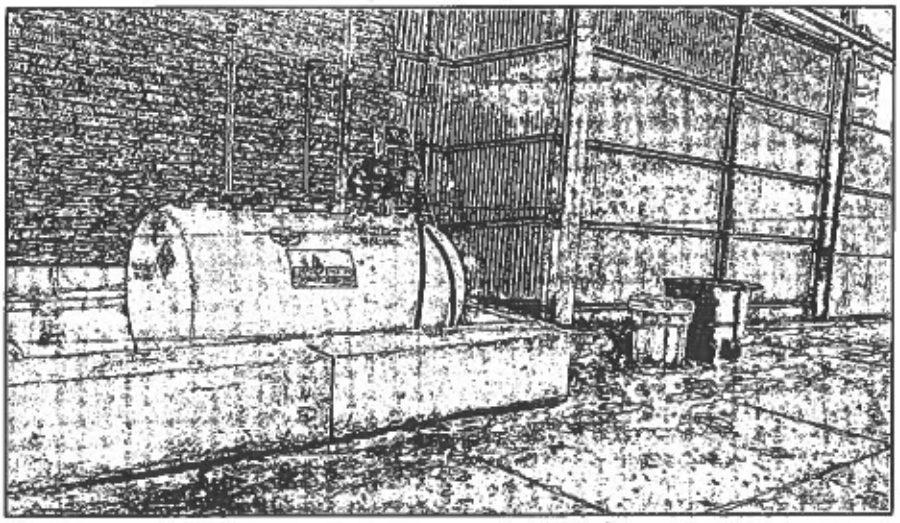
Photograph No.:	9	Direction:	Northwest
Description:	View of fueling area and spill kit

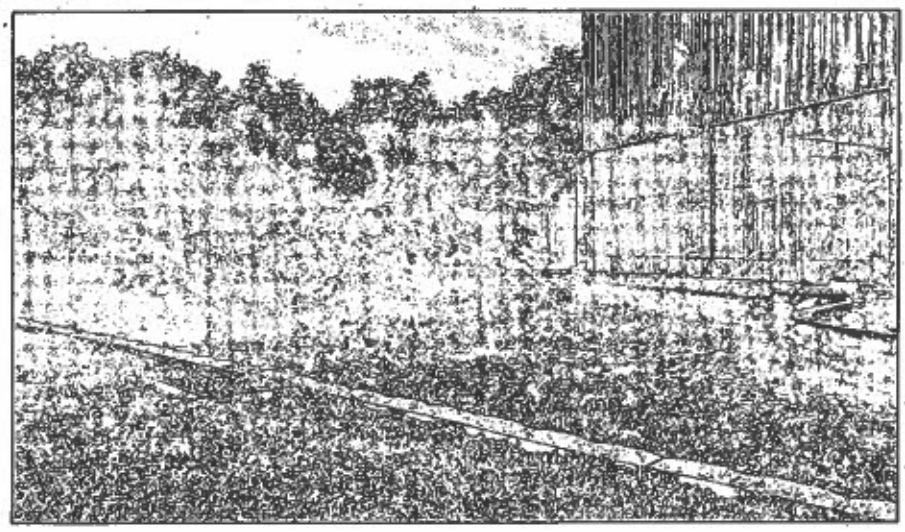
Photograph No.:	10	Direction:	Southeast
Description:	View of stormwater BMP
