Illinois Environmental Protection Agency
Delegated Agency Solid Waste Program
Transfer/Storage Inspection

COOK COUNTY
DEPARTMENT OF ENVIRONMENT AND SUSTAINABILITY
SOLID WASTE INSPECTION REPORT

Facility:	Veolia-Evanston Transfer Station				
CCDEC ID:		IEPA ID or Other ID:		0310810003	
Address:	1711 Church Street				
City:	Evanston	Date:	12/12/2022	Time:	7:55 am
Inspector:	Travis Wood			Badge No.:	122

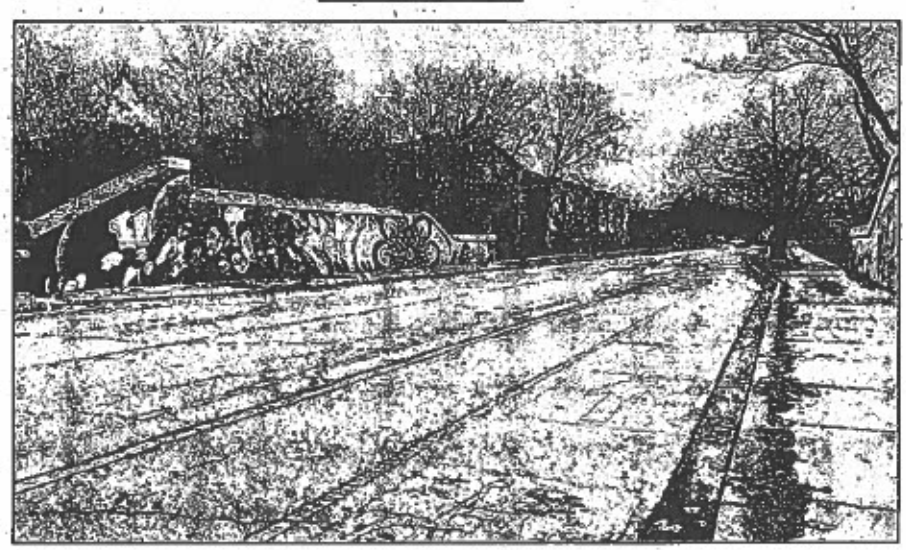
Site Map

Photo does not depict current conditions at the site at the time of inspection.

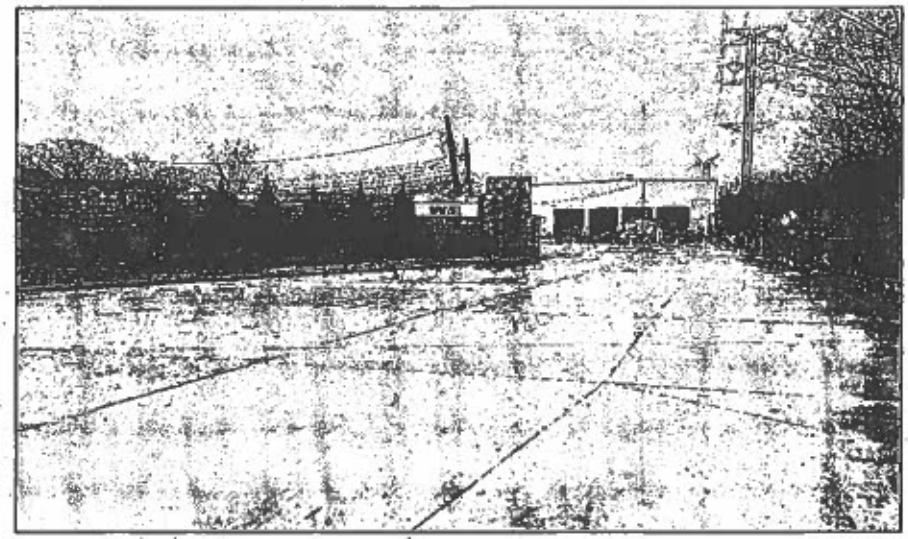
Photograph No.:	1	Direction:	Northeast
Description:	View of roadway adjacent to site, no litter observed

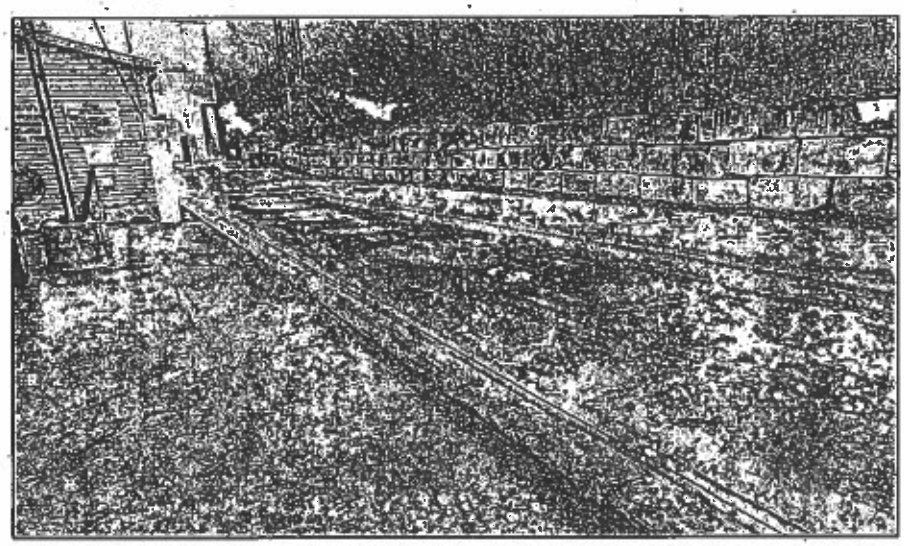
Photograph No.:	2	Direction:	Northeast
Description:	View of site entrance free from litter

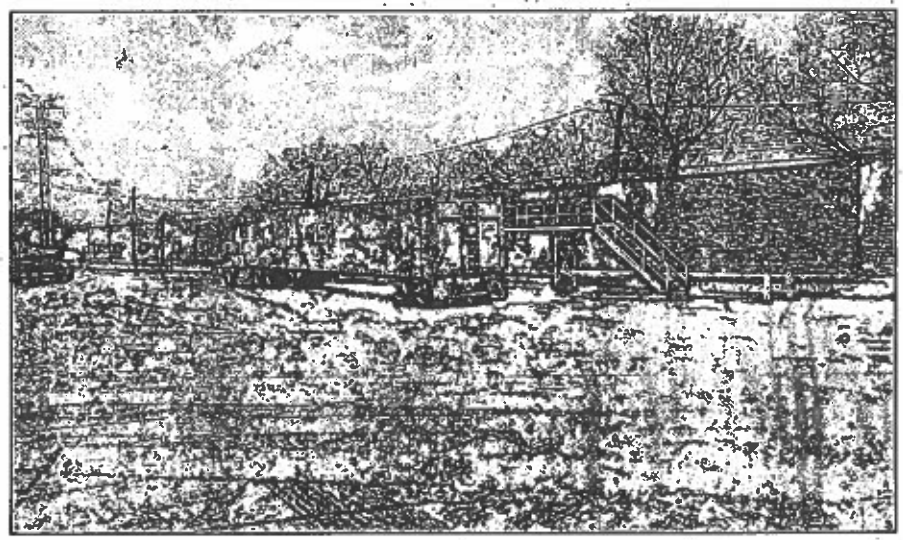
Photograph No.:	3	Direction:	Northeast
Description:	View of scale and scale house

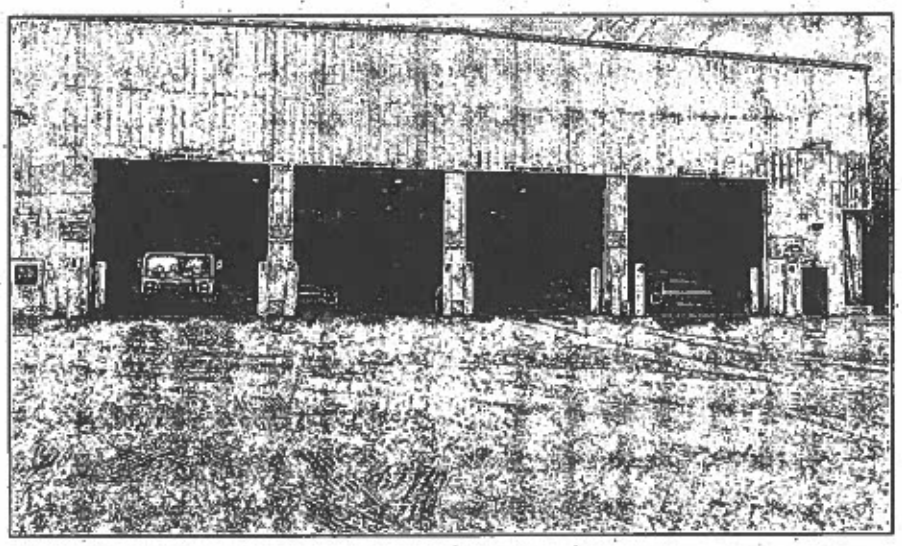
Photograph No.:	4	Direction:	Southwest
Description:	View of load checking and tarping platform

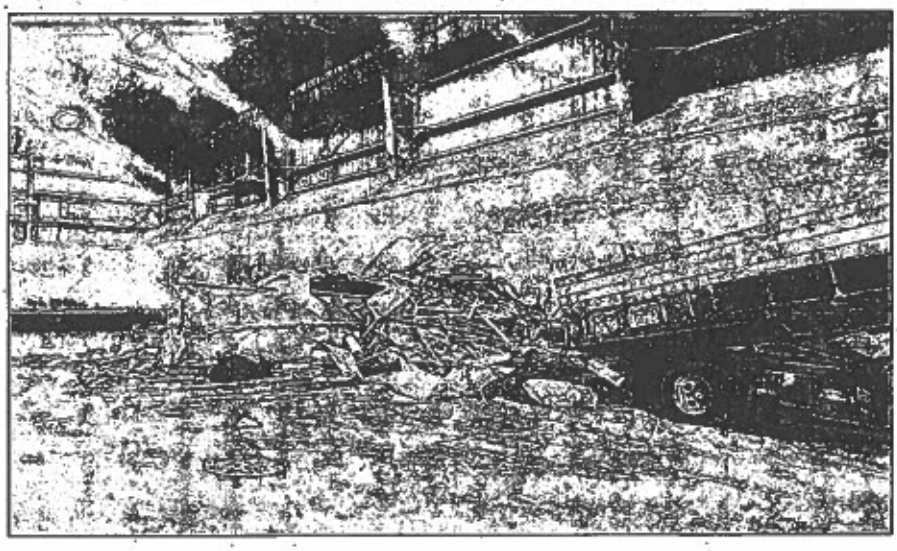
Photograph No.:	5	Direction:	North
Description:	View of MSW pile in transfer station building

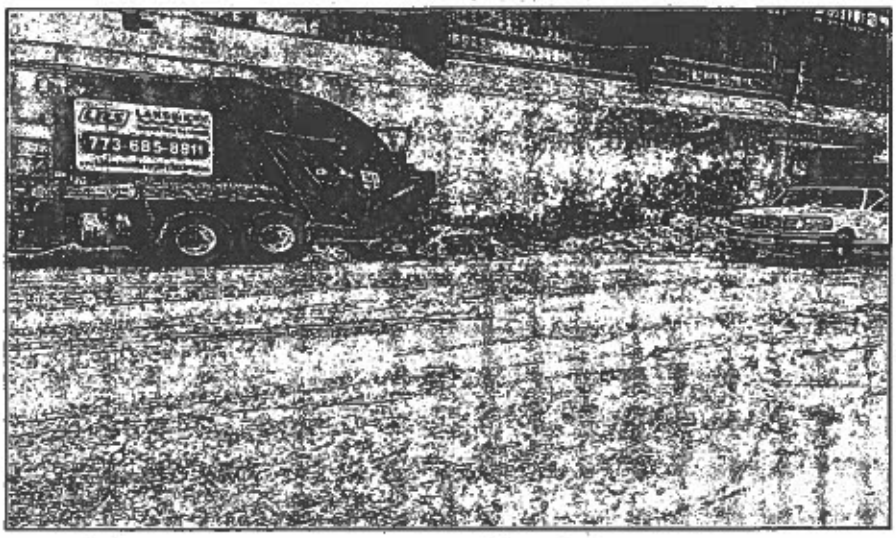
Photograph No.:	6	Direction:	Northeast
Description:	View of small contractor truck tipping area

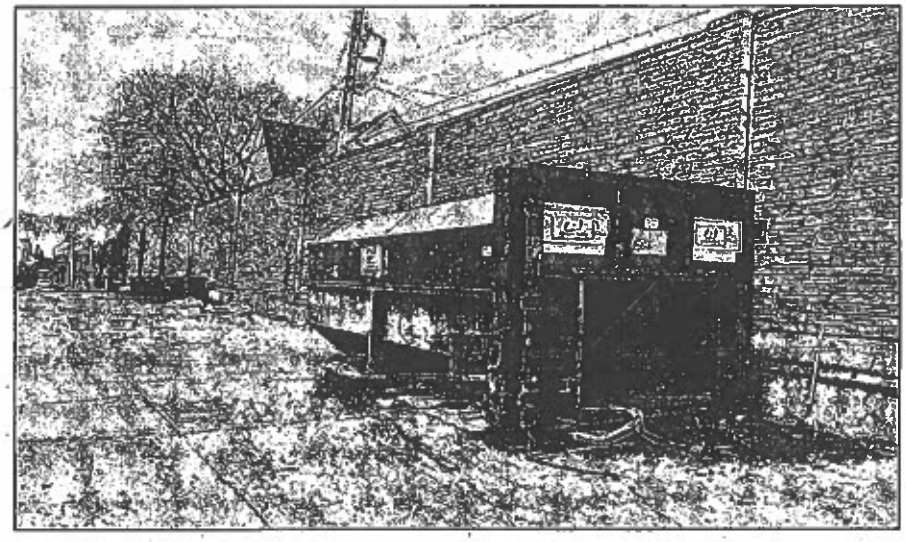
Photograph No.:	7	Direction:	Northeast
Description:	View of MSW tipping area
