Illinois Environmental Protection Agency
Delegated Agency Solid Waste Program
Transfer/Storage Inspection

COOK COUNTY
DEPARTMENT OF ENVIRONMENT AND SUSTAINABILITY
SOLID WASTE INSPECTION REPORT

Facility:	Evanston Transfer Station				
CCDEC ID:		IEPA ID or Other ID:		0310810003	
Address:	1711 Church Street				
City:	Evanston	Date:	2/27/2023	Time:	7:45 am
Inspector:	Travis Wood			Badge No.:	122

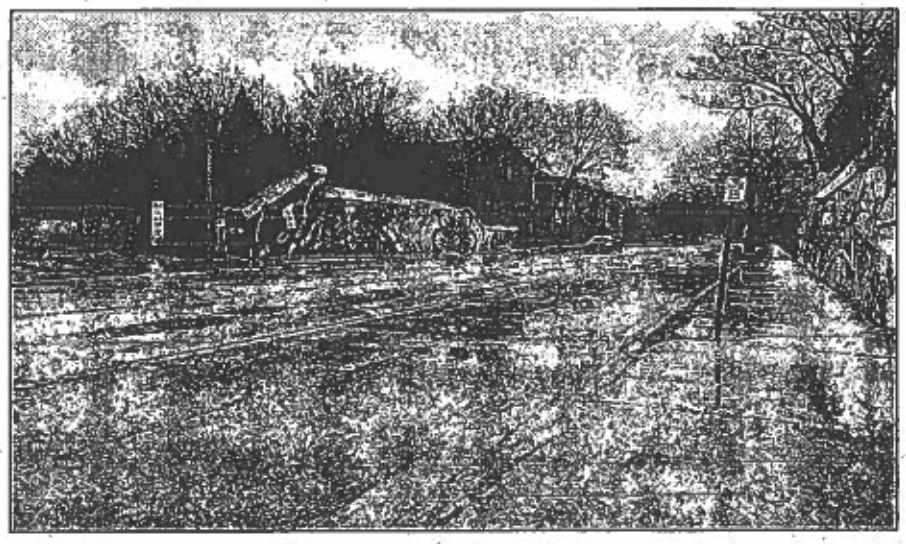
Photograph No.:	1	Direction:	Northeast
Description:	View of roadway adjacent to site, no litter observed

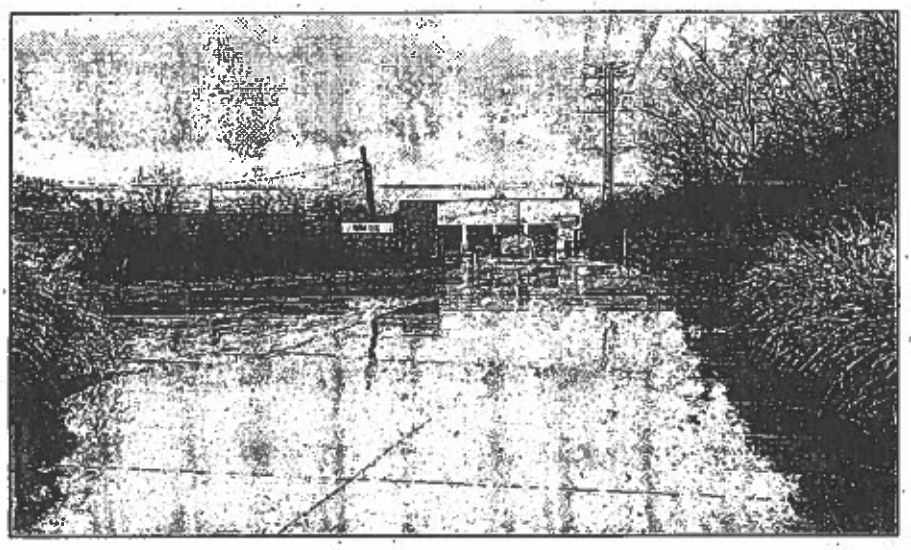
Photograph No.:	2	Direction:	Northeast
Description:	View of site entrance free from litter

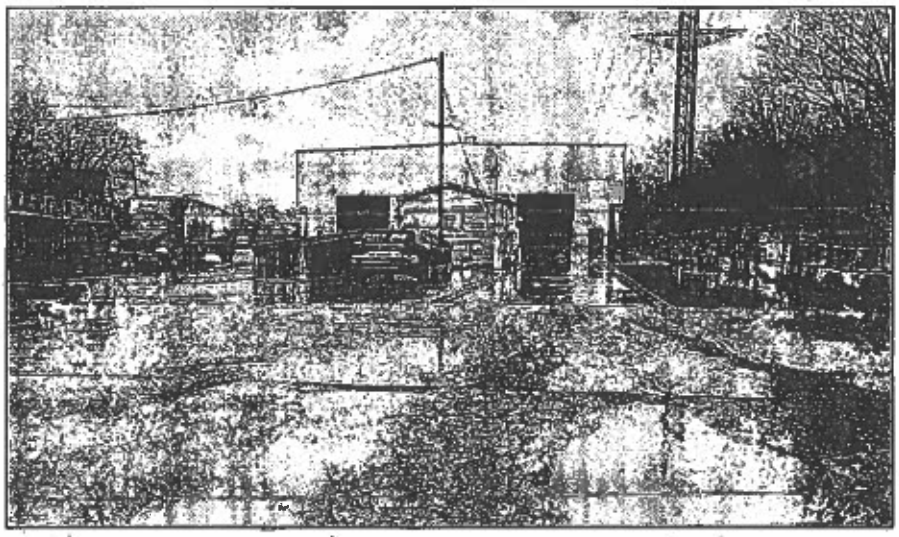
Photograph No.:	3	Direction:	Northeast
Description:	View of scale and scale house

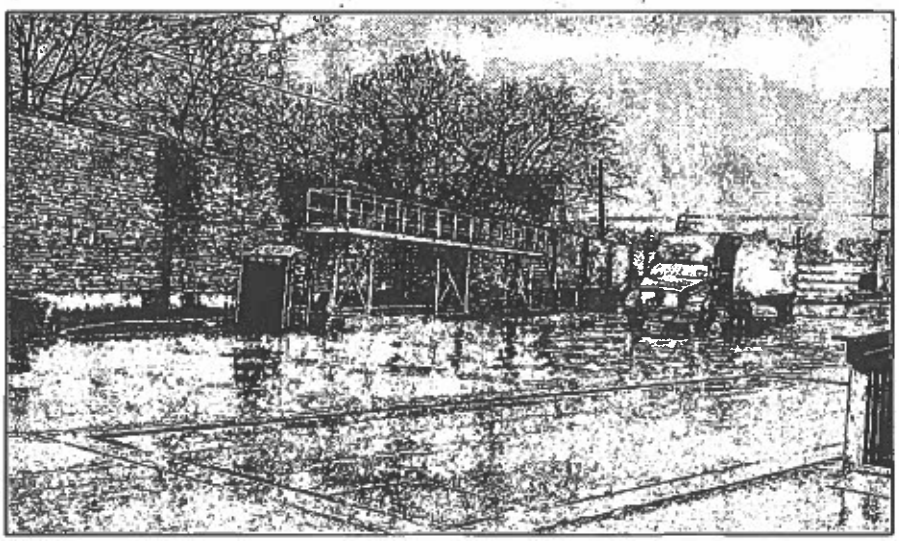
Photograph No.:	4	Direction:	Northwest
Description:	View of load checking and tarping platform

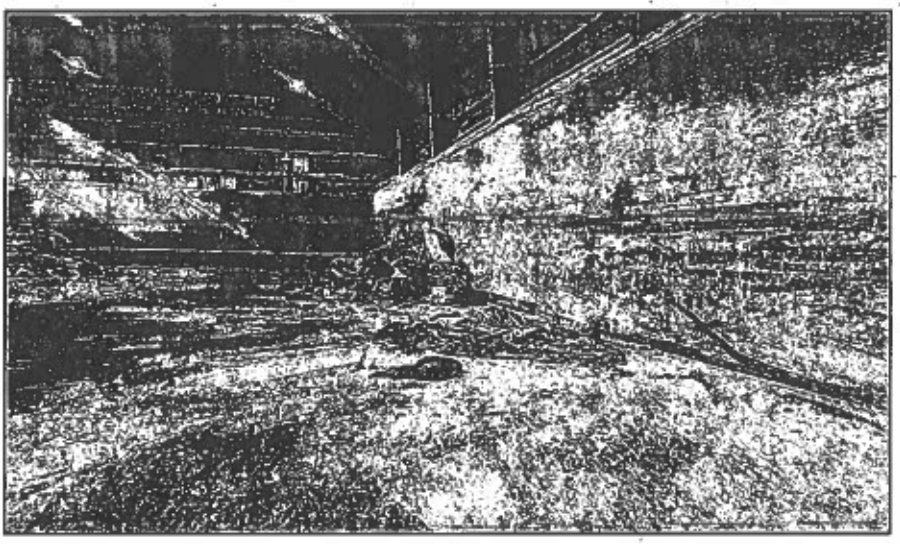
Photograph No.:	6	Direction:	Northeast
Description:	View of small contractor truck tipping area

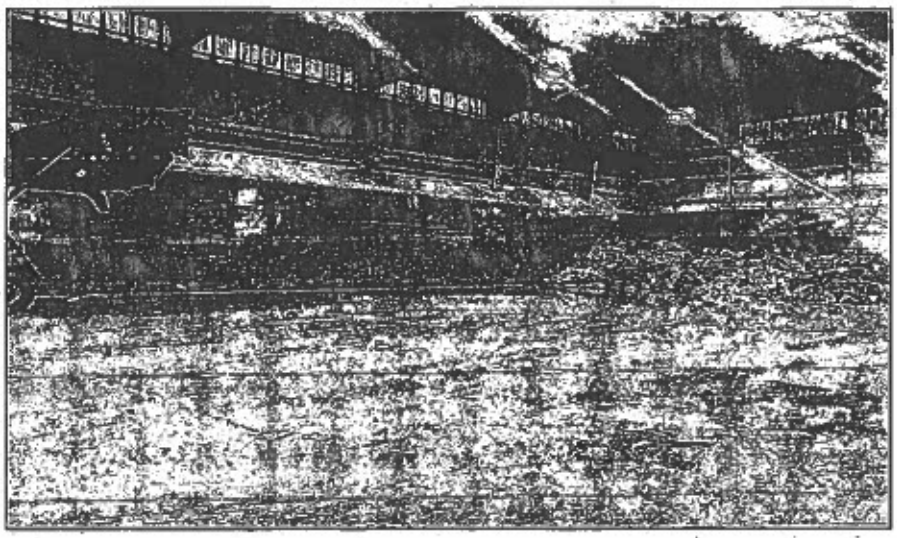
Photograph No.:	7	Direction:	Northeast
Description:	View of MSW tipping area

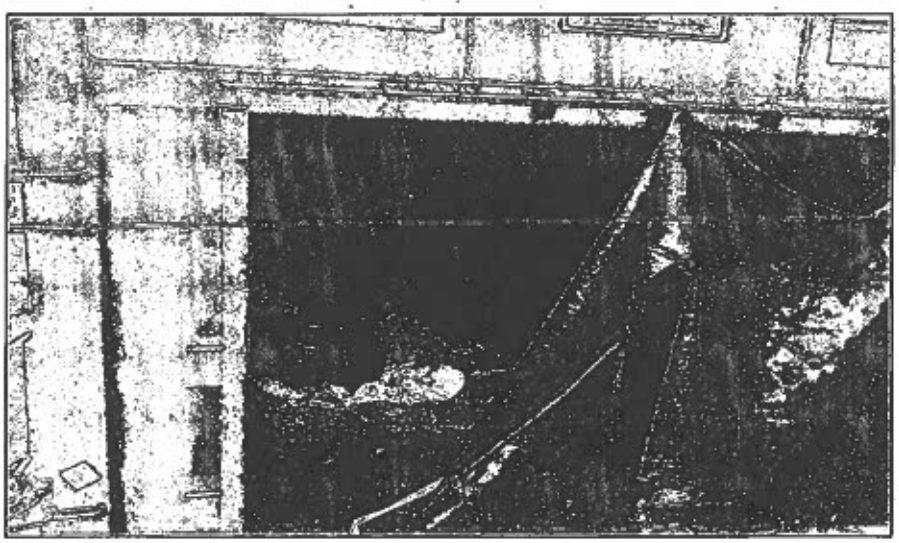
On the west side of the site, a covered tire bin was observed. Pomp's Tires picks up any used tires when they are on site each month. The tires are picked up on the first Thursday of each month.

Photograph No.:	8	Direction:	Southwest
Description:	View of tire storage bin

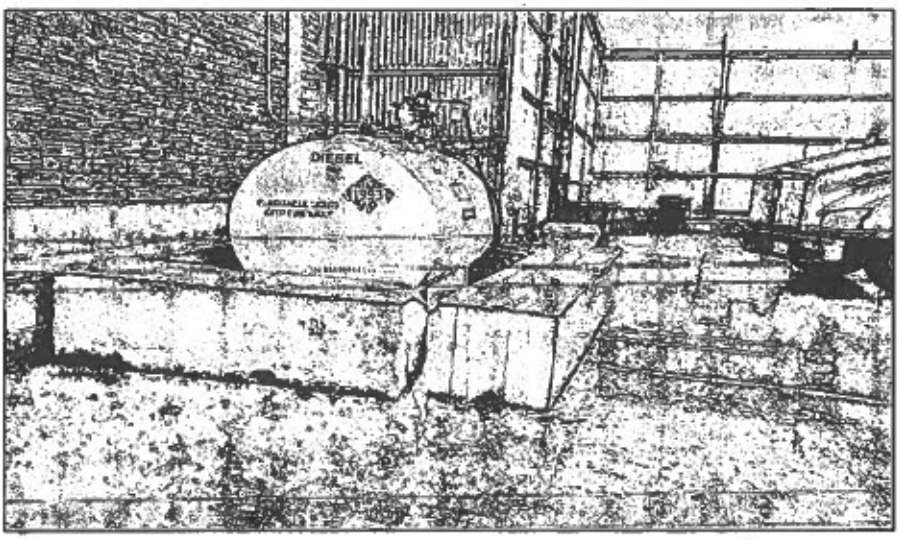
Photograph No.:	9	Direction:	Northwest
Description:	View of fueling area and spill kit
