Illinois Environmental Protection Agency
Delegated Agency Solid Waste Program
Transfer/Storage Inspection

COOK COUNTY
DEPARTMENT OF ENVIRONMENT AND SUSTAINABILITY
SOLID WASTE INSPECTION REPORT

Facility:	Evanston Transfer Station				
CCDEC ID:		IEPA ID or Other ID:		0310810003	
Address:	1711 Church Street				
City:	Evanston	Date:	1/29/24	Time:	1:32 PM
Inspector:	Andrew Nowak			Badge No.:	128

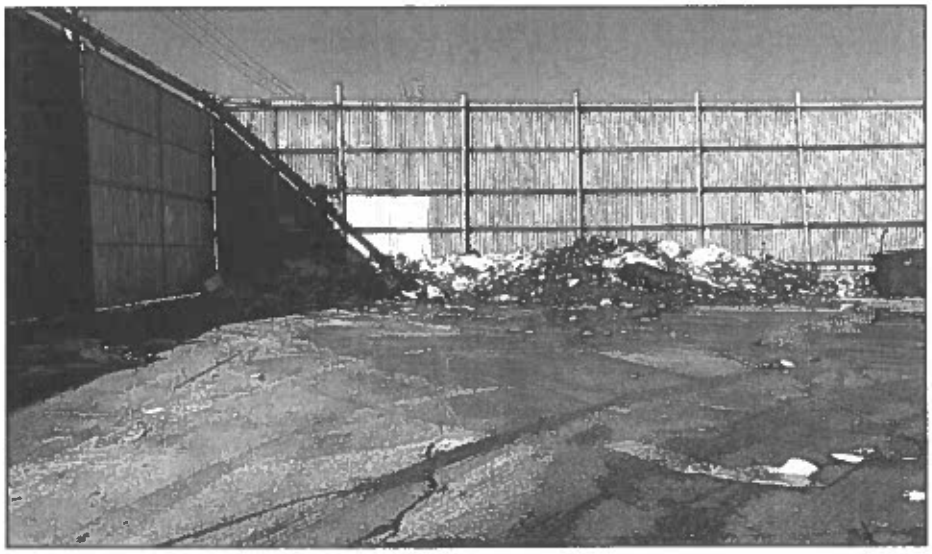
There was some light litter behind the transfer station building, with a couple items being in tree branches, as well as some litter near a sliding door along the northwest perimeter of the site. Engineer pointed out this area for site staff to address before any litter blew below the sliding door.

Photograph No.:	5	Direction:	East
Description:	View of litter

The site needs to clean up the light litter around the site.
