Illinois Environmental Protection Agency
Delegated Agency Solid Waste Program
Transfer/Storage Inspection

COOK COUNTY
DEPARTMENT OF ENVIRONMENT AND SUSTAINABILITY
SOLID WASTE INSPECTION REPORT

Inspection Report

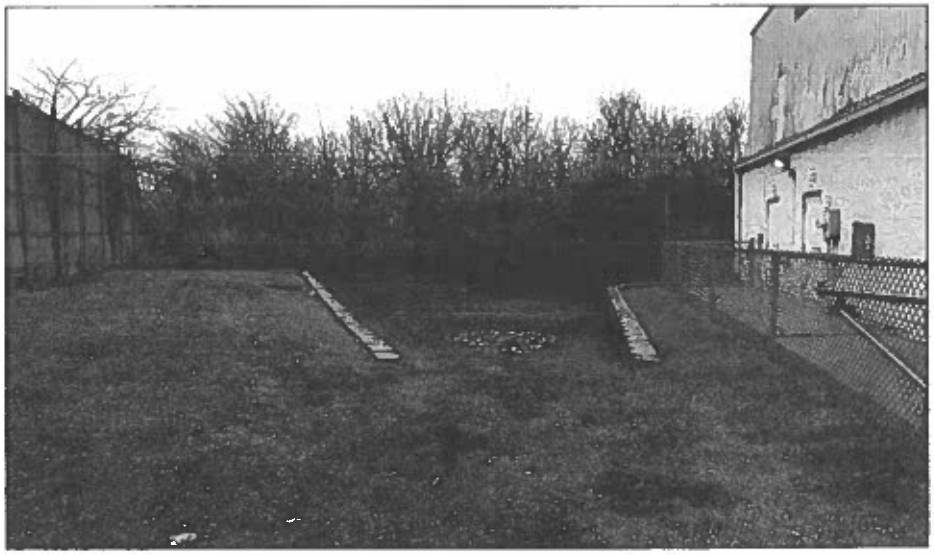
Photograph No.:	1	Direction:	Northeast
Description:	View of the site entrance/exit

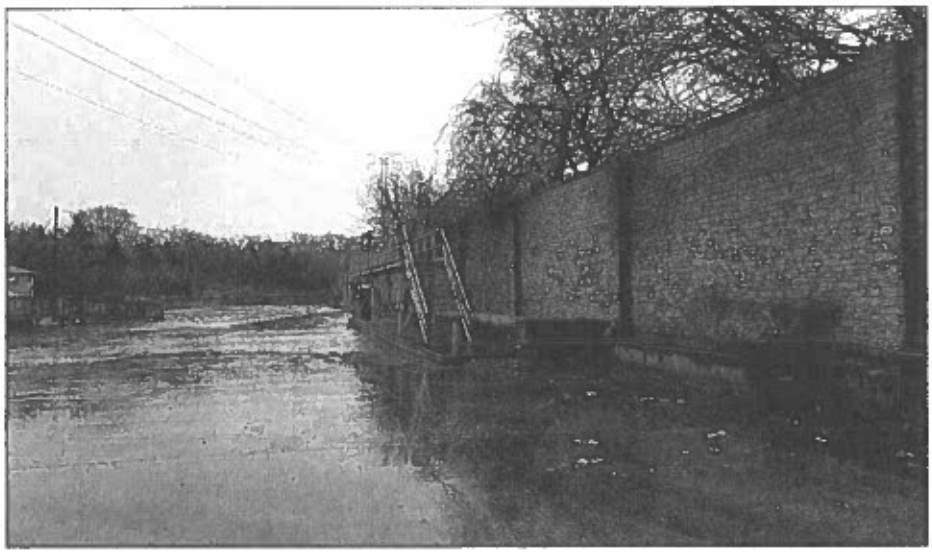
Photograph No.:	5	Direction:	South
Description:	View of the tarping station
