Delegated Agency Solid Waste Program
Transfer/Storage Inspection

COOK COUNTY
DEPARTMENT OF ENVIRONMENT AND SUSTAINABILITY
SOLID WASTE INSPECTION REPORT

Facility:	Evanston Transfer Station				
CCDEC ID:		IEPA ID or Other ID:		0310810003	
Address:	1711 Church Street				
City:	Evanston	Date:	8/13/24	Time:	1:32 PM
Inspector:	Andrew Nowak			Badge No.:	128

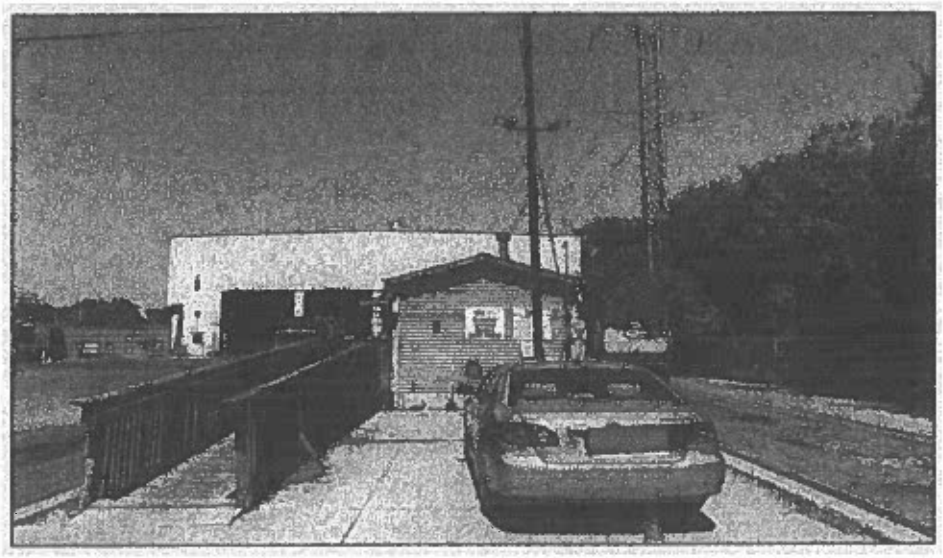
Photograph No.:	7	Direction:	North
Description:	View of the scales, office, and site
