**City of Evanston  
Civic Center 2000+**

**2100 Ridge Avenue  
Evanston, Illinois**

**RECOMMENDATIONS FOR  
INTERIM MITIGATIONS**

MARCH 24, 1999

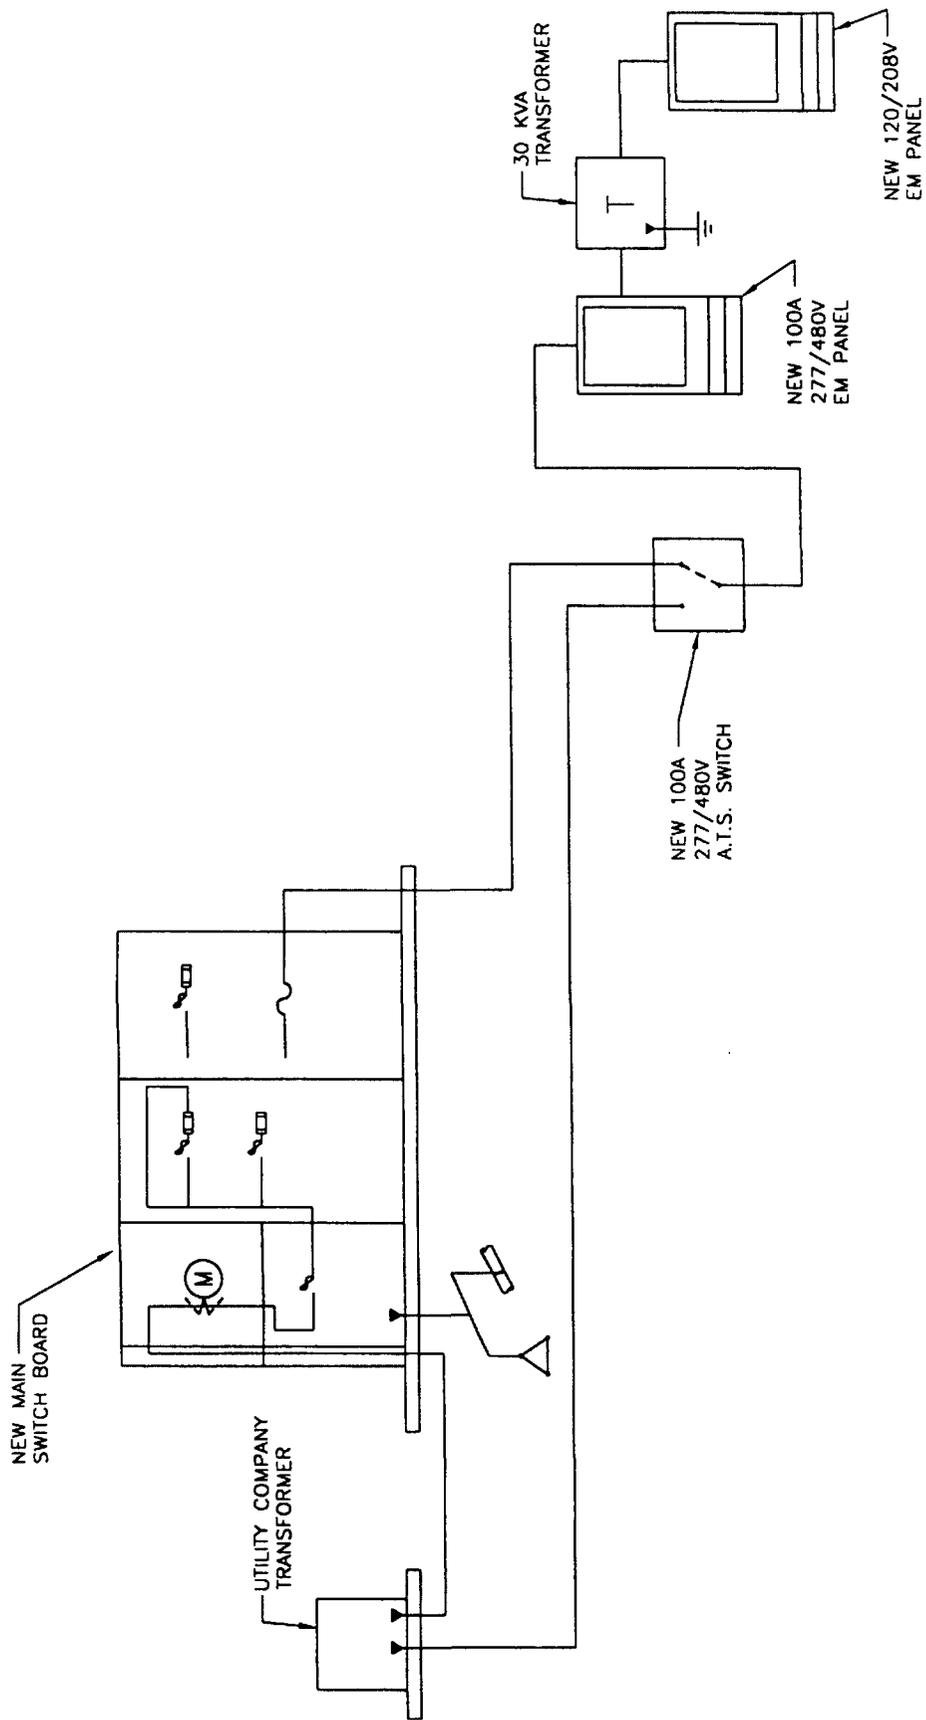
<b>Hinkle Engineering, Inc.</b> 175 W. Jackson Blvd., #2109 Chicago, IL. 60604 Tel: 312-789-8020 Fax: 312-789-8021	Drawing Title : <b>PROPOSED EM DIST. SYSTEM</b>	Date : 1-22-99	By : D.C.	Dwg No : <b>SK-3</b>
	Project : <b>EVANSTON CMC CENTER</b>	Proj. # : 98-010b	Scale : NONE

**PROPOSED EM DISTRIBUTION SYSTEM**  
N.T.S.
