# **Code Analysis and Conditions Assessment Report**

## **Evanston Arts Center**

2603 Sheridan Road  
Evanston, IL 60201

June 25, 2012

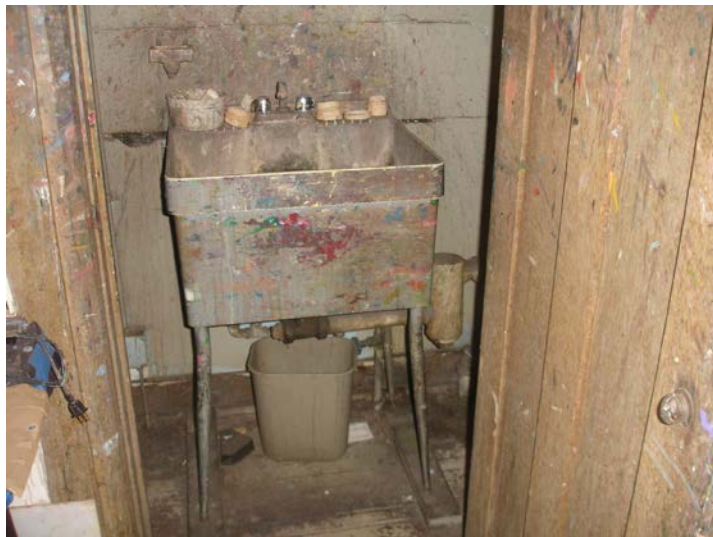
Slop sink in 3rd floor art studio

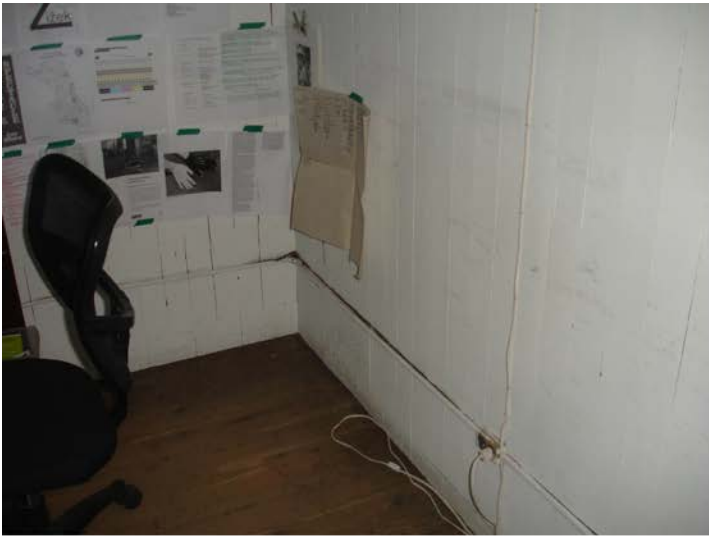
Panel in art studio

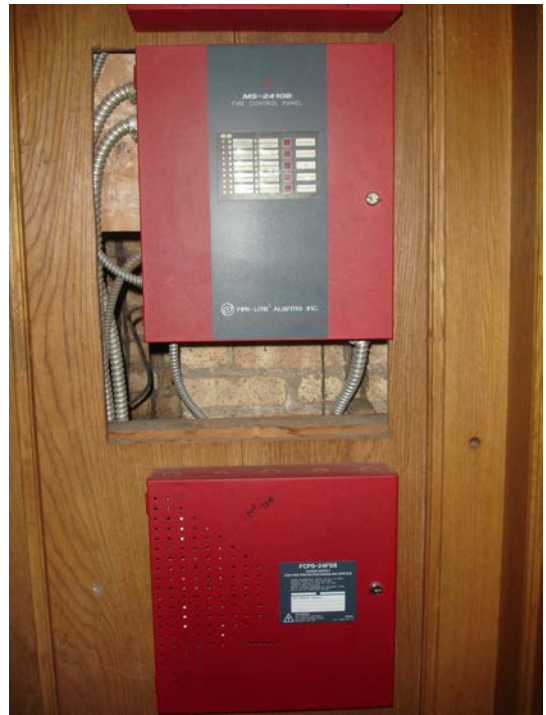
Fire alarm panel
