# **Code Analysis and Conditions Assessment Report**

## **Evanston Arts Center**

2603 Sheridan Road  
Evanston, IL 60201

June 25, 2012

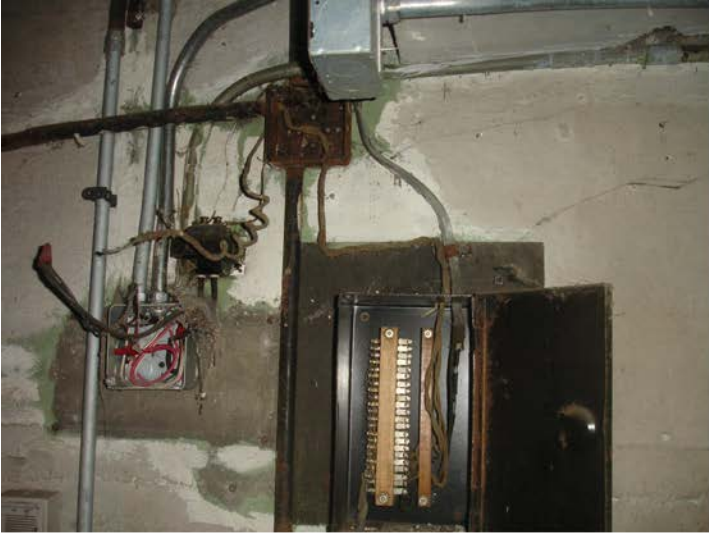
Old electrical panel

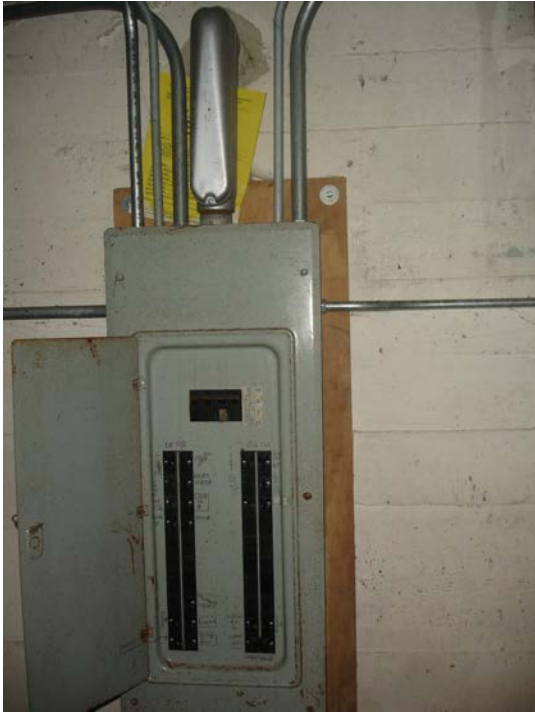
New coach house electrical panel

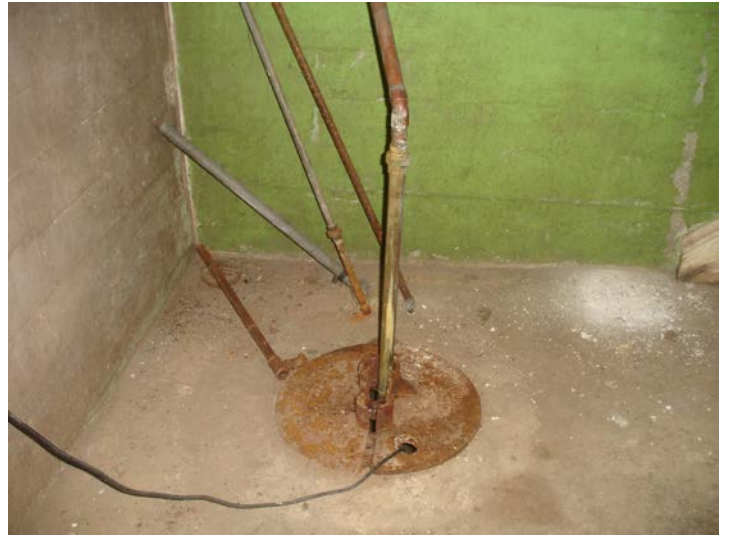
Sump pump in basement of coach house

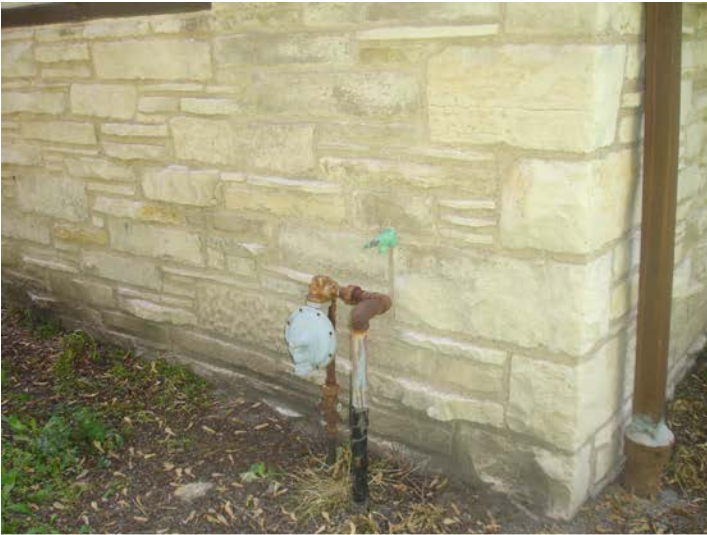
Gas service to coach house

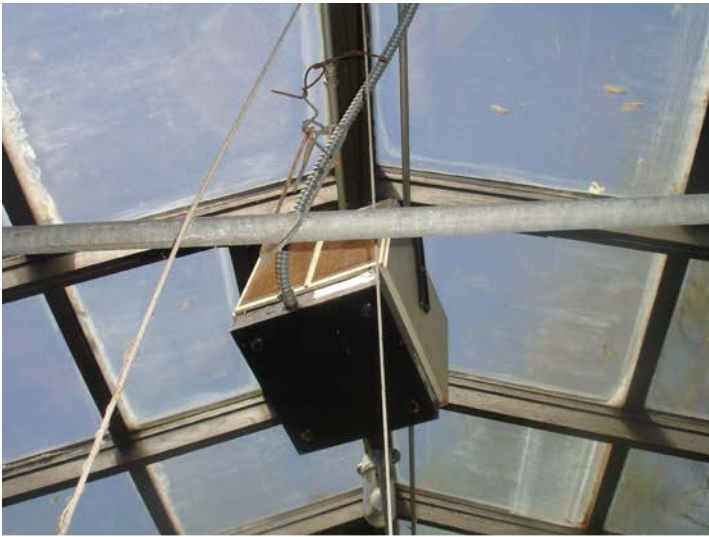
The attached greenhouse has its own heating and ventilating equipment however it appears to be older and in poor condition. If the greenhouse were to be put back in service these systems would need to be replaced with new.

Green house heating unit

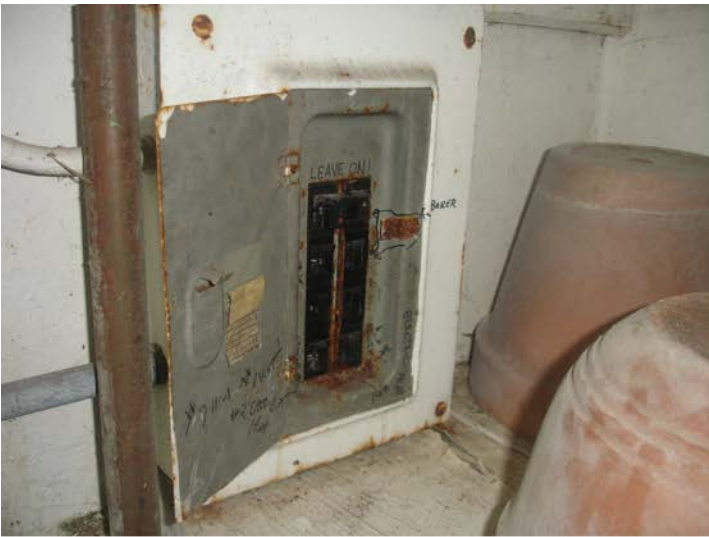
Green house electrical panel

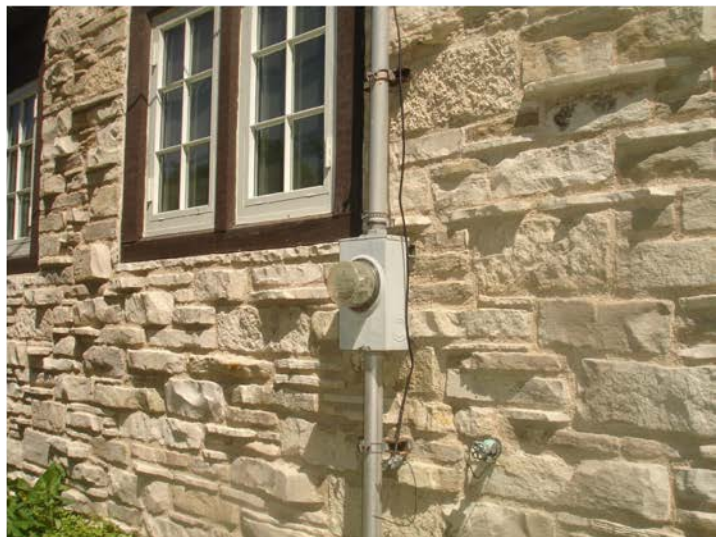
Coach house electric meter

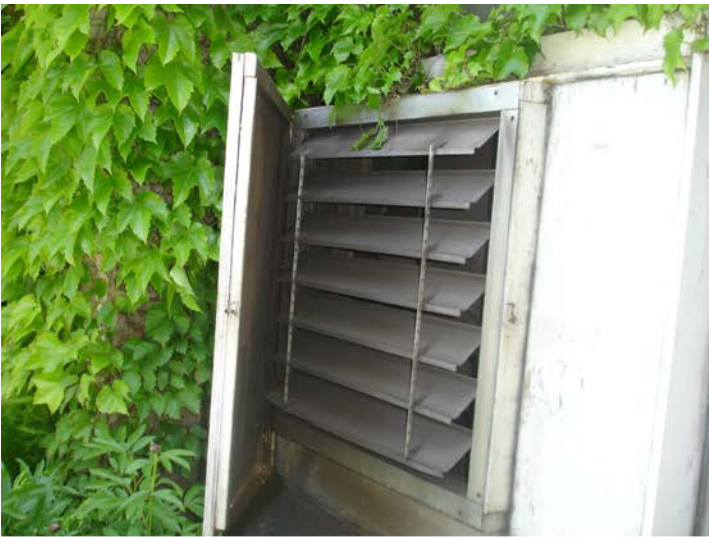
Spray booth exhaust

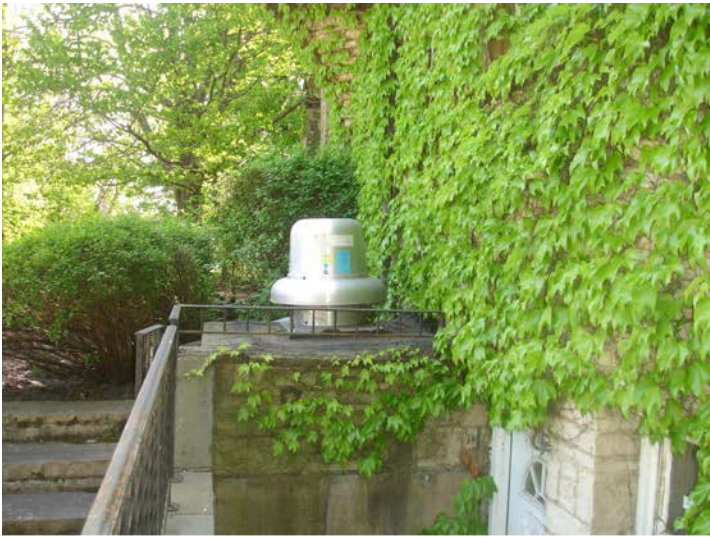
Basement photo area exhaust

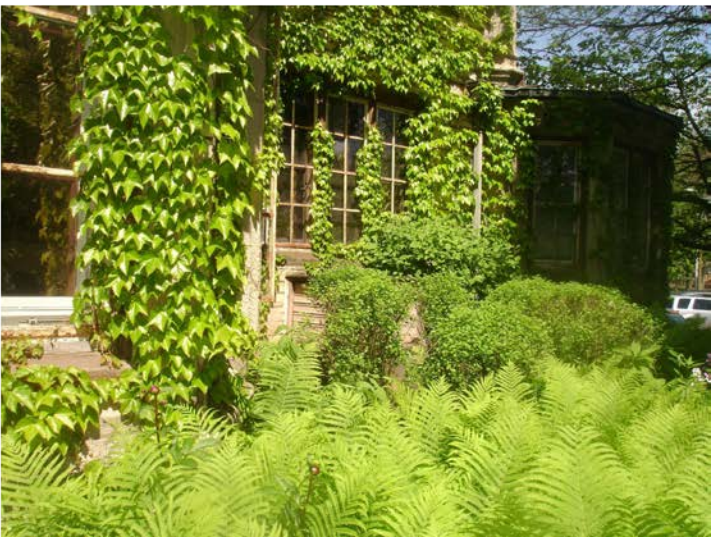
Spray booth exhaust
