May 20, 2024
GEI Project No.: 2200549

RE: **Vibration Monitoring Report – Northwestern University Ryan Field,
Evanston, Illinois– Report No. 3 (May 5, 2024, through May 20, 2024)**

**Northwestern University Ryan Field
Evanston, Illinois**

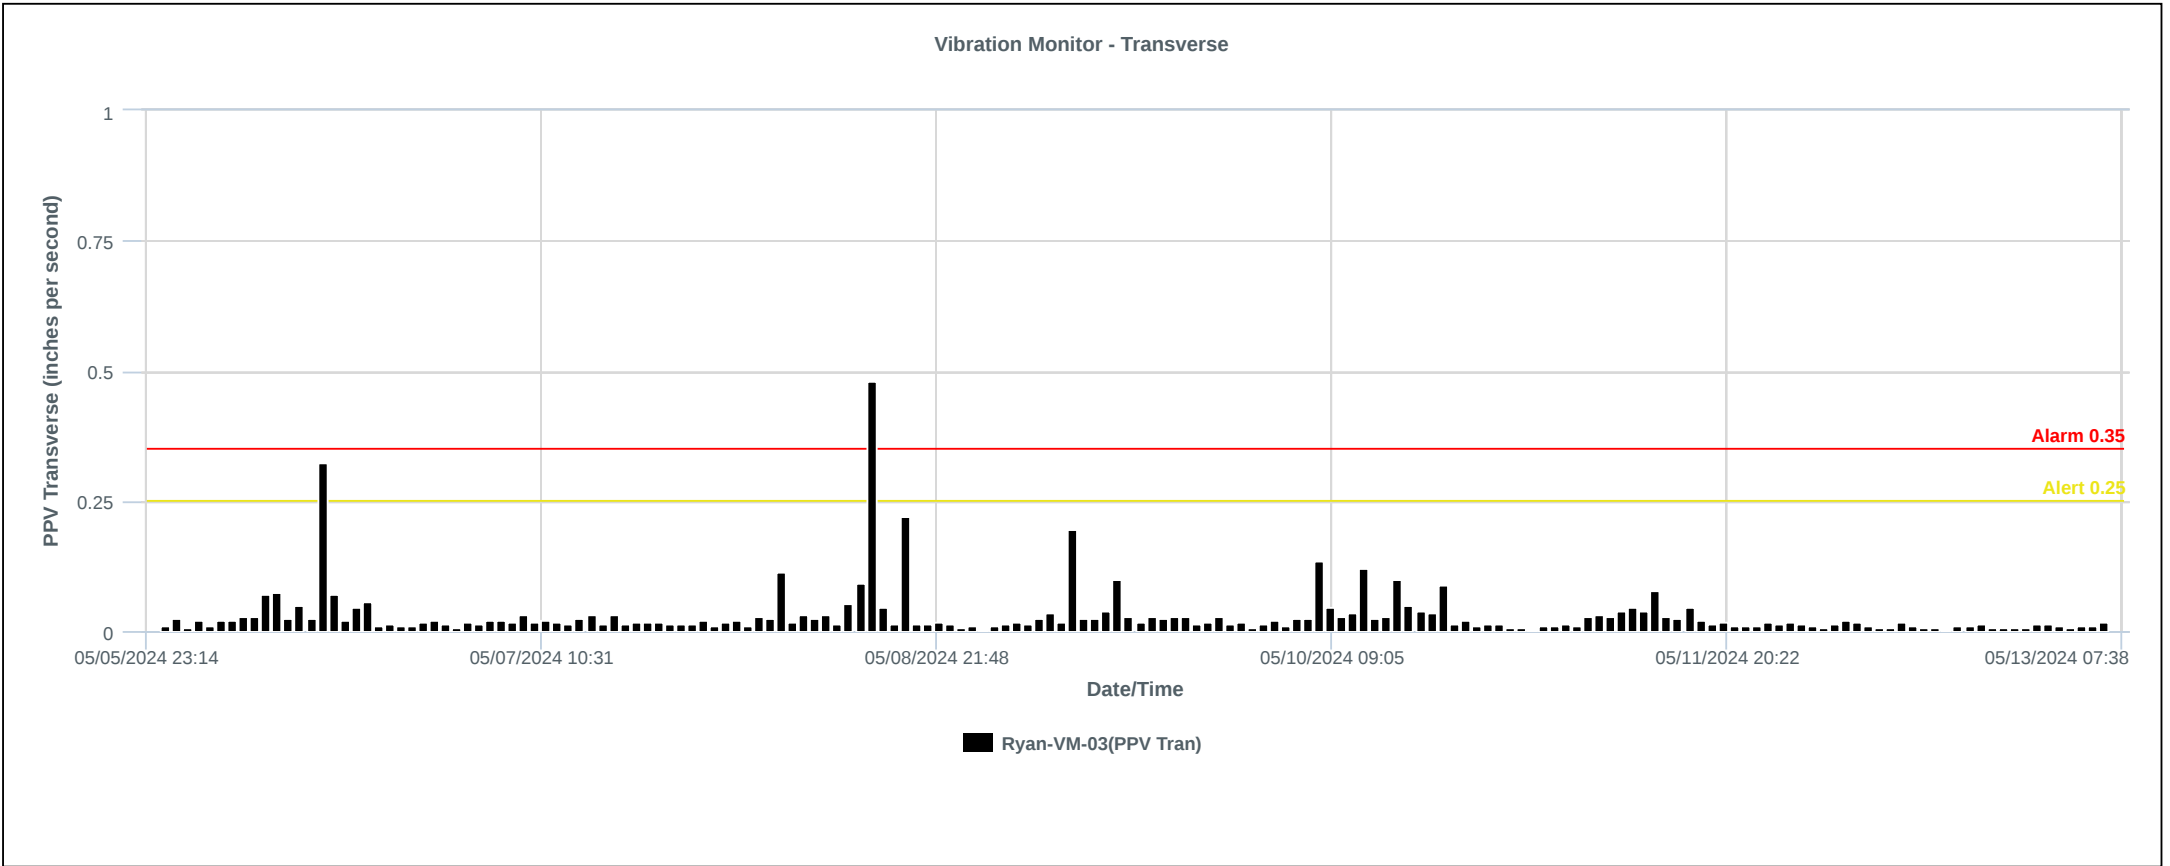
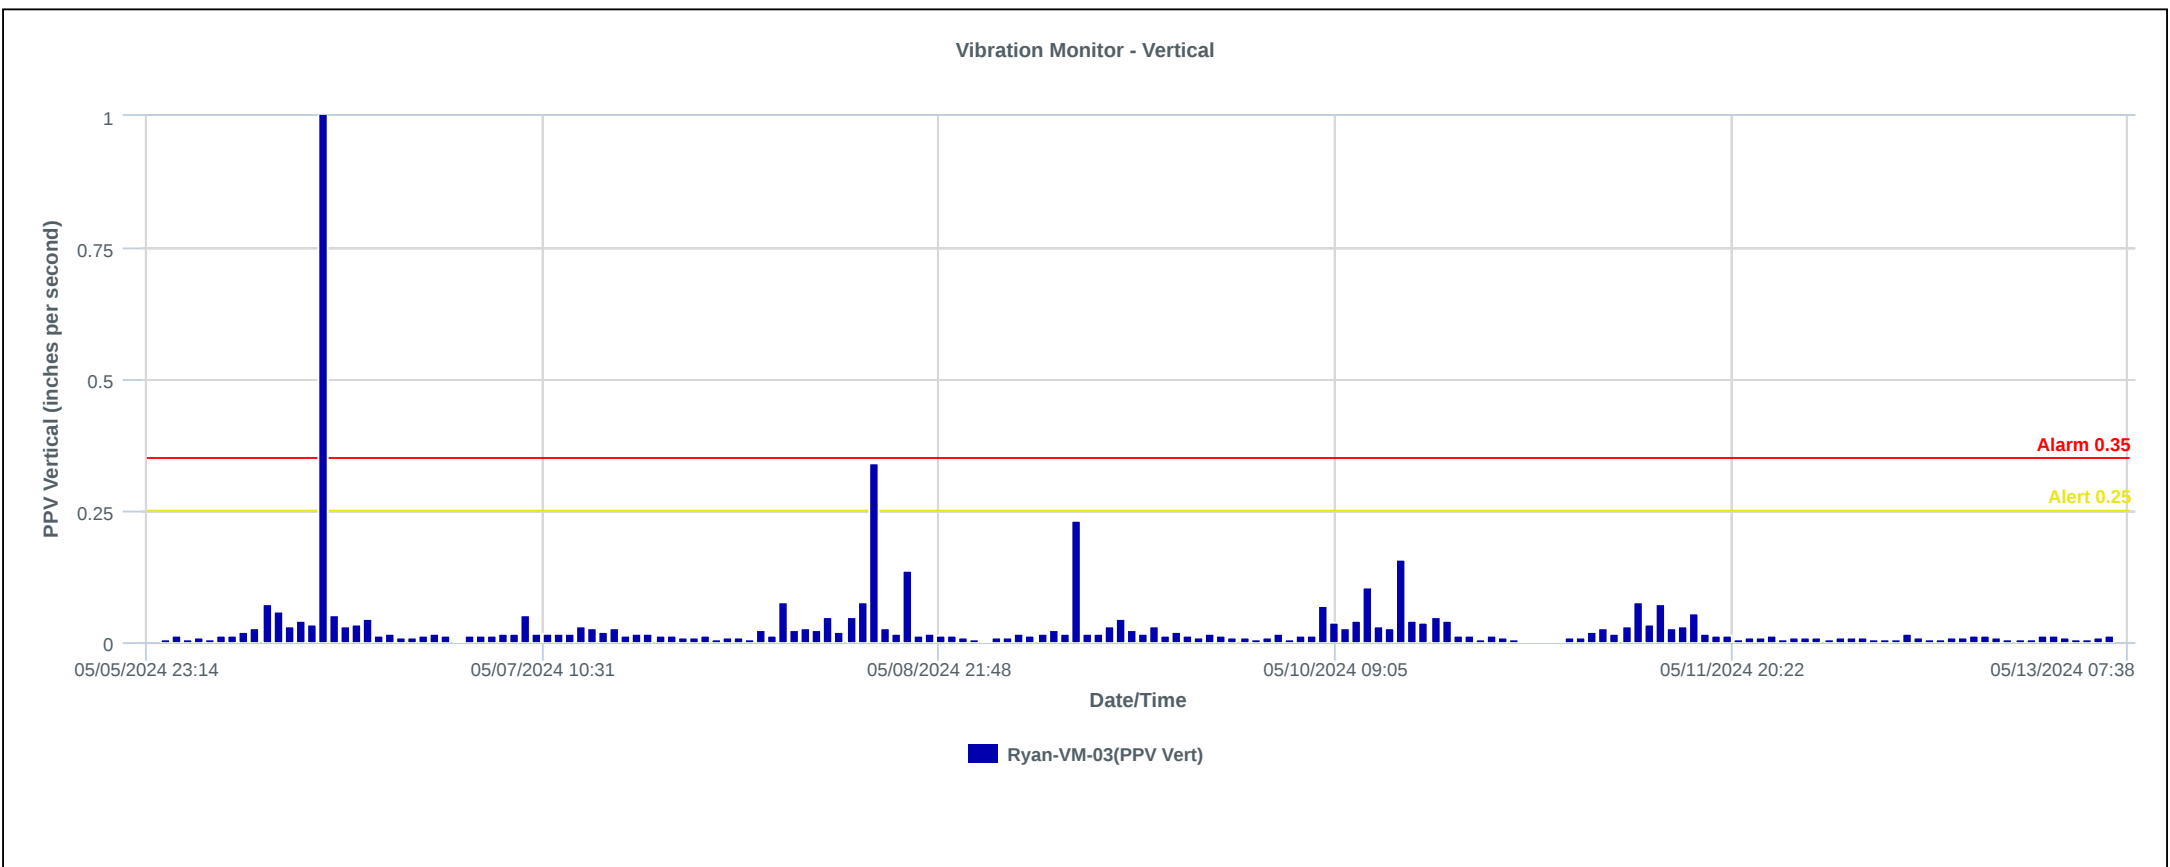
VM-03 Weekly

Vibration Monitor Locations	Maximum Daily Vibration Level Range
VM-1 East Property Line RVM No. UM 10183	0.010 to 0.2640 in/sec.
VM-2 South Property Line RVM No. UM 12092	0.010 to 0.2260 in/sec.
VM-3 West Property Line RVM No. UM 11876	0.010 to 0.2920 in/sec.
VM-4 Welsh Ryan Arena RVM No. UM 19052	0.010 to 0.1490 in/sec.
VM-5 Anderson Hall RVM No. UM 19035	0.010 to 0.1120 in/sec.
VM-6 North Property Line near Ballfield RVM No. UM 16916	0.010 to 0.2340 in/sec.

Four events at VM-3 were recorded that were not related to construction activity after the geophone was disturbed during demolition equipment movement and demobilization preparation. These four events were excluded from the vibration summary for the period of May 5th thru May 20th, 2024, report.
