RE: **Vibration Monitoring Report – Northwestern University Ryan Field,
Evanston, Illinois– Report No. 4 (May 19, 2024, through June 3, 2024)**

Appendix for Vibration Monitoring Report

Report No. 4

**Northwestern University Ryan Field
Evanston, Illinois**

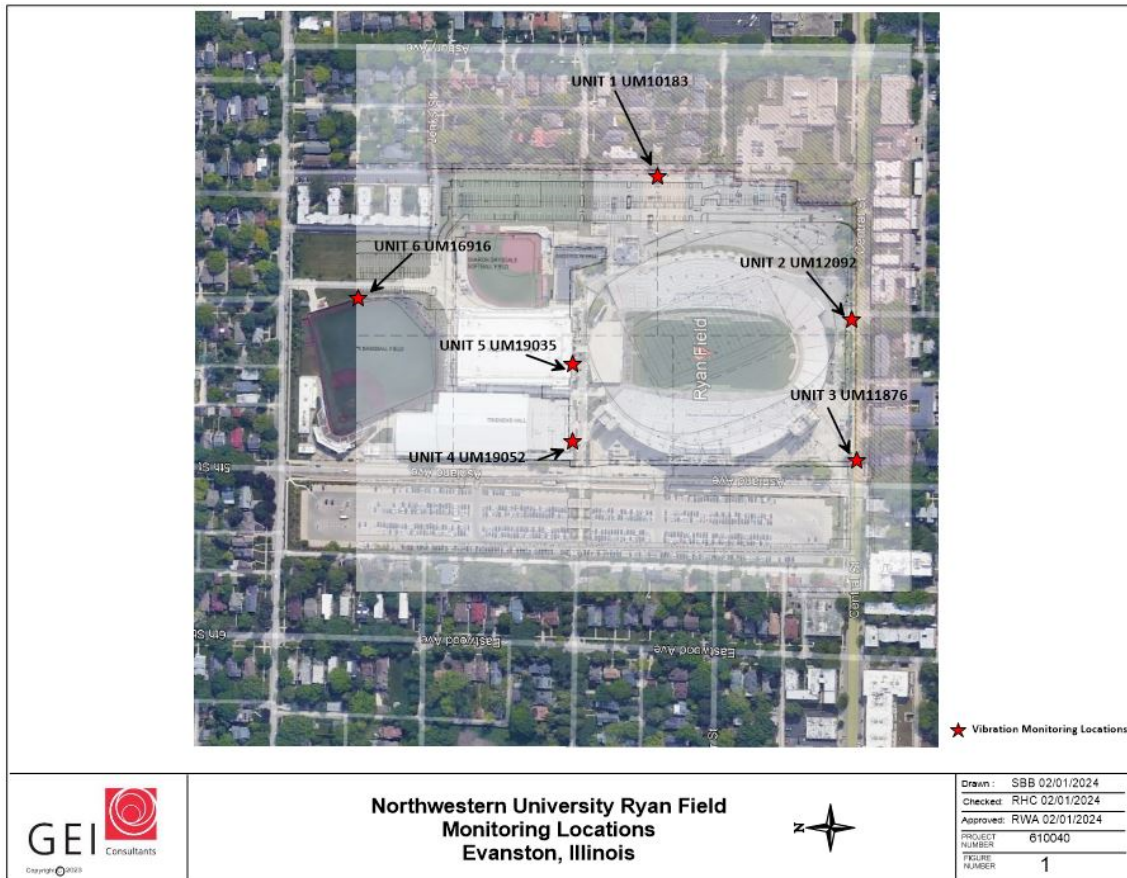
Figure 1: Vibration Monitor Locations

Monitor No.	Location
VM-1 UM 10183	East Property Line
VM-2 UM 12092	North Property Line
VM-3 UM 11876	West Property Line
VM-4 UM 19052	Welsh Ryan Arena Mechanical Room
VM-5 UM 19035	Anderson Hall Mechanical Room
VM-6 UM 16916	North Property line near Baseball Field
