October 1, 2024
GEI Project No.: 2200549

RE: **Vibration Monitoring Report – Northwestern University Ryan Field,
Evanston, Illinois– Report No. 8 (September 1, 2024, through September 30,
2024)**

Report No. 8

Northwestern University Ryan Field
Evanston, Illinois

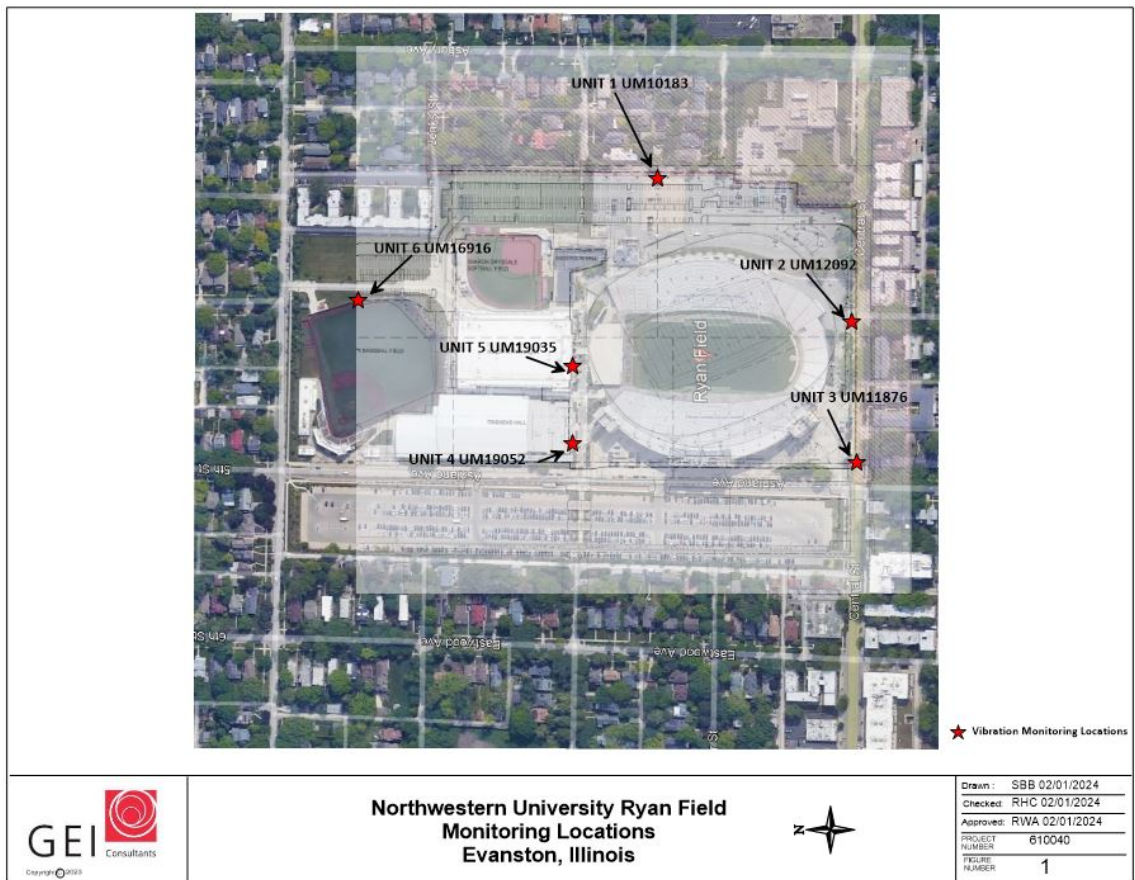
Figure 1: Vibration Monitor Locations

The locations of the installed RVMs are:

Monitor No.	Location
VM-1 UM 10183	East Property Line
VM-2 UM 12092	North Property Line
VM-3 UM 11876	West Property Line
VM-4 UM 19052	Welsh Ryan Arena Mechanical Room
VM-5 UM 19035	Anderson Hall Mechanical Room
VM-6 UM 16916	North Property line near Baseball Field

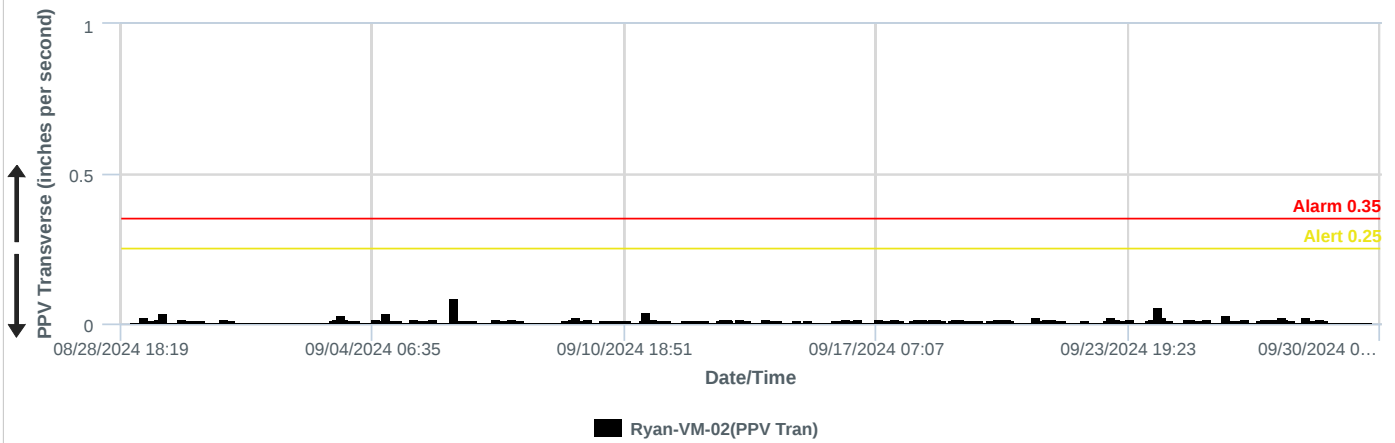
Vibration Monitor - Transverse

Vibration Monitor Locations	Maximum Daily Vibration Level Range
VM-1 East Property Line RVM No. UM 10183	0.010 to 0.103 in/sec.
VM-2 South Property Line RVM No. UM 12092	0.010 to 0.104 in/sec.
VM-3 West Property Line RVM No. UM 11876	0.010 to 0.602 in/sec.
VM-4 Welsh Ryan Arena RVM No. UM 19052	0.010 to 0.261 in/sec.
VM-5 Anderson Hall RVM No. UM 19035	0.010 to 0.082 in/sec.
VM-6 North Property Line near Ballfield RVM No. UM 16916	0.010 to 0.069 in/sec.

The vibration levels recorded by the vibration monitors were all below the established project threshold of 0.35 in/sec.
