# **Code Analysis and Conditions Assessment Report**

## **Evanston Arts Center**

2603 Sheridan Road  
Evanston, IL 60201

June 25, 2012

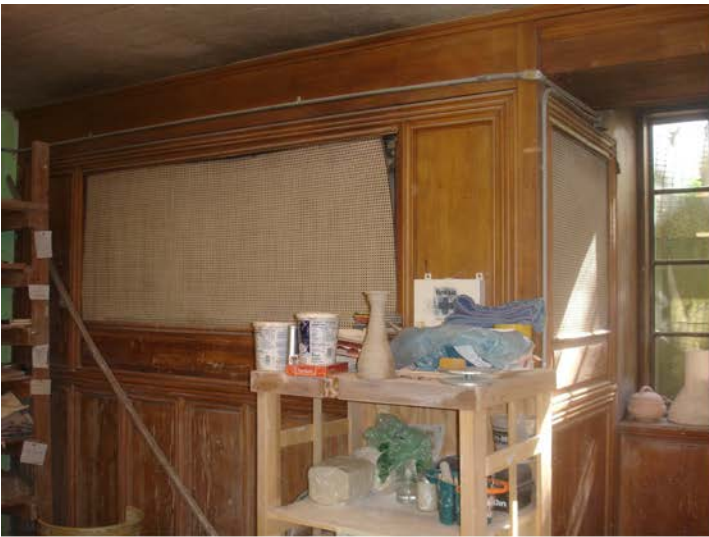
In the basement, there are a number of gas fired ceramics kilns. This space by code needs to be enclosed in a fire rated room. Presently it is open to the rest of the basement. A few of the Kilns have exhaust hoods over them but they appear inadequate in size and location to do an adequate job of exhausting heat and fumes.

Basement pottery studio

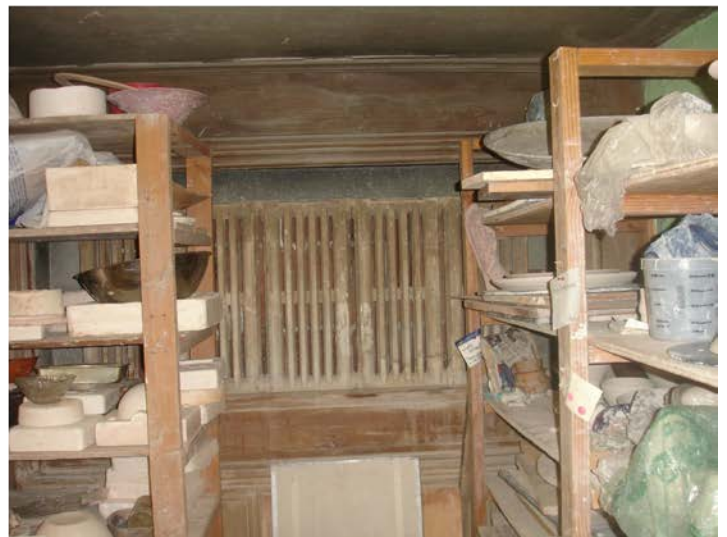
Plug strips used in studio

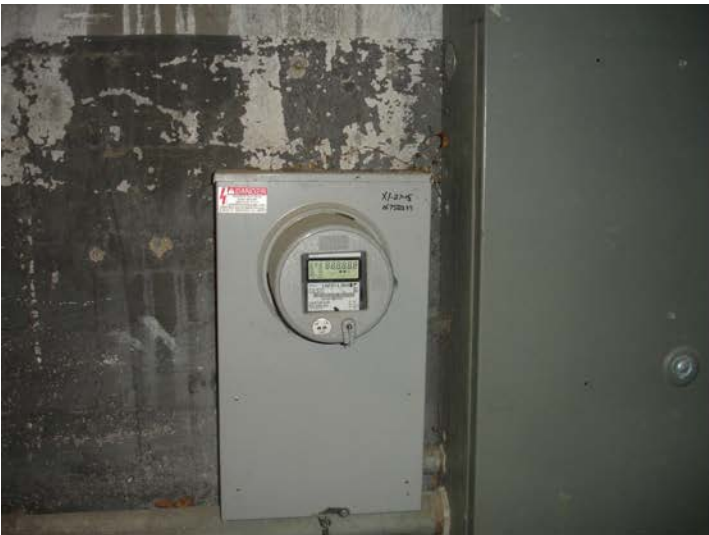
Electric meter

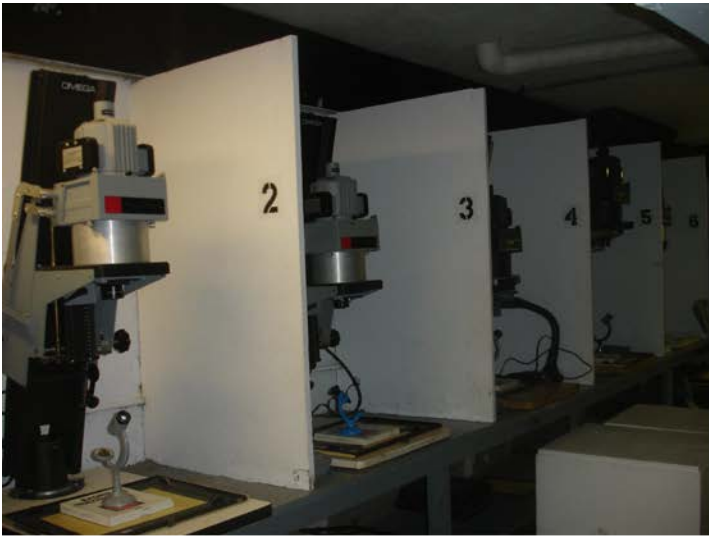
Photo lab

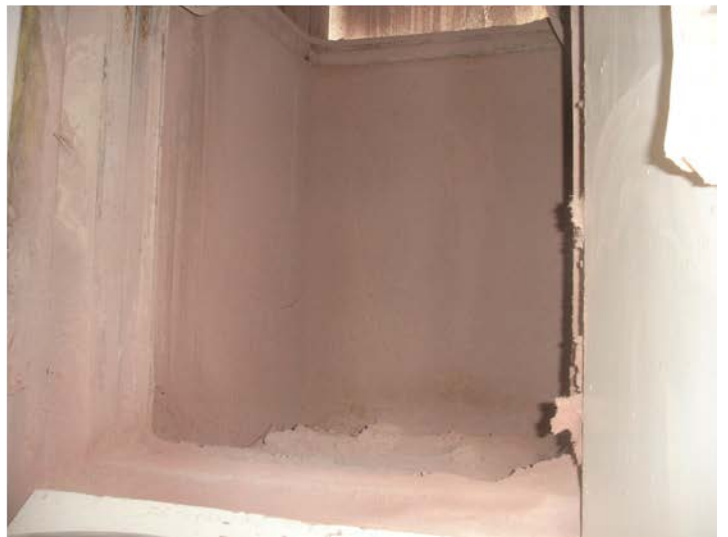
Spray booth exhaust

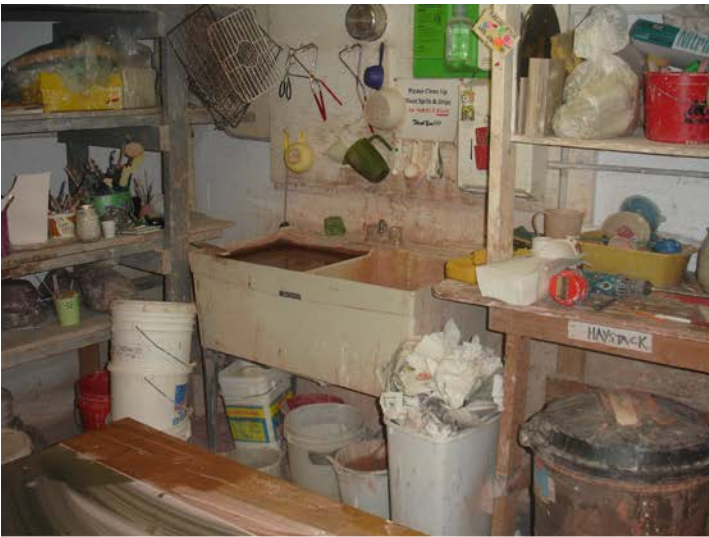
Slop sink in ceramics studio

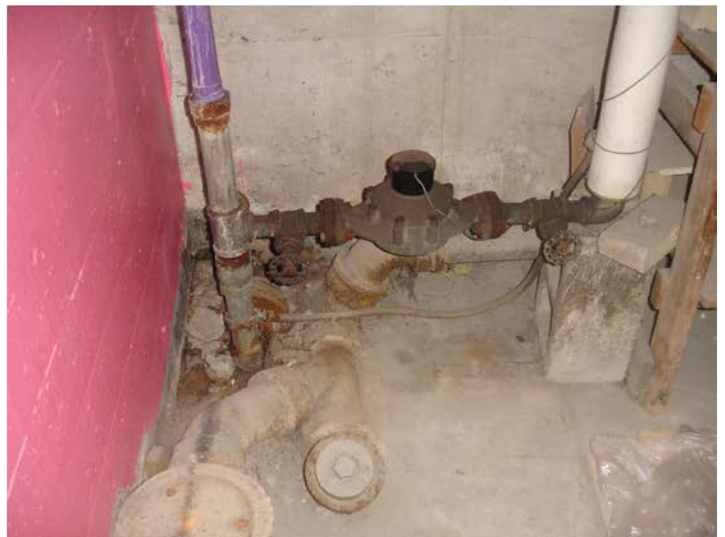
If this were done, the incoming water service may need to be replaced. Presently there is a 1 ½" supply pipe and a 1" water meter. The new requirement would be for at least a 2" possibly larger. Also, if flush valve fixtures were to be used instead of tank type which is normal for business uses a domestic water booster pump may be needed.

Water meter

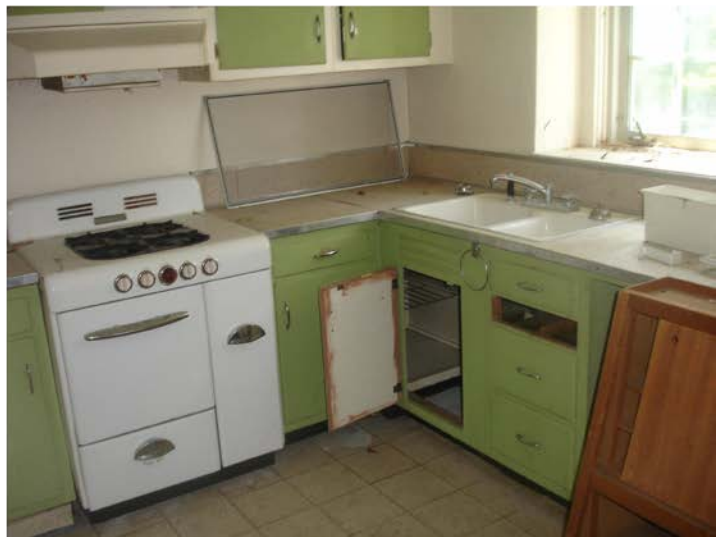
The Coach house on the EAC property has a first floor and a second floor apartment. As they exist, due to the long time being unoccupied, all of the fixtures etc. are in poor condition and would need to be replaced.

Coach house apt bedroom

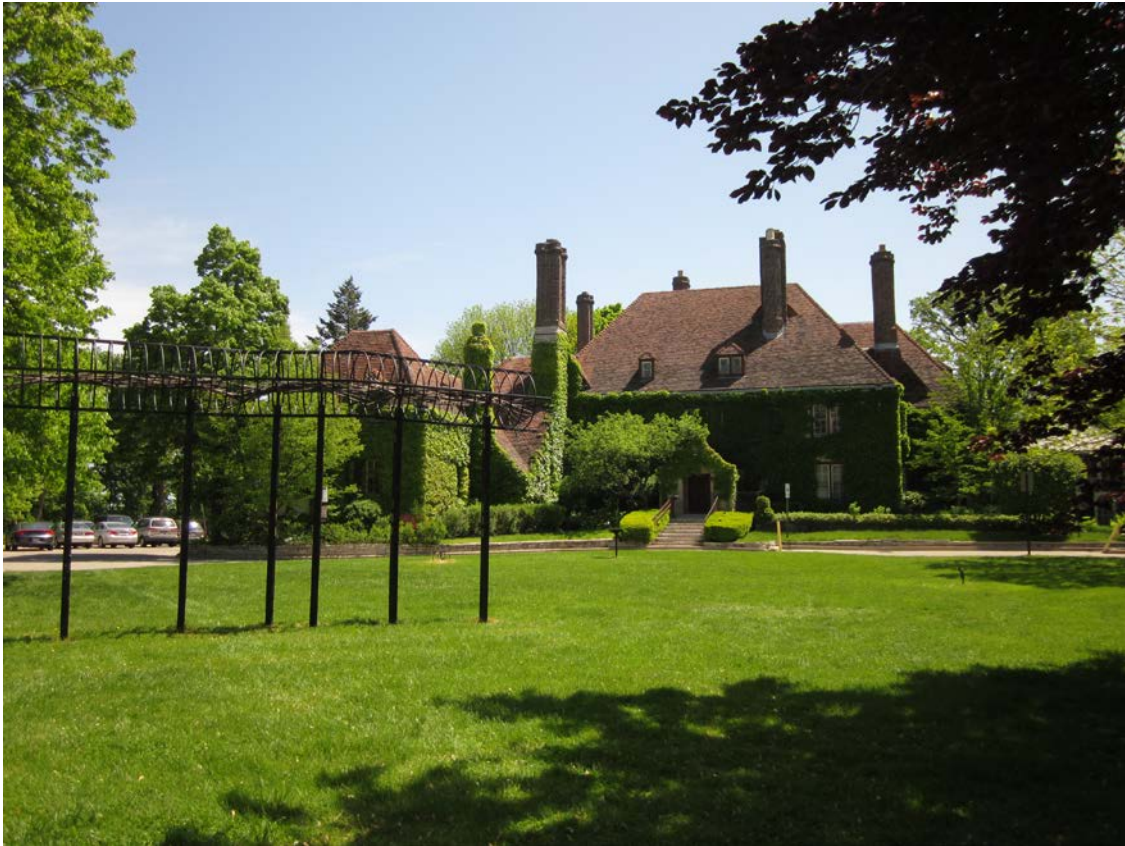
Photo 1 – West Elevation

No major structural deficiencies were observed in the EAC; the conditions observed are generally a result of deferred maintenance, with exterior resulting in varying states of material degradation. The majority of exterior stone is covered by ivy and plant growth, which has a tendency to trap and hold moisture against the masonry. The density of the plant growth is so heavy that the stonework cannot be assessed (Photos 1 and 2). Mortar joint deterioration was observed in many locations (Photo 3). The stone walls supporting the original north exterior stair are in very poor condition (Photo 4). A new wood stair has been constructed over the original construction.
