# **Code Analysis and Conditions Assessment Report**

## **Evanston Arts Center**

2603 Sheridan Road  
Evanston, IL 60201

June 25, 2012

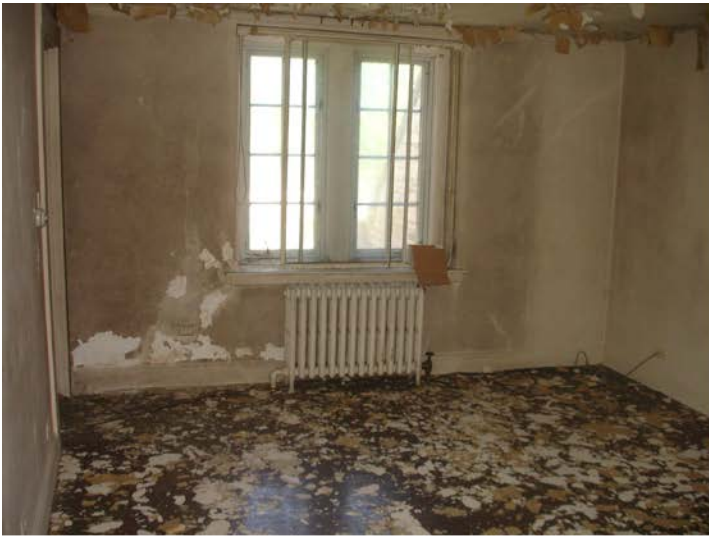
The Coach house on the EAC property has a first floor and a second floor apartment. As they exist, due to the long time being unoccupied, all of the fixtures etc. are in poor condition and would need to be replaced.

Coach house apt kitchen

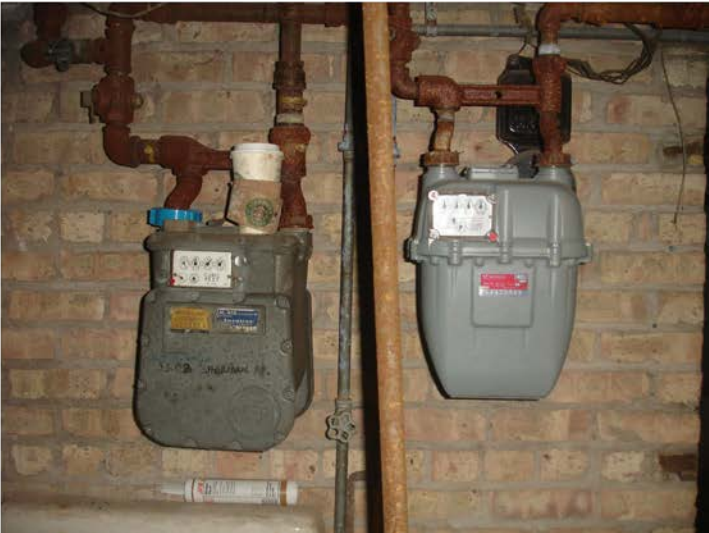
Coach house gas meters

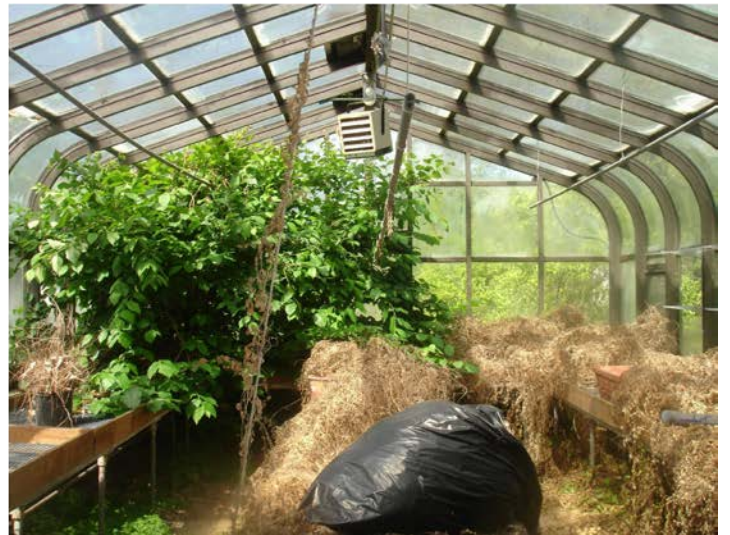
Greenhouse attached to coach house

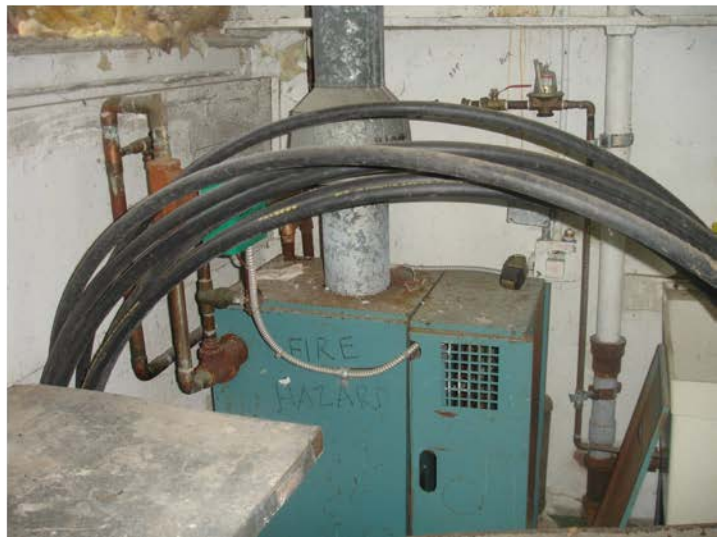
The attached greenhouse has its own heating and ventilating equipment however it appears to be older and in poor condition. If the greenhouse were to be put back in service these systems would need to be replaced with new.

Greenhouse boiler

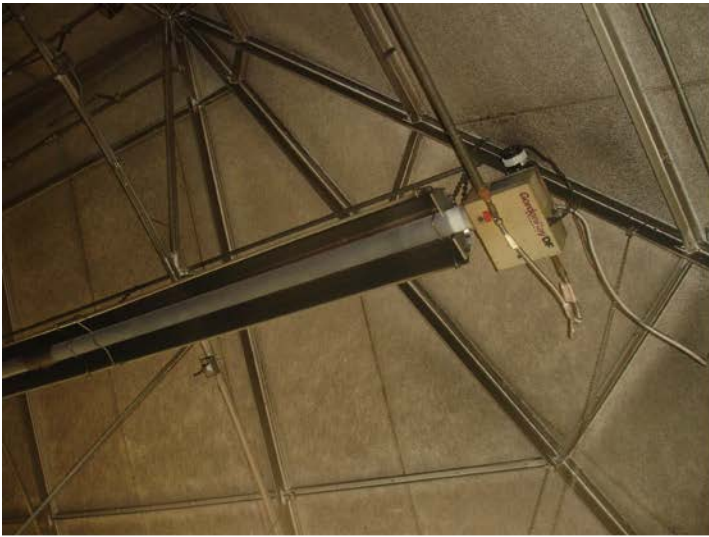
Metal shop heating unit

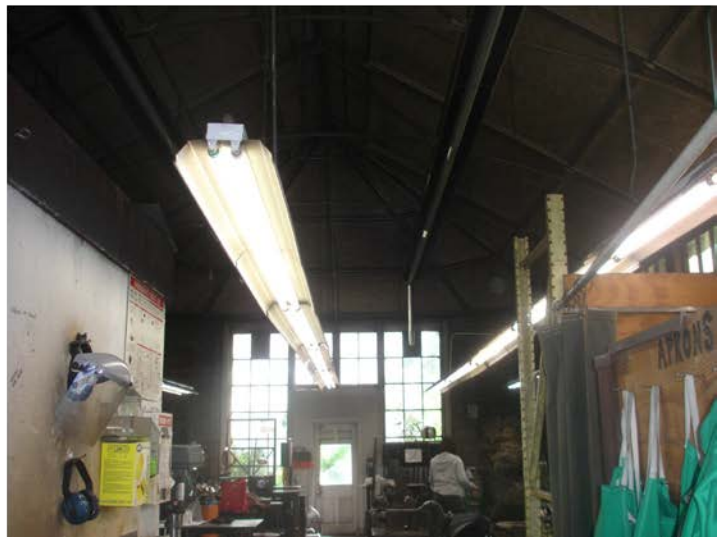
Metal shop

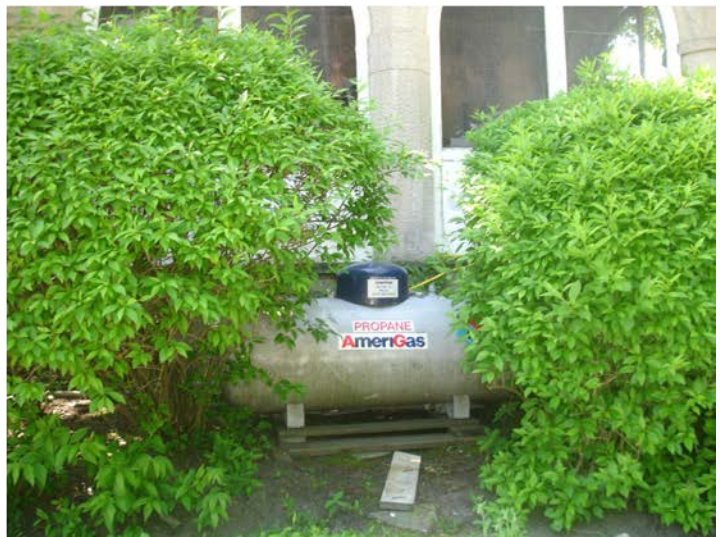
Propane tank on grade
